## Department of Toxic Substances Control

REPAIRING WELLS IN ACCORDANCE WITH CALIFORNIA WELL STANDARDS AT  
PACIFIC GAS AND ELECTRIC COMPANY (PG&E), TOPOCK COMPRESSOR  
STATION, NEEDLES, CALIFORNIA (EPA ID NO. CAT080011729)

| Department of Toxic Substances Control<br>Site Visit Report | | | |
| <b>Purpose of Visit:</b> | Observe damage to groundwater wells after 10/11/12 storm. | | |

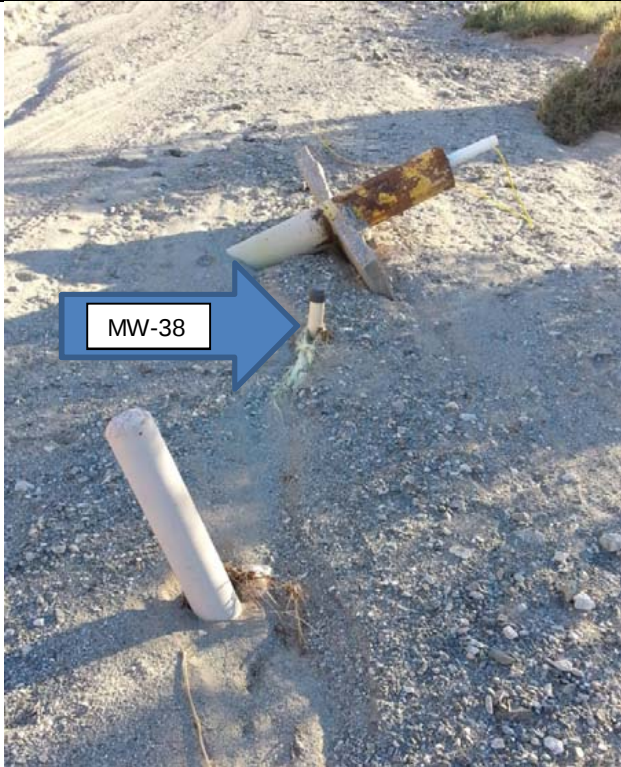
| 1 | Southerly view in Bat Cave Wash of destroyed well cluster MW-38 (11/6/12). The yellow casing rising about a foot from the wash is MW-38S. It is located between a toppled traffic bollard (foreground) and the remnant well head completion from well MW-38D (background). | |

1. Implement the CH2M Hill February 11, 2011 Implementation Plan for Repair of Monitoring Wells MW-38S and MW-38D and Old Well/Pipe Reconnaissance. PG&E must take all reasonable steps to comply with the substantive requirements of all applicable mitigation measures (e.g., cultural sensitivity training, Tribal notification, Tribal monitoring to observe activities). DTSC expects the repair plan to commence by the end of March 2013.

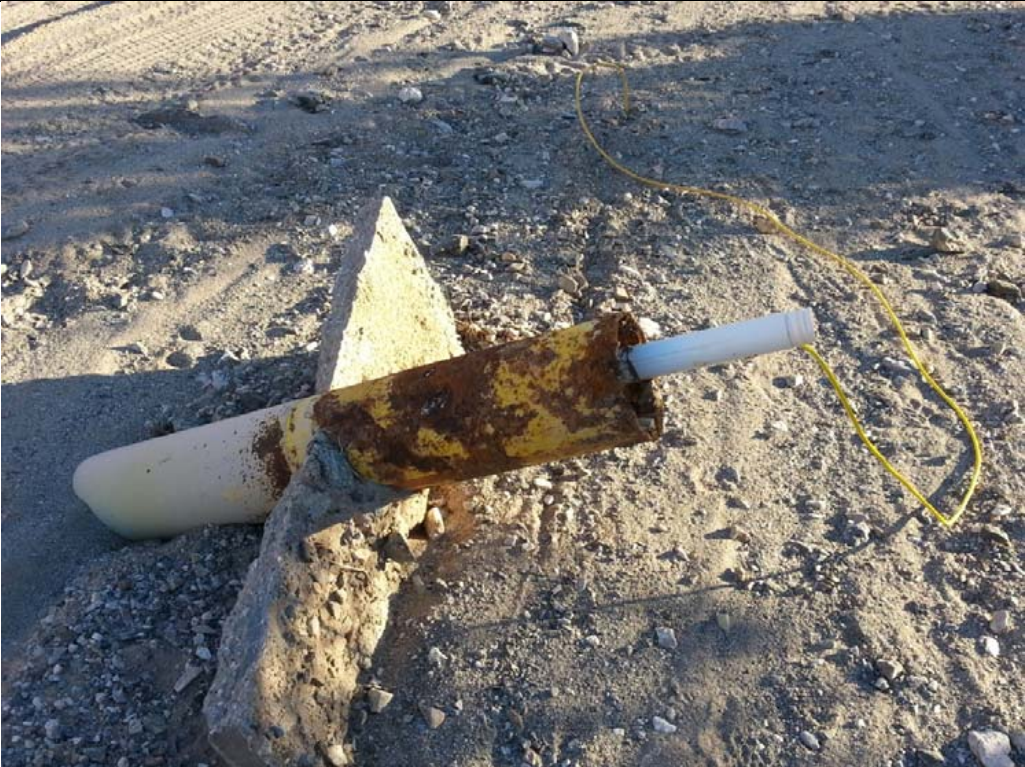
| 2 | Southerly view in Bat Cave Wash of remnant well head completion from MW-38D (11/6/12). The former base of the completion and exposed white PVC well casing is protruding in the air to the right. Note the yellow pressure transducer cable running out of the disjointed PVC casing. | |

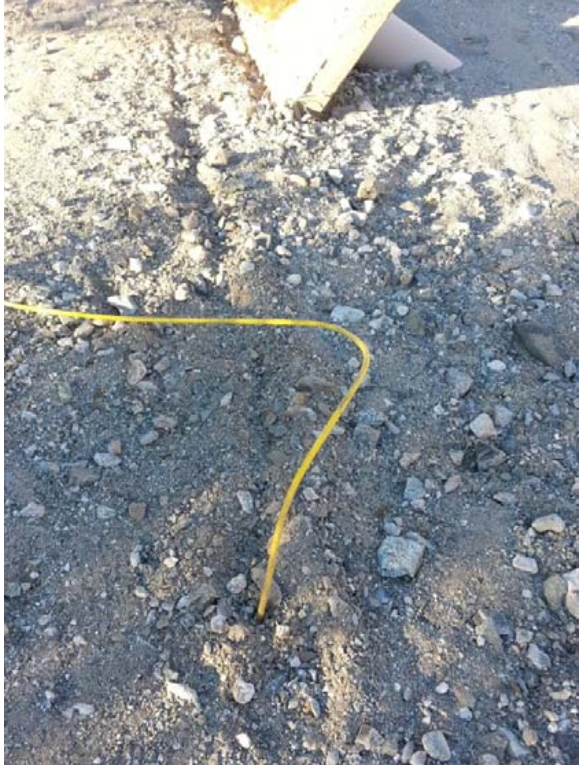
| 3 | <p>Close up of the yellow pressure transducer cable from well MW-38D running into the ground (11/6/12). The well is no longer visible and excavation will be required to locate the buried, disjointed well.</p> | |

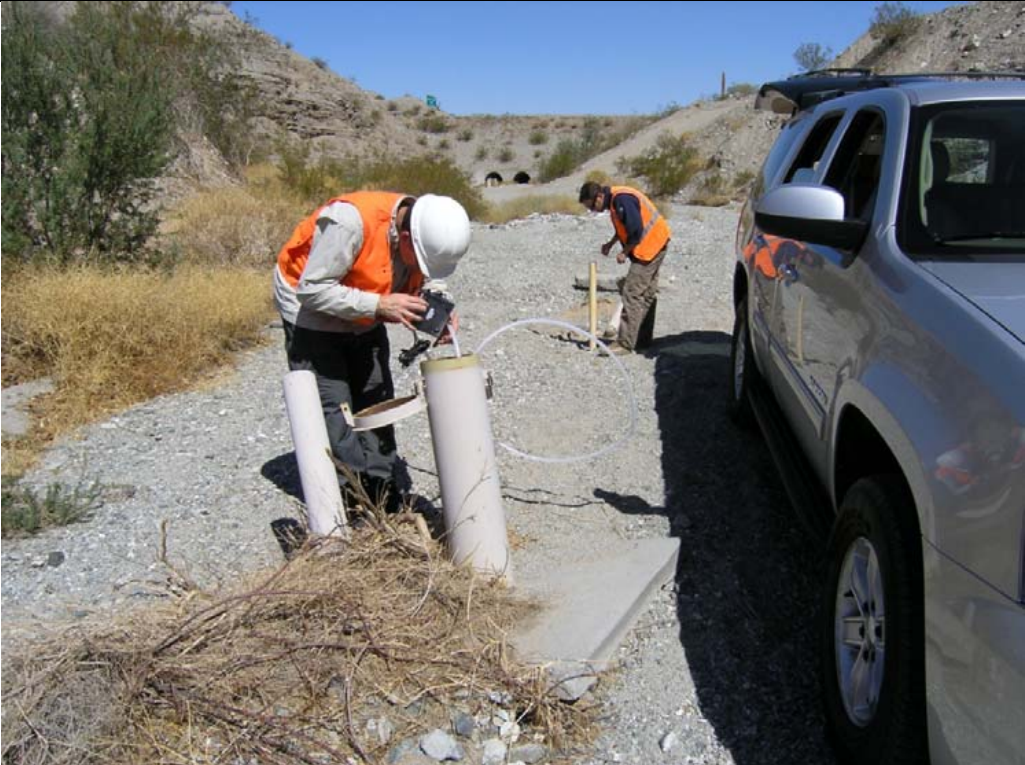
| 4 | | <p>Northerly view along Bat Cave wash of MW-38 cluster on September 14, 2010. These wells were initially damaged due to storms during the week of January 20, 2010. MW-38D in foreground and MW-38S in background.</p> |

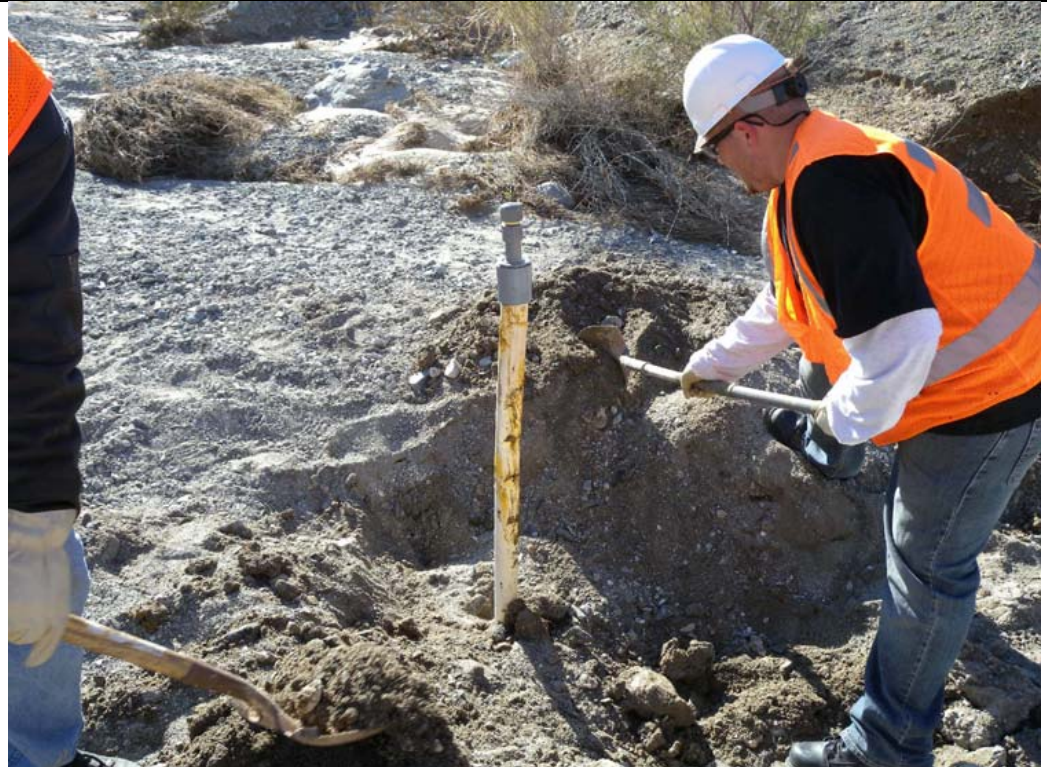
| 5 | <p>Westerly view of MW-38S in Bat Cave Wash, circa February 2010. Digging out buried well. Total depth was measured to be 33 feet below ground surface. The pressure transducer was missing and assumed to still be inside the well.</p> |

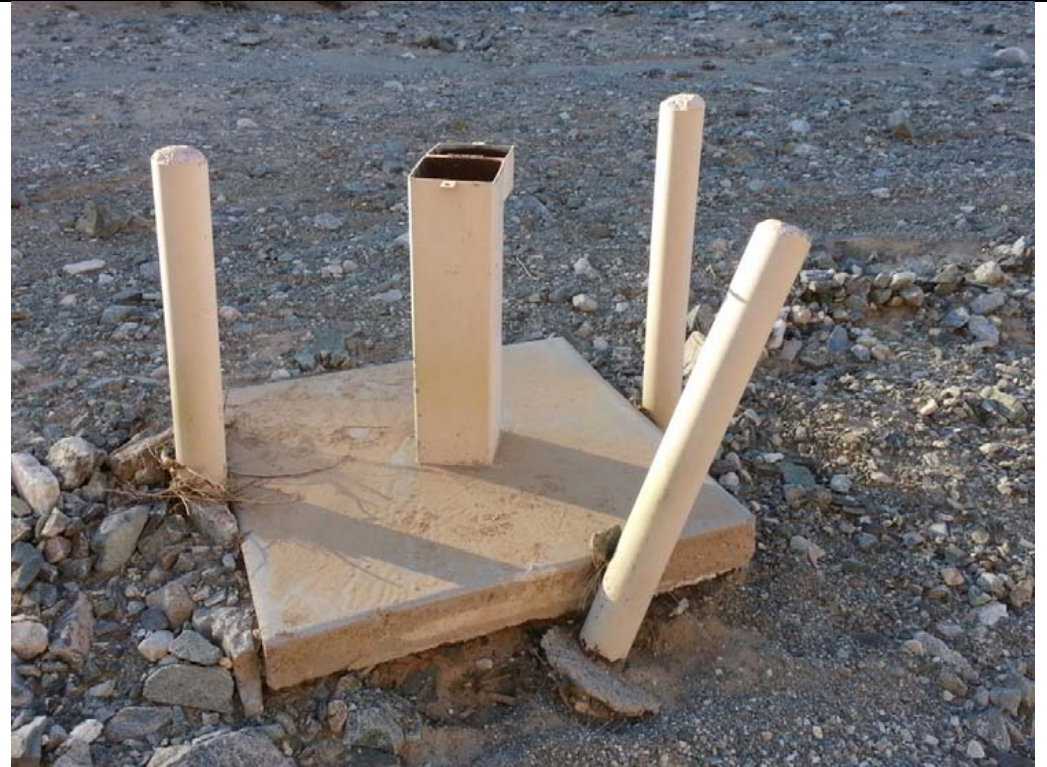
| 6 | <p>Westerly view of well MW-9 in Bat Cave Wash (11/6/12). No locking cover. Traffic bollard damaged due to excessive erosion.</p> |

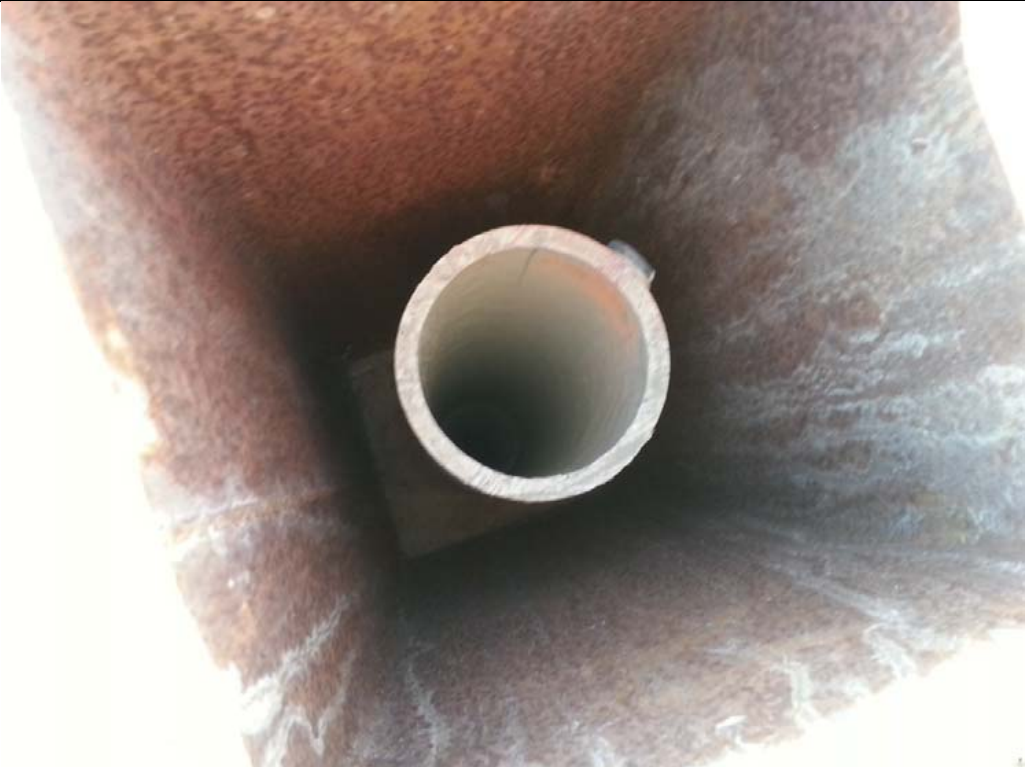
| 7 | View inside protective casing of well MW-9 in Bat Cave Wash (11/6/12). No casing cap is present. |

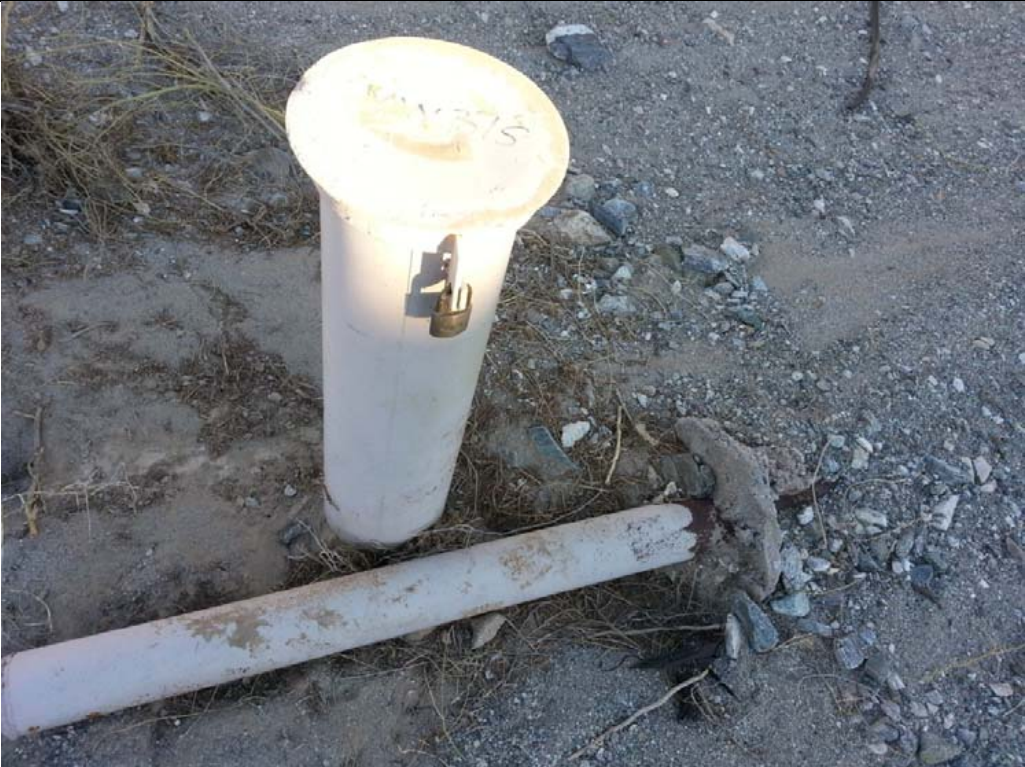
| 8 | View of well MW-37S in Bat Cave Wash (11/6/12). Traffic bollard damaged. Lock present. Well pad not visible. |

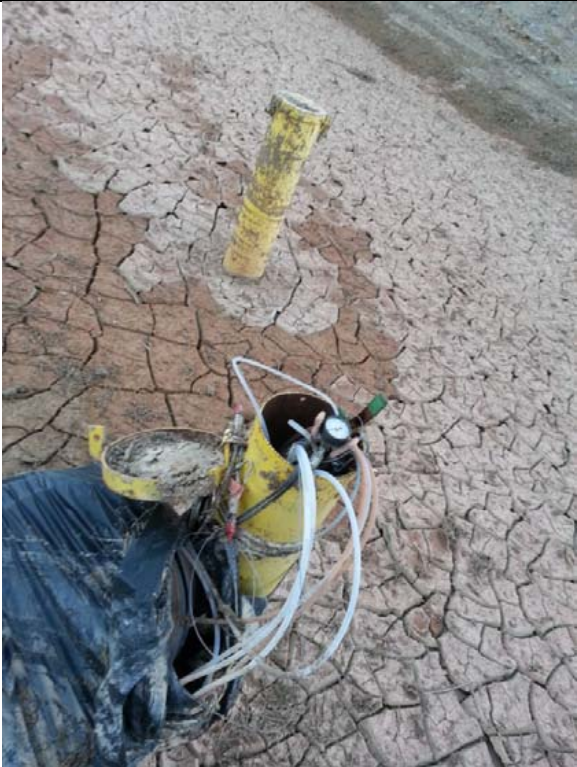
| 9 | View of wells MW-58-65 (background) and MW-58BR-Upper/Lower (foreground) in the impoundment area within the East Ravine (11/6/12). Flooding occurred on October 11, 2012. | |

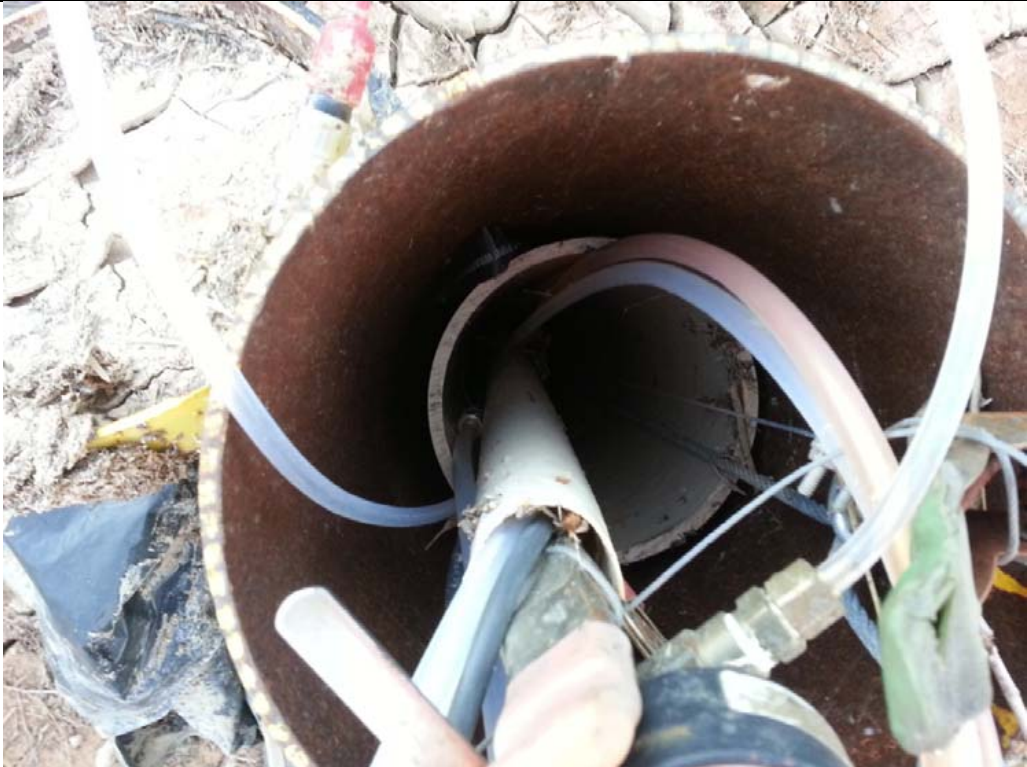
| 10 | View inside protective casing of well MW-58BR-Upper/Lower in the impoundment area within the East Ravine (11/6/12). No casing cap or lock. Note that water has entered the well following flooding as evidenced by organic debris on both white PVC casings. | |

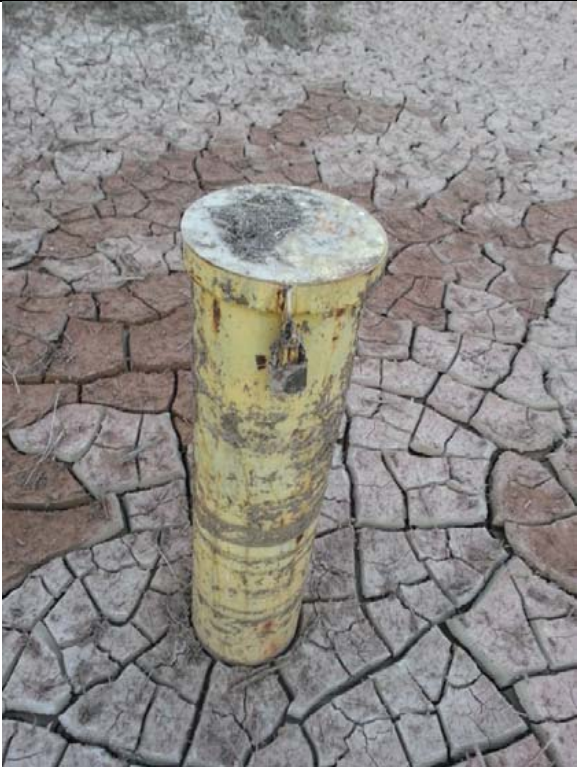
| 11 | <p>View of well MW-58-65 in the impoundment area within the East Ravine (11/6/12). Lock present. Note that the debris on top of the protective casing indicates that flood waters had completely overtopped this well.</p> | |

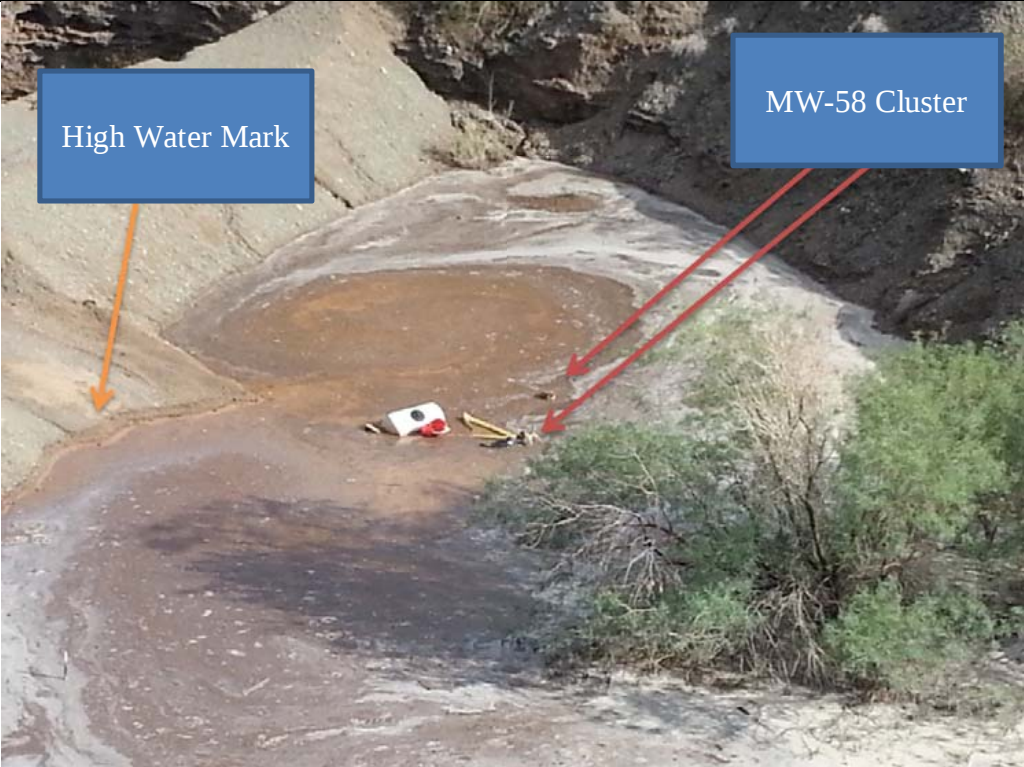
| 12 | <p>View of flooded impoundment area within the East Ravine (10/11/12) in the afternoon several hours after the storm had passed. Both MW-58 wells are almost completely submerged. Note that the high water mark suggests the wells were overtopped for a period of time.</p> | |

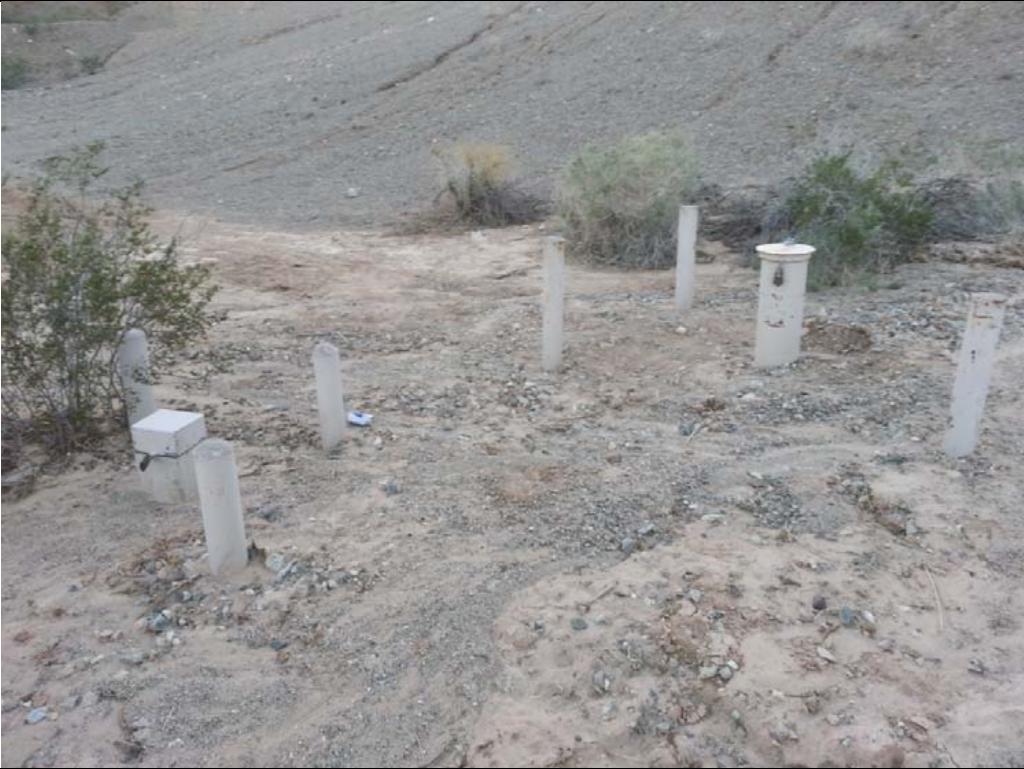
| 13 | View of wells MW-12 and MW-48 in the topographic low area (AOC-11) east of the station (11/6/12). Locks present. The storm has covered the well area with soils and well pads are not visible. |

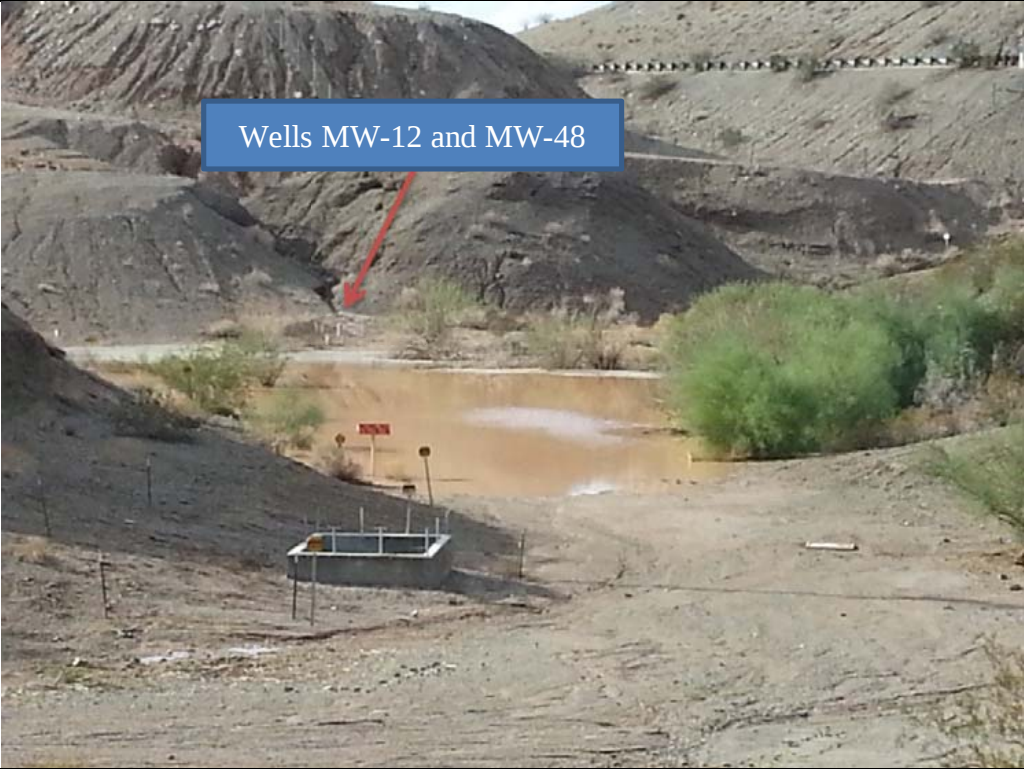
| 14 | Northwesterly view of flooded lowland area near the access road approaching the station (aka AOC-11). Wells MW-12 and MW-48 are barely visible in the background (see arrow). |
