Pacific Gas and Electric Company

Topock Revegetation Year 1 Mitigation Monitoring Report

December 2023

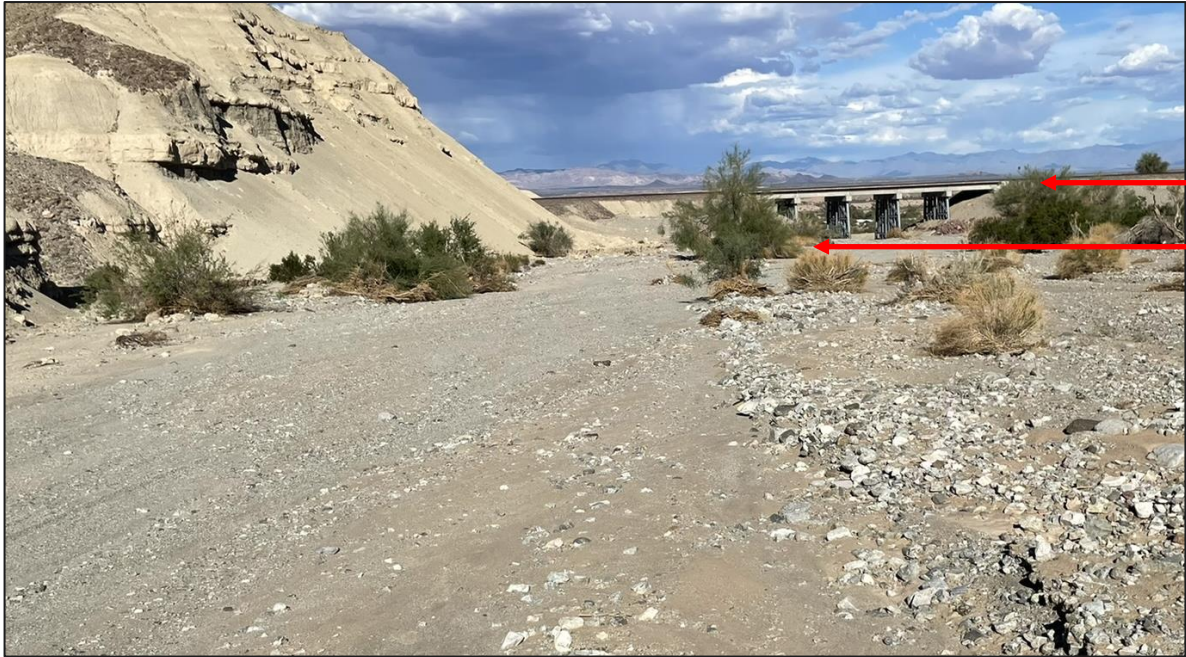
PS013 - RF-1 (October 7, 2022). Natural large wash supporting native mitigation plant species, including blue palo verde and desert smoke tree. Note large blue palo verde dominate the northern section of RF-1. Native cover = 10%. View looking northeast.

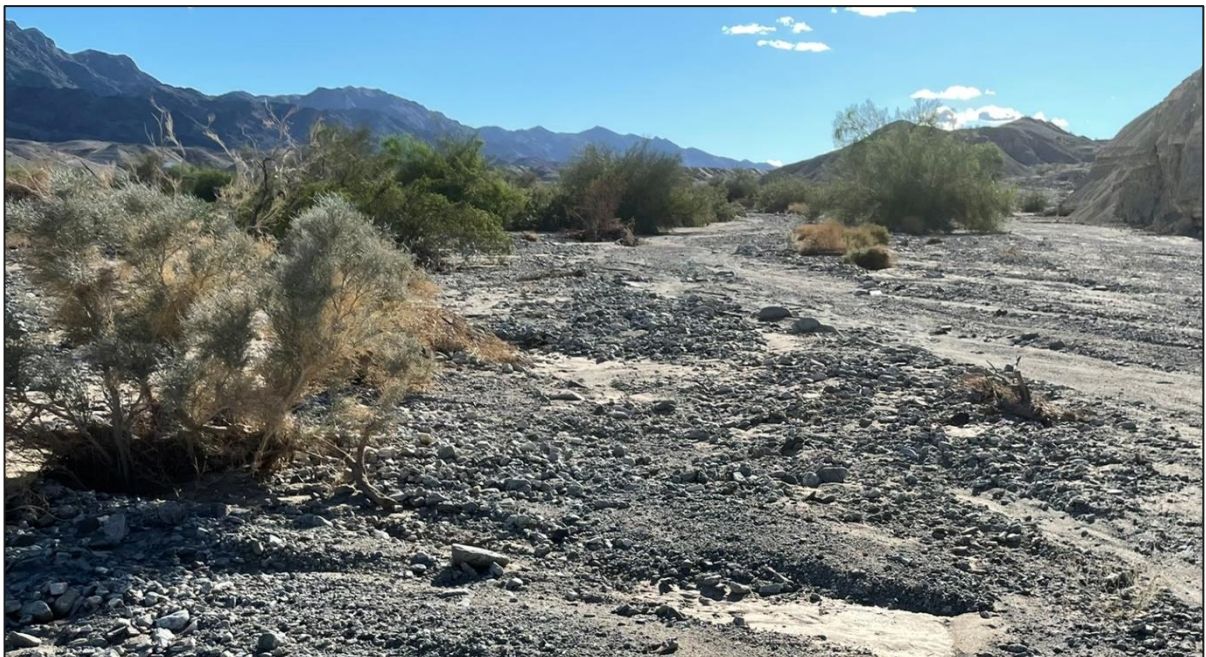
PS013 - RF-1 (October 7, 2022). Large wash with rocks, cobble, and gravel, with desert smoke tree in foreground and large blue palo verde in the background. Other species in this reference area that are not visible include buckhorn cholla, honey mesquite, and catclaw acacia. Native cover = 10%. View looking southwest.

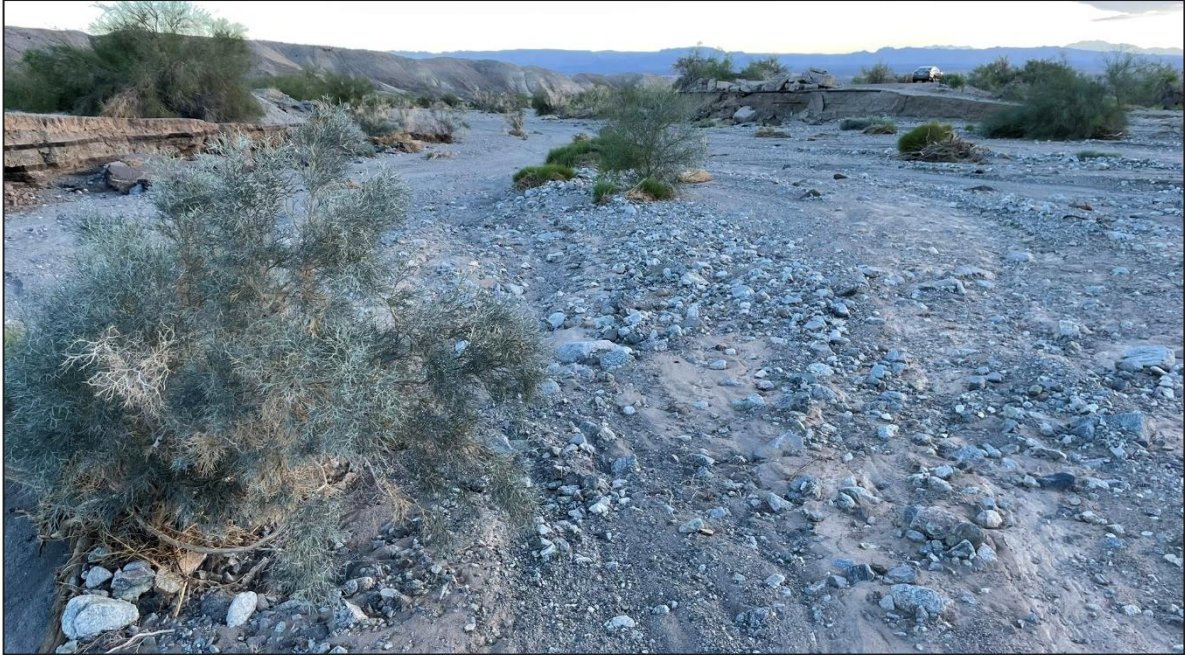
PS014 - RF-1 (October 8, 2022). Large natural wash supporting native mitigation plant species, including blue palo verde, honey mesquite, catclaw acacia, desert smoke tree, and buckhorn cholla. Note desert smoke tree in foreground. Native cover = 10%. View looking northeast.

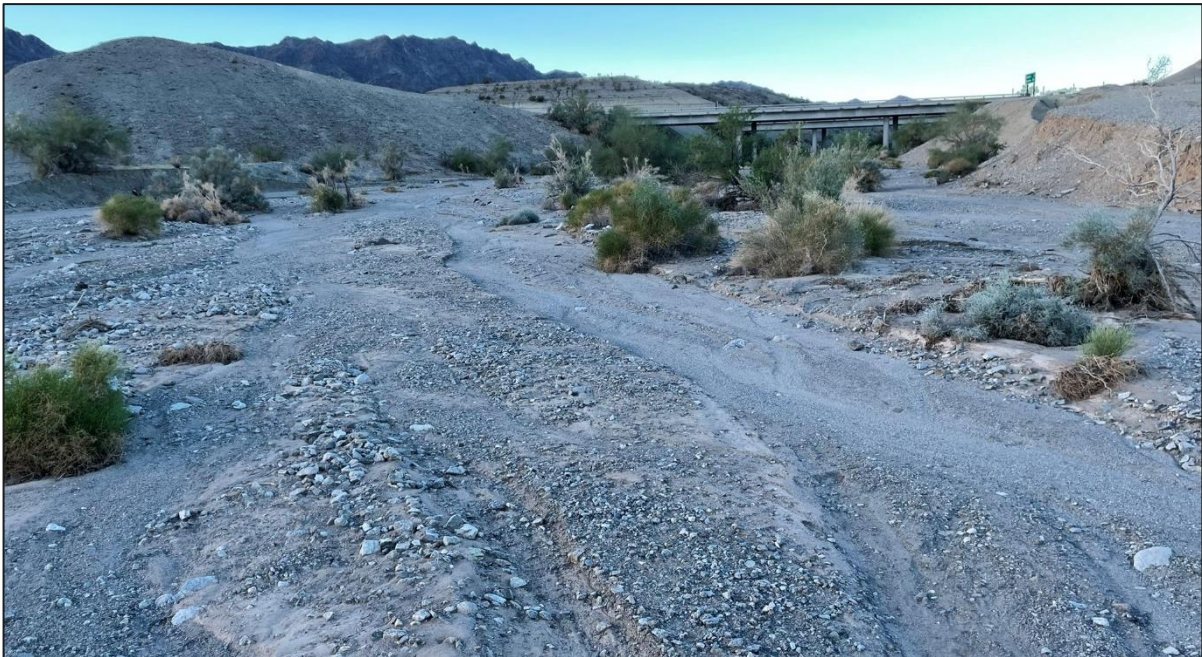
PS014 - RF-1 (October 8, 2022). Large natural wash supporting native mitigation plant species, particularly desert smoke tree (southern end near Interstate 40 bridge in background). Native cover = 10%. View looking southwest.

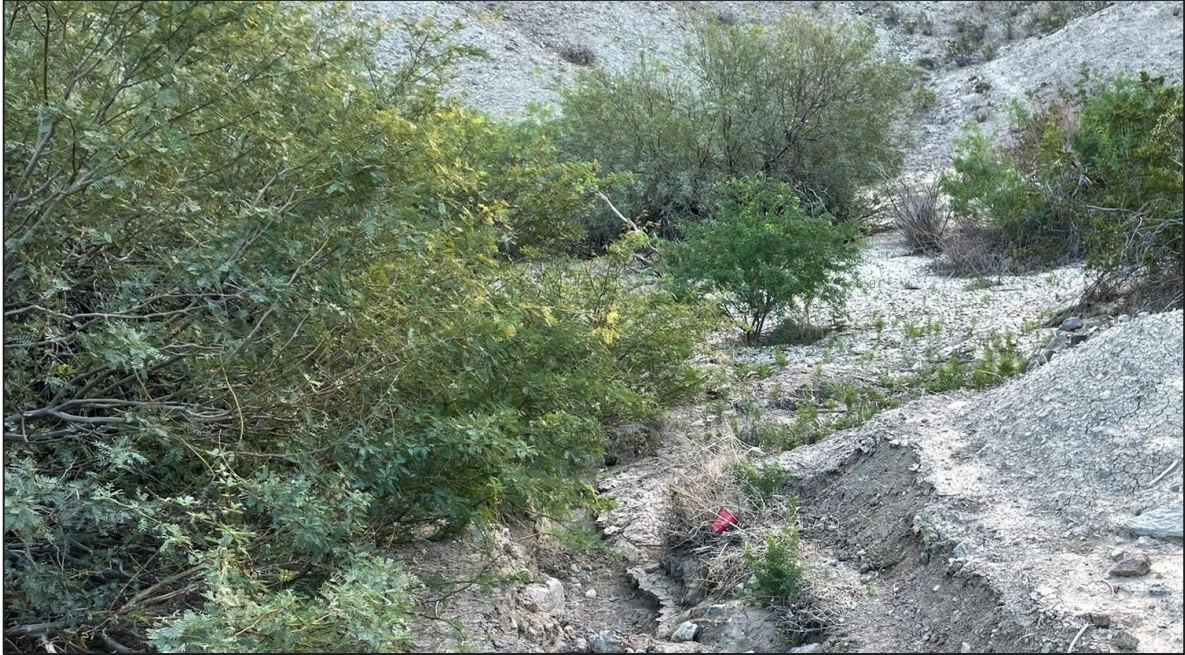
PS015 – RF-2 (October 7, 2022). Small natural wash supporting large honey mesquite, as well as seedlings and juveniles (not visible). Native cover = 25%. View looking southeast.

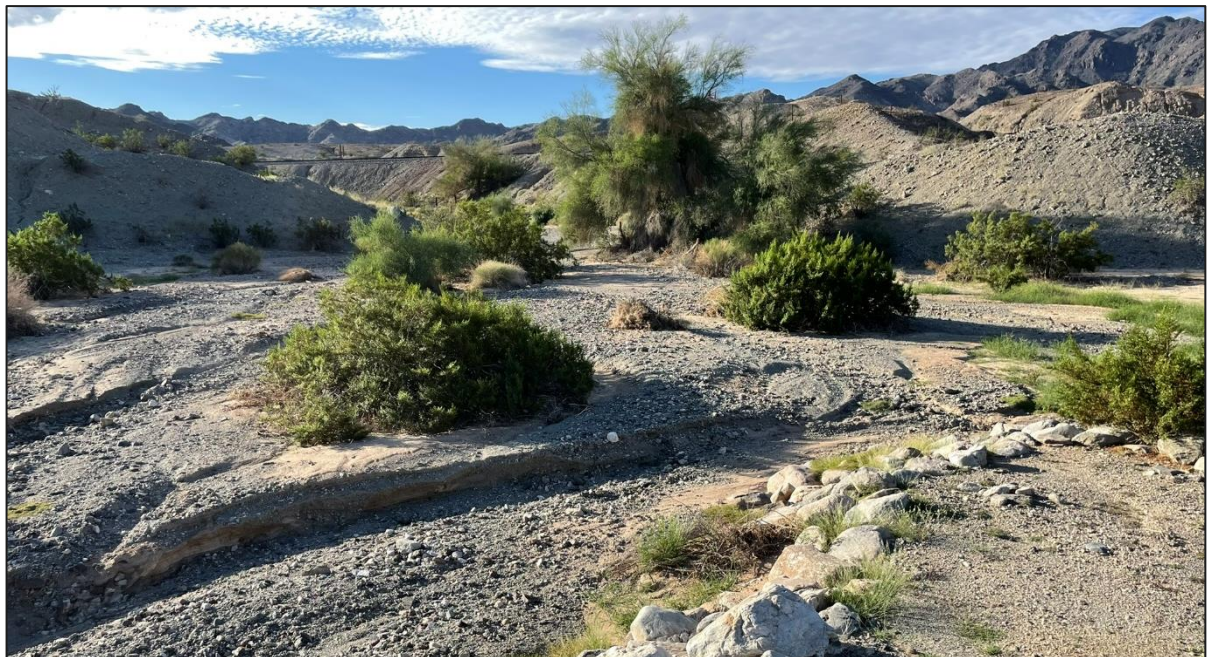
PS016 – RF-3 (October 8, 2022). Natural wash supporting blue palo verde with a range of age classes (very large individual in the background and three smaller individuals in the middle). Catclaw acacia also present. Native cover = 10%. View looking south.

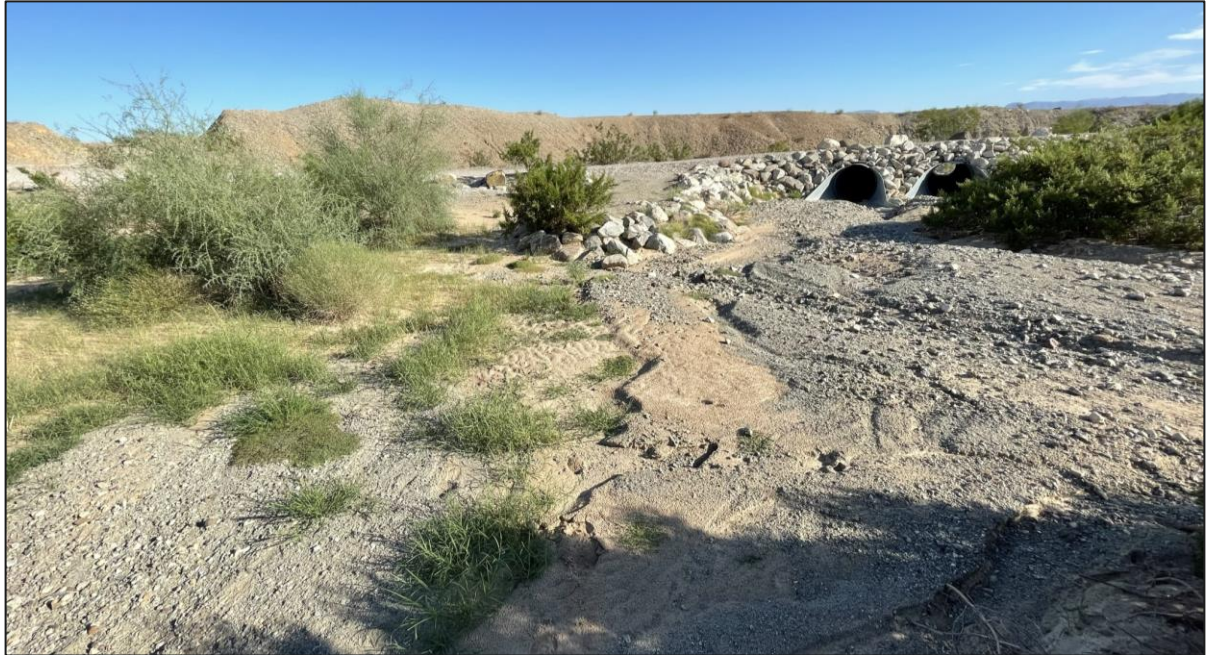
PS016 – RF-3 (October 8, 2022). Wash adjacent to recently constructed road (note culverts) supporting primarily blue palo verde, as well as a large swath of non-native Bermuda grass growing under and around native shrubs. Native cover = 10%. View looking north.

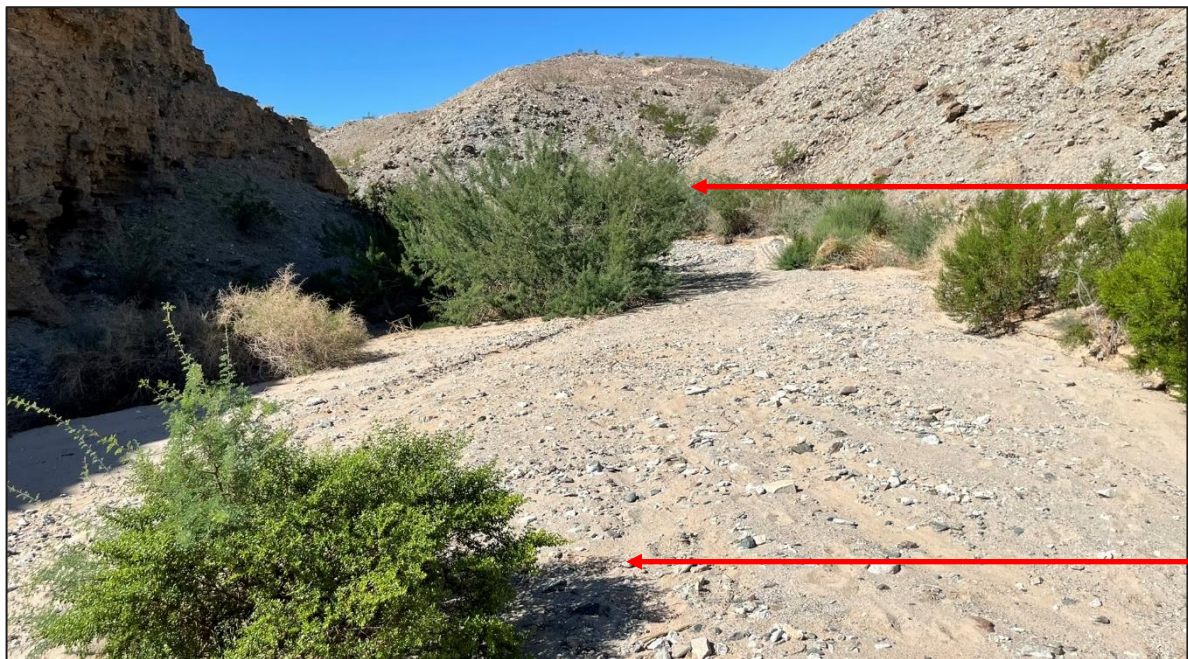
PS017 – RF-4 (October 8, 2022). This reference area in Bat Cave Wash supports catclaw acacia, with silver cholla and beavertail cactus occurring on slopes above wash. Note catclaw acacia in foreground and background. Native cover = 10%. View looking west.

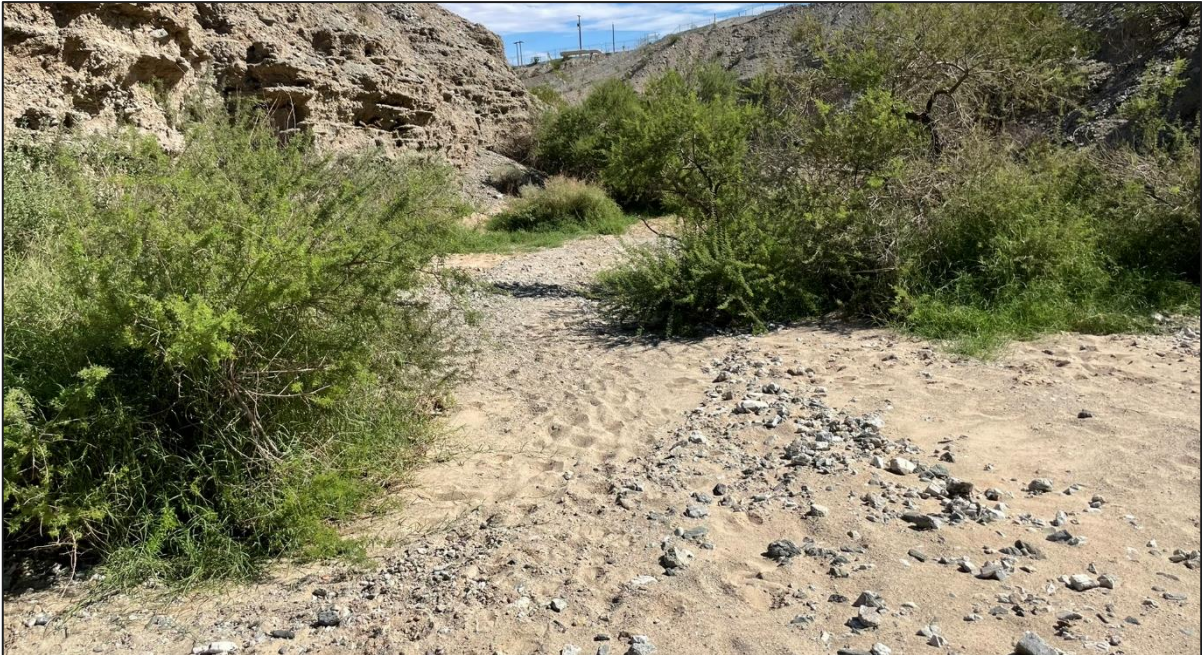
PS018 – RF-4 (October 8, 2022). Another view of Bat Cave Wash with catclaw acacia individuals along the wash with non-native Bermuda grass occurring under shrubs and along the slope edge. Native cover = 10%. View looking east.

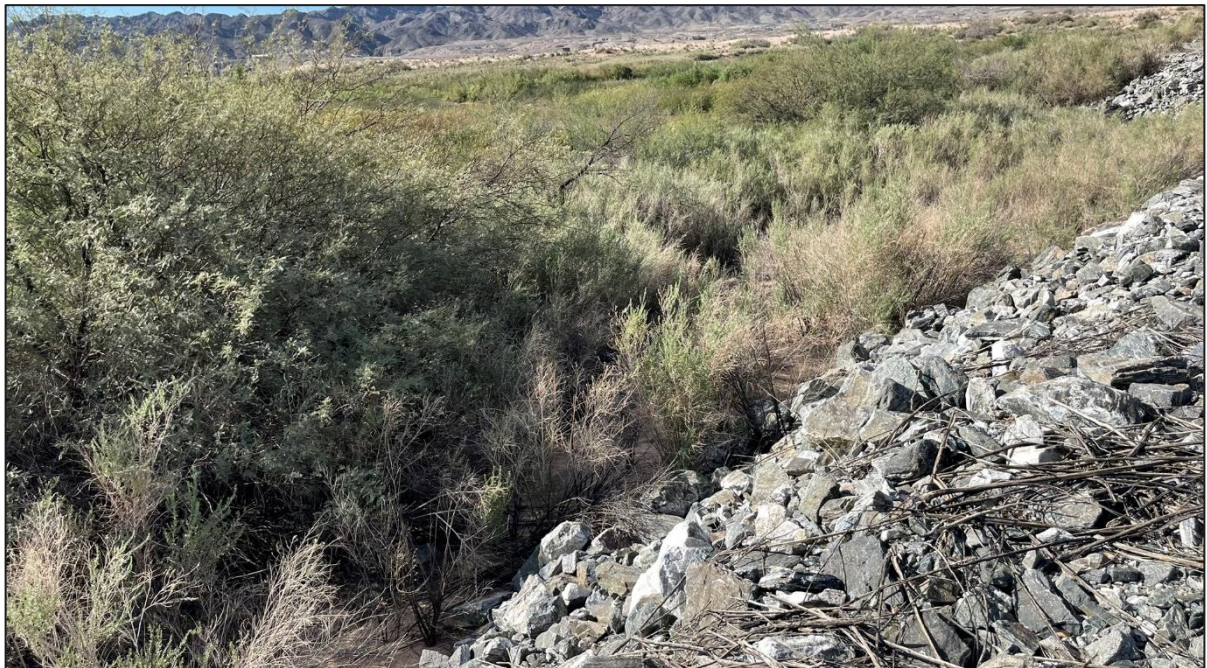
PS019 – RF-5 (October 8, 2022). Reference site located at the edge of a tributary to the Colorado River within the Havasu National Wildlife Refuge supporting a range of wash, riparian, and upland species, including screwbean mesquite (in foreground). Native cover = 90%. View looking southeast.
