Pacific Gas and Electric Company

Topock Revegetation Year 2 Mitigation Monitoring Report

January 2025

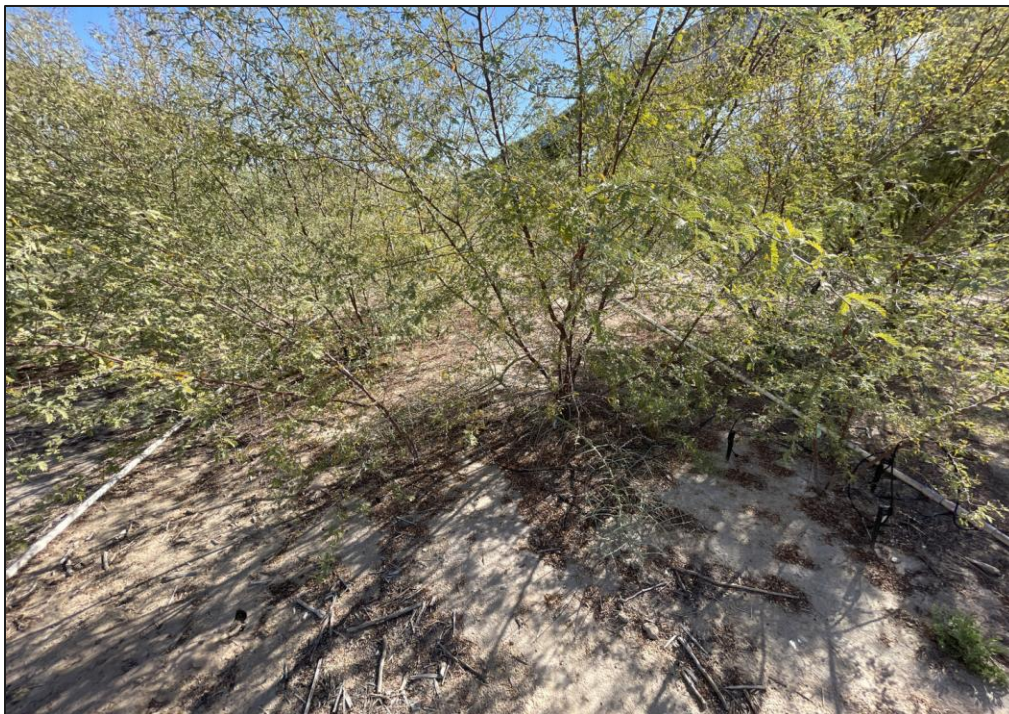
Photostation-003

The greatest cover by mitigation plants in Area 1 occurs between the I-40 bridge and the railroad bridge: blue palo verde (25% cover), honey mesquite (7% cover), and screwbean mesquite (20% cover). This portion of Area 1 also supports large stands of arrowweed (25% cover). Volunteer mesquite mitigation plants tower over blue palo verde in this area, with some individuals reaching up to 14 feet tall and 11 feet wide.

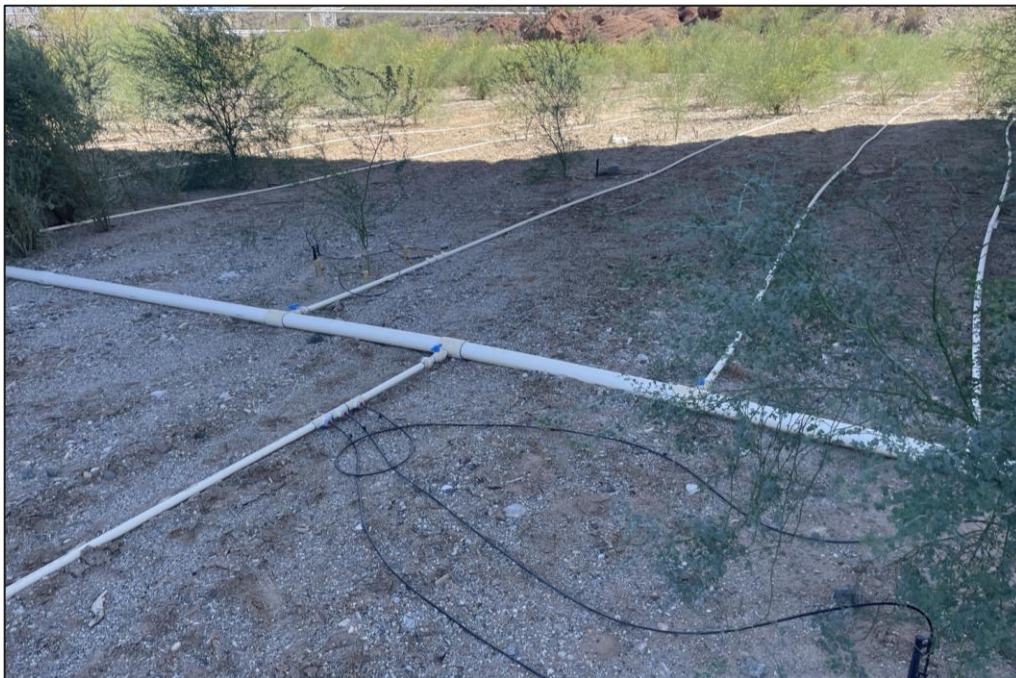
Photostation-004

Area 2, like Area 1, was planted with blue palo verde and supports volunteer recruit mitigation plants of honey mesquite and screwbean mesquite. Cover in this section of Area 1 is dominated by blue palo verde (13% cover) with honey mesquite (3% cover) and screwbean mesquite (5% cover) mitigation plants. Arrowweed (10% cover) is scattered throughout this portion of Area 2.

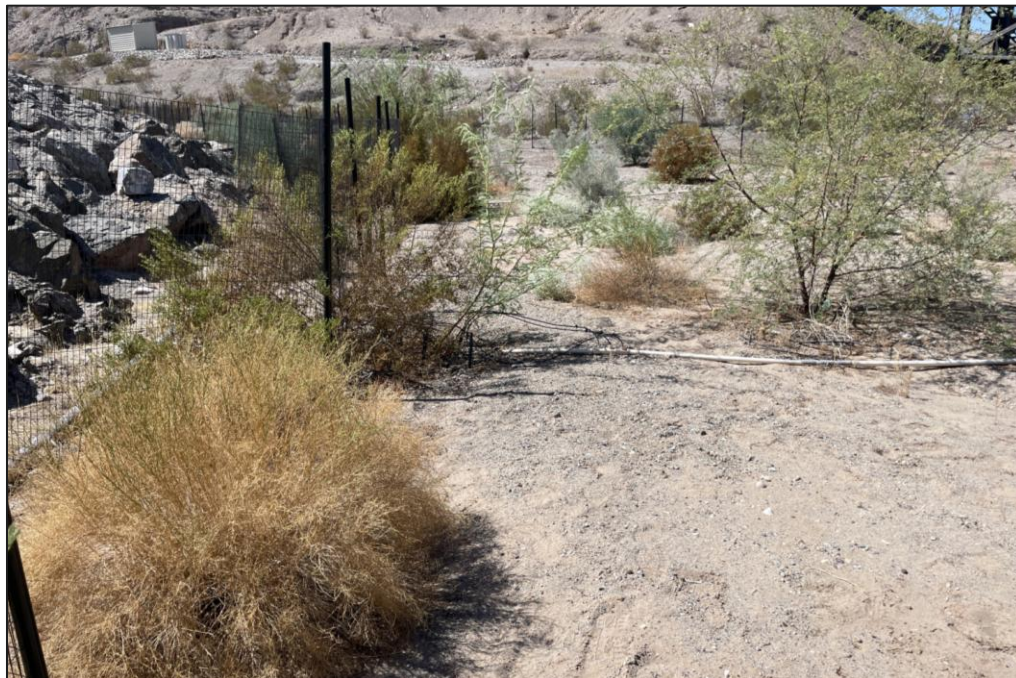
Photostation-008

Area 5 supports mitigation plantings of blue palo verde (2% cover), desert smoke tree (4% cover), and catclaw acacia (1% cover), as well as honey mesquite and screwbean mesquite mitigation plants originating from volunteer recruits (10% cover, including a large existing honey mesquite tree that occurs in this area, not shown in photo). Area 5 also supports mature naturally-occurring shrubs, including cheesebush, sweetbush, and creosote bush. Like Area 3, Area 5 experiences elevated water flow during heavy rain events.
