<p>Document Title:</p> <p>Wetlands and Waters of the United States, Delineation for the Topock Compressor Station Groundwater Remediation Project (PGE20130822A)</p> <p>Submitting Agency: DTSC, DOI</p> <p>Final Document? <input checked="" type="checkbox"/> Yes <input type="checkbox"/> No</p>	<p>Date of Document: August 22, 2013</p> <p>Who Created this Document?: (i.e. PG&E, DTSC, DOI, Other) – PG&E</p>
<p>Priority Status: <input type="checkbox"/> HIGH <input type="checkbox"/> MED <input checked="" type="checkbox"/> LOW</p> <p>Is this time critical? <input type="checkbox"/> Yes <input checked="" type="checkbox"/> No</p>	<p>Action Required:</p> <p><input checked="" type="checkbox"/> Information Only <input type="checkbox"/> Review & Comment</p> <p>Return to: _____</p> <p>By Date: _____</p> <p><input type="checkbox"/> Other / Explain:</p>
<p>Type of Document:</p> <p><input type="checkbox"/> Draft <input checked="" type="checkbox"/> Report <input type="checkbox"/> Letter <input type="checkbox"/> Memo</p> <p><input type="checkbox"/> Other / Explain:</p>	<p>What does this information pertain to?</p> <p><input type="checkbox"/> Resource Conservation and Recovery Act (RCRA) Facility Assessm

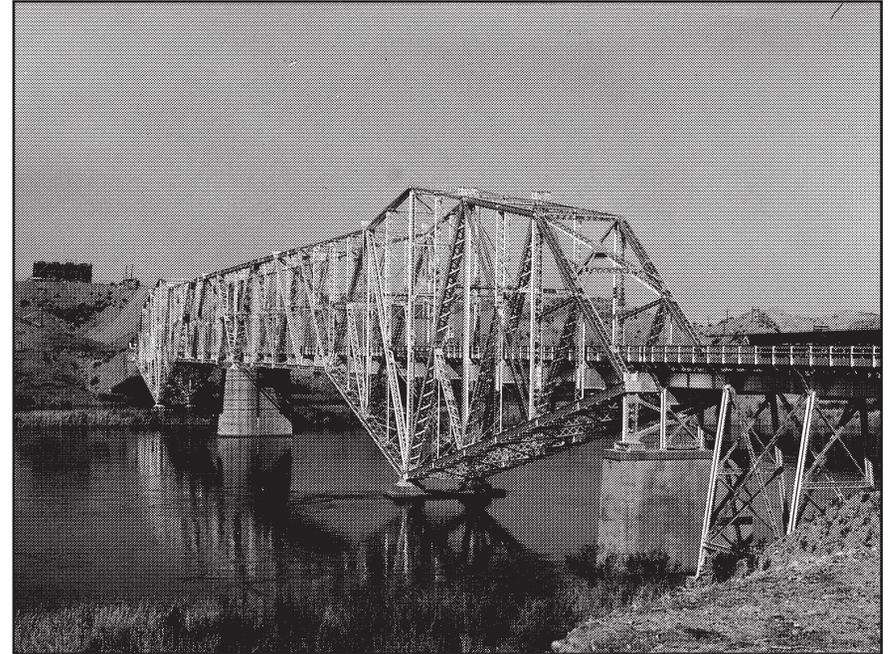
300-4385A. Colorado River Front Work & Levee System.
Photograph of highway bridge across Colorado River near Topock, California, 1962.
Bureau photo by R.C. Middleton.

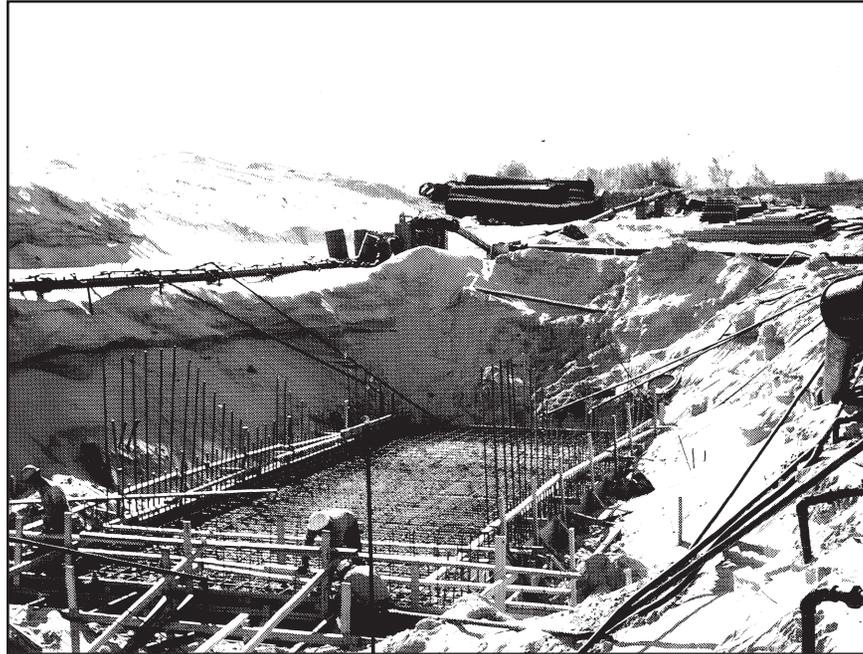
P423-306-4347 NA. Colorado River Front Work and Levee System, Region 3. Topock Marsh Development. Specifications No. 300C-232. Contractor's forces placing reinforcing steel in floor of inlet structure. 11/29/65. Bureau of Reclamation photo by Fred Burley.

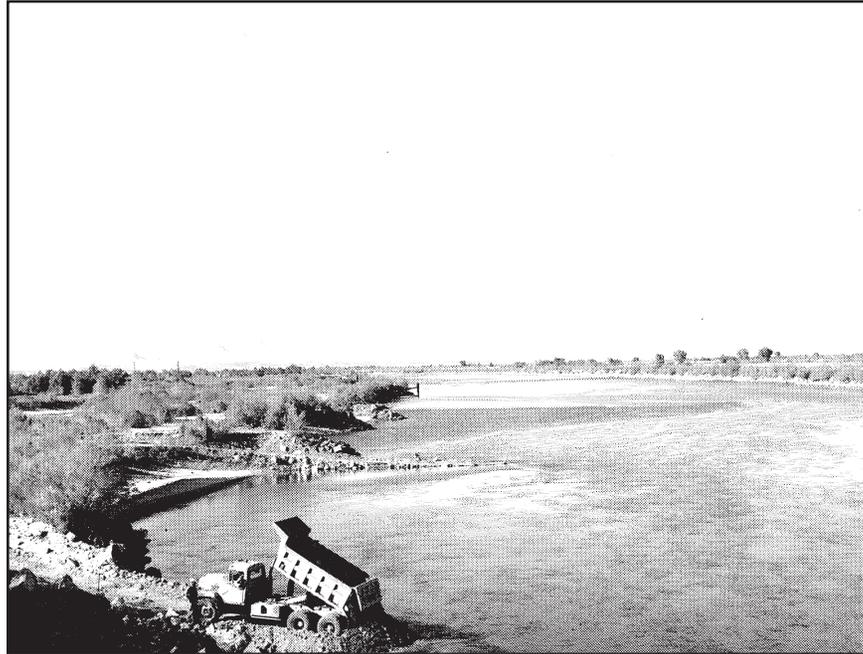
P423-306-4340 NA. Colorado River Front Work and Levee System, Region 3. Needles to Topock Division. Government forces constructing jetty to narrow the width of channel. The channel was narrowed to cause the water to scour sand bar at entrance to Topock Marsh inlet channel structure. Truck at Station 558, California bank. 12/1/65. Bureau of Reclamation photo by Fred Burley.

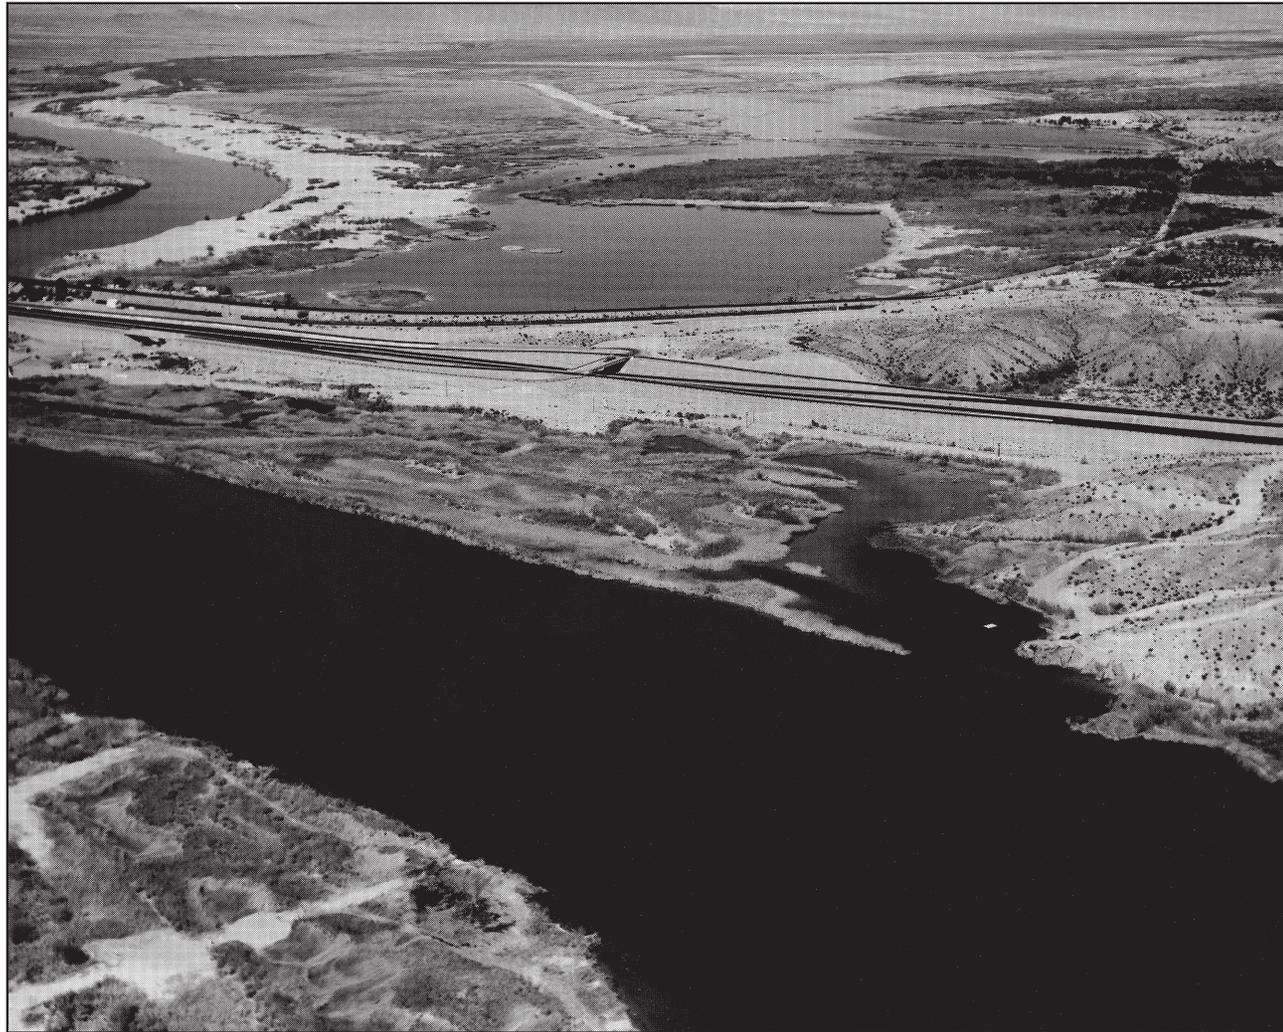
P423-300-7748 NA Topock Gorge Division – Colorado River Front Work & Levee System, Arizona-California. Looking upstream at Spoil Site No. 1 (south of U.S. 66). Spoil will be placed here to provide an access site for recreation and wildlife use. The Bureau of Reclamation will provide a parking lot, boat ramp, restroom facilities, and landscape the site for day-use. 2/29/68 Bureau of Reclamation photo by Al R. Jonez.

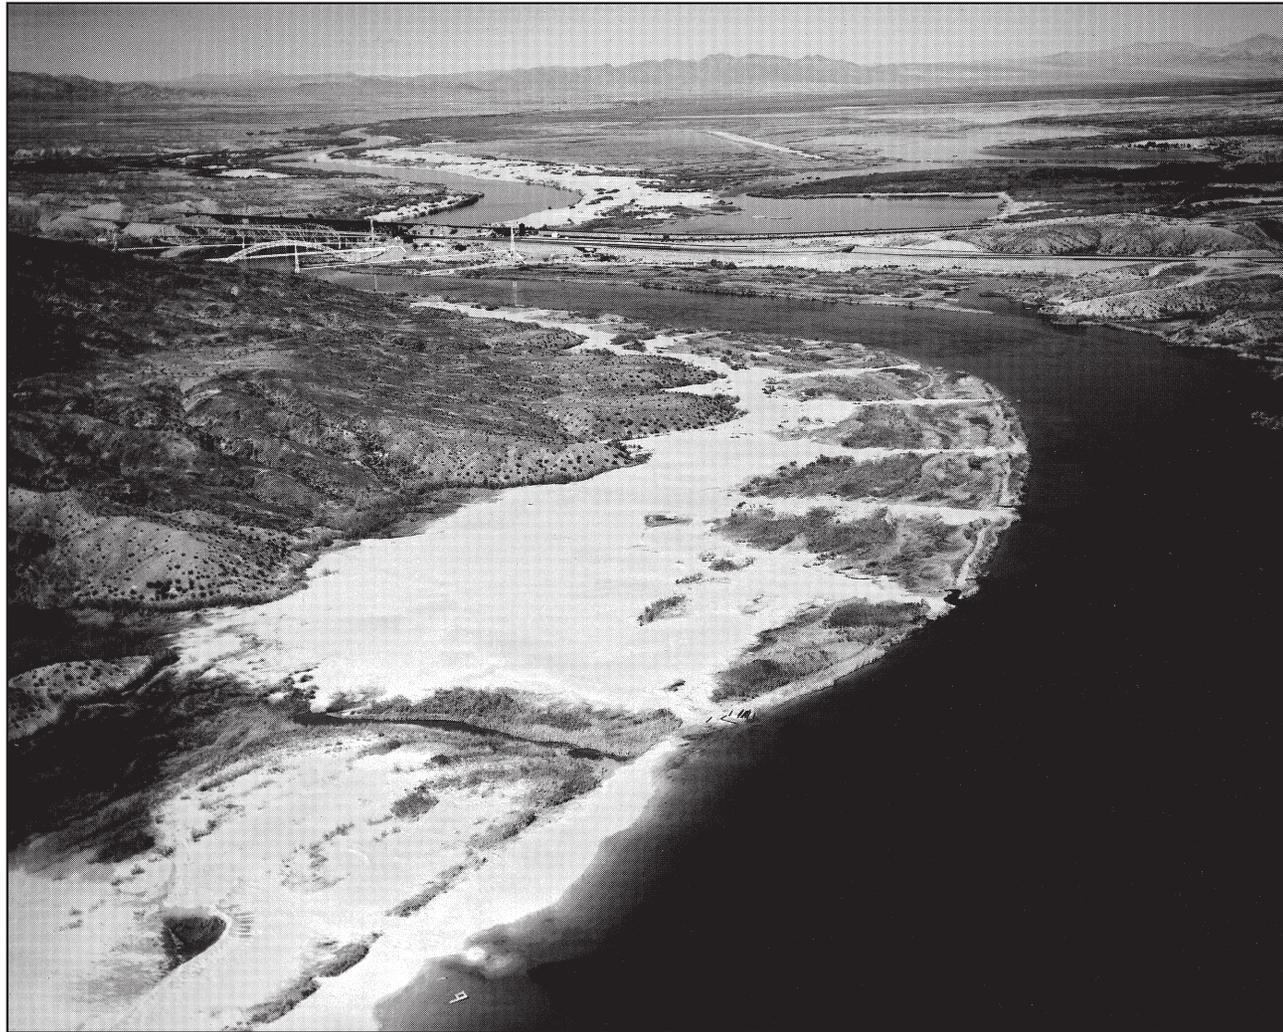
P423-300-7747 NA Topock Gorge Division – Colorado River Front Work & Levee System, Arizona-California. Looking north at the Topock Ridge which is the start of the Division. Spoil placed on Spoil Site No. 2 on the left, will be landscaped and planted for recreation day-use this spring. Topock Marsh can be seen in the distance (River Mile 465). 2/29/68 Bureau of Reclamation photo by Al R. Jonez.

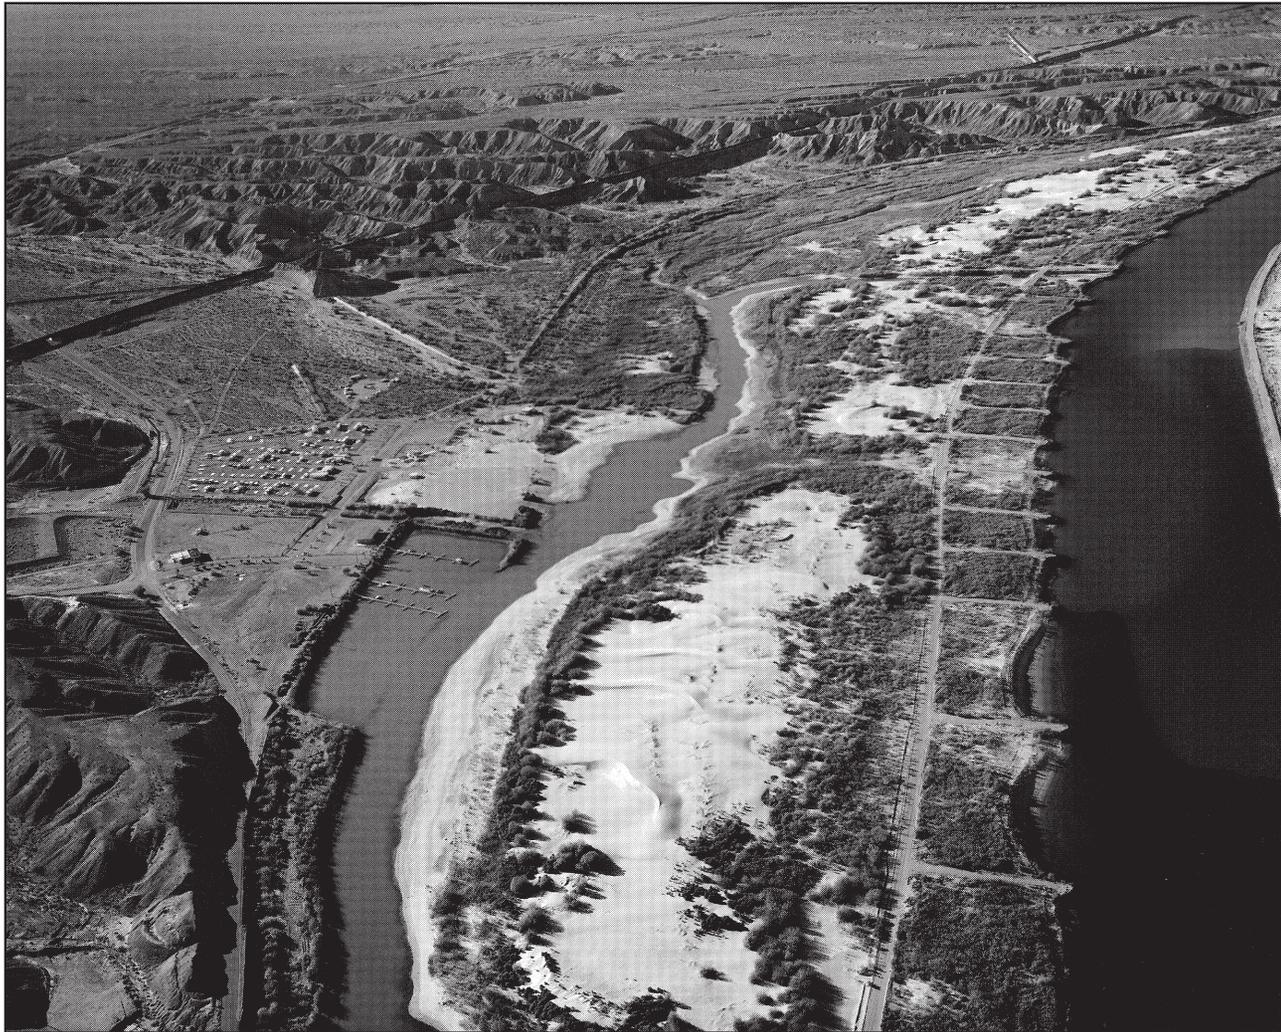
P423-300-8735 NA Mohave Valley Division – Colorado River Front Work & Levee System, Arizona-California. Looking upstream at the Park Moabi Marina complex operated by the County of San Bernardino. The Reclamation withdrawn lands are leased to the county for park and recreation purposes. River Mile 462.5 is at the bottom of the photograph. 1/6/69 Bureau of Reclamation photo by E. E. Hertzog.

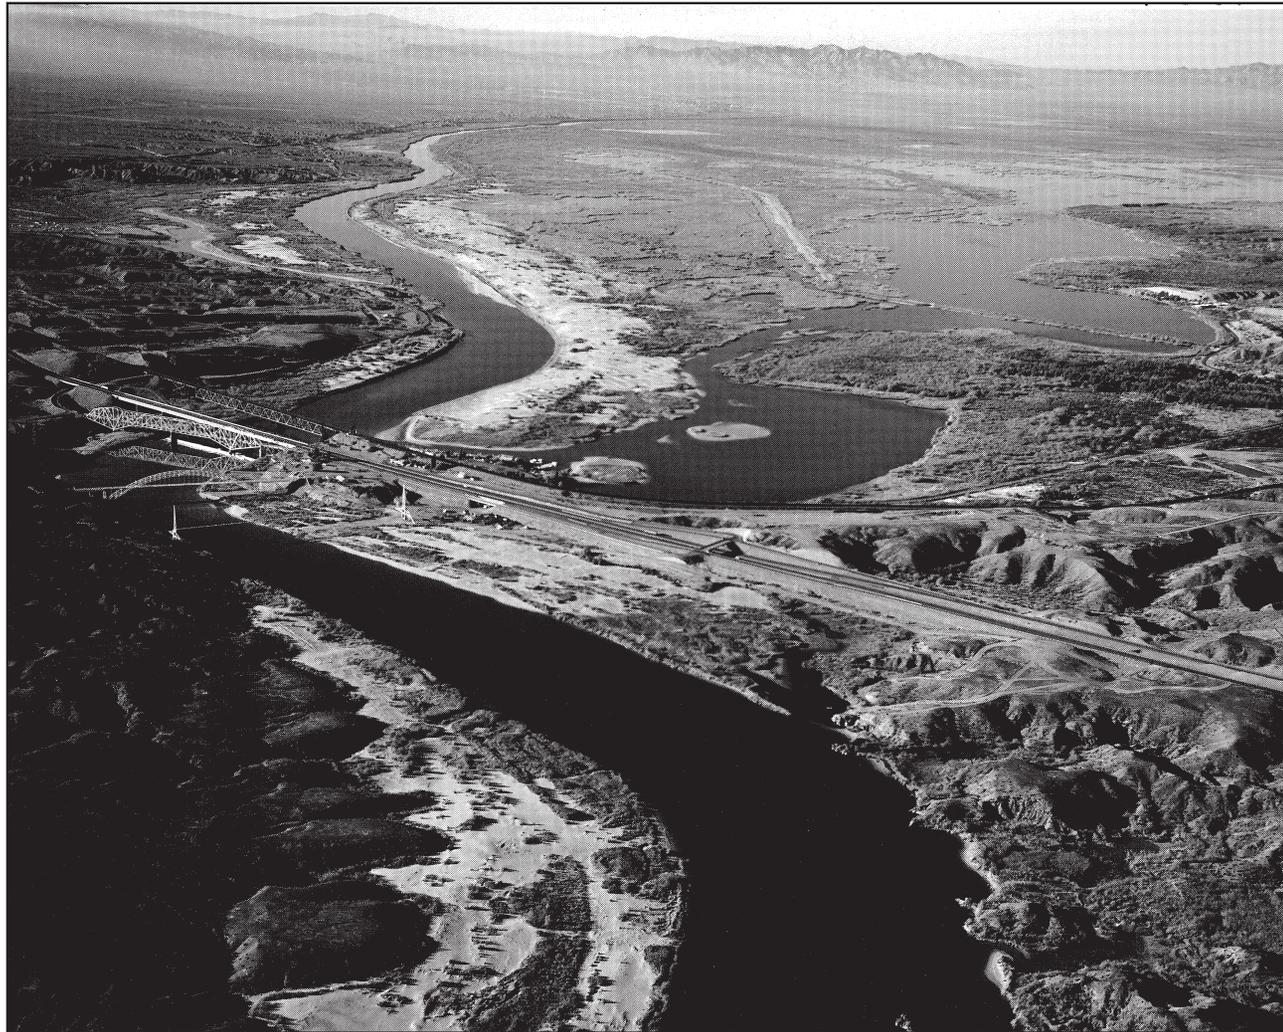
P423-300-8737 NA Topock Gorge Division – Colorado River Front Work & Levee System, Arizona-California. Looking upstream at the start of the Topock Gorge Division area. Portions of this section have been dredged prior to the time that Secretary of the Interior, Stewart Udall, suspended all work in the Topock Gorge Division pending a reevaluation of the dredging program. River Mile 465 is at the bottom of the photograph. 1/6/69 Bureau of Reclamation photo by E. E. Hertzog.

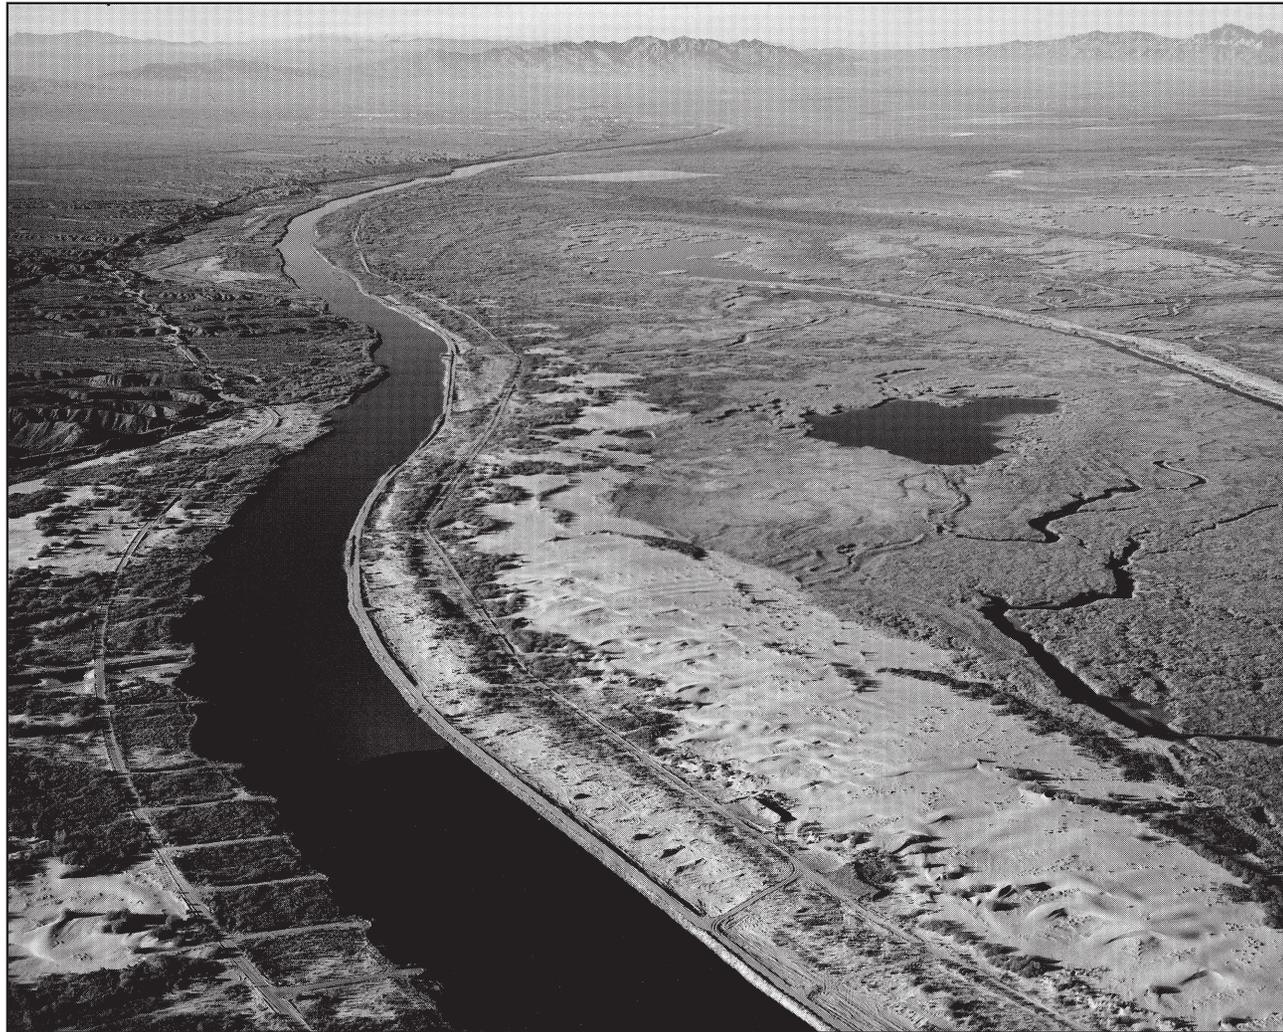
P423-300-8734 NA Mohave Valley Division – Colorado River Front Work & Levee System, Arizona-California. Looking upstream in the river section opposite the inlet to Park Moabi Marina. The lake on the right is called Lost Lake. The sandy areas are a by-product of several years settling basin dredging in this section. Part of the sediment moving downstream in the Mohave Division was removed at this location before it moved on into the Topock Gorge Division. River Mile 462 is at the bottom of the photograph. 1/6/69 Bureau of Reclamation photo by E. E. Hertzog.

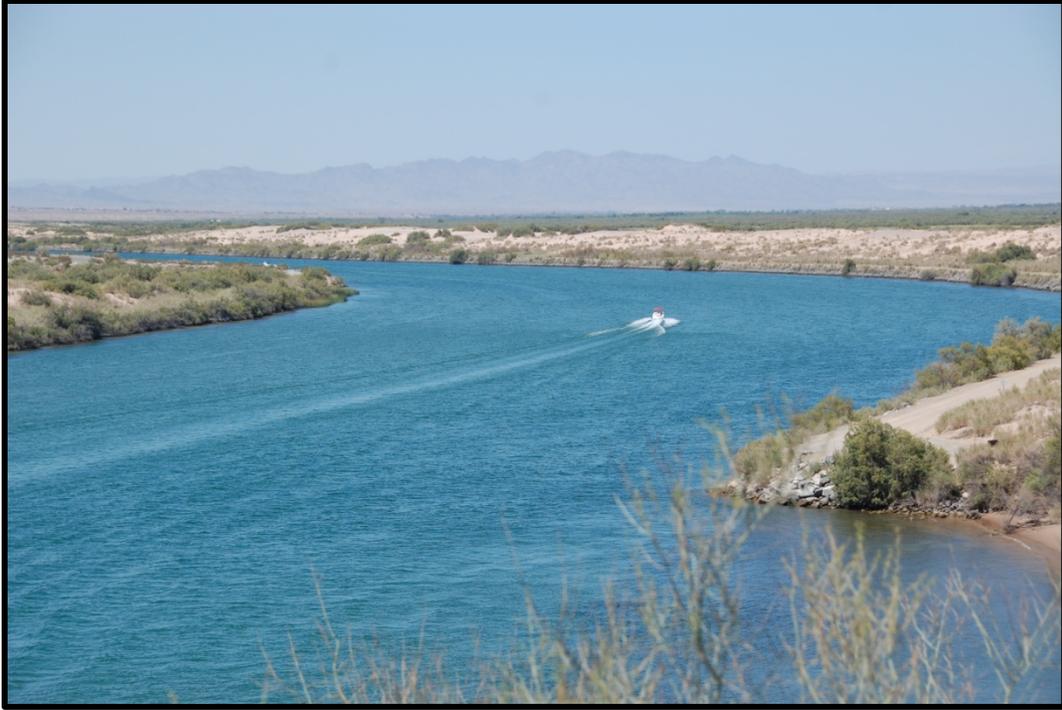
Colorado River (R2UB2), looking north

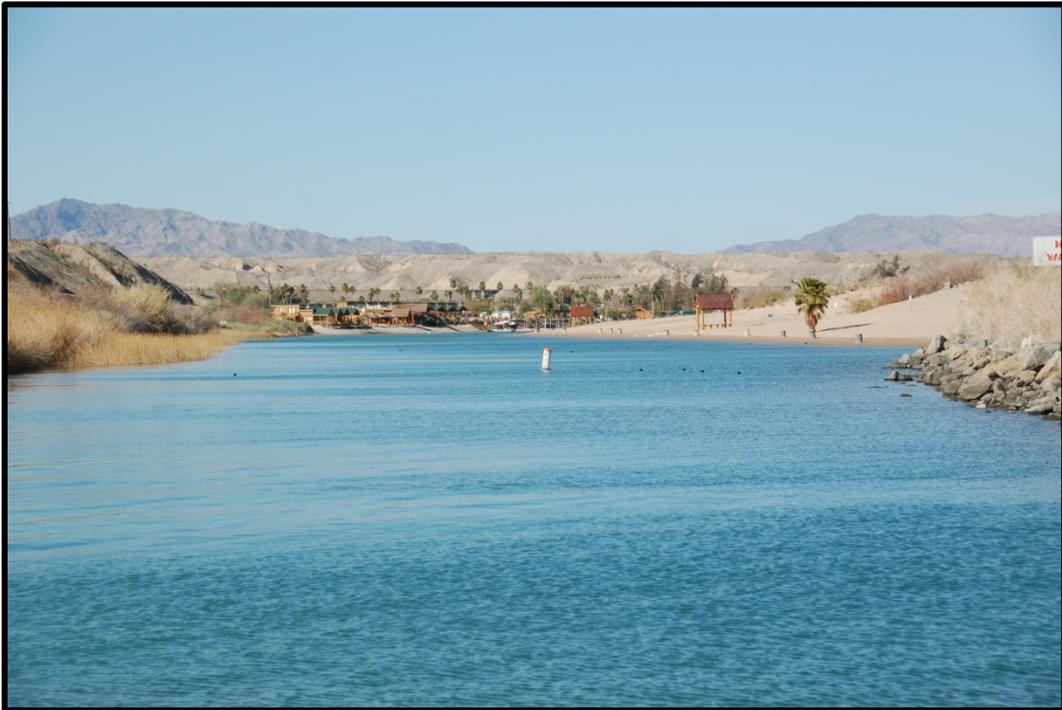
Park Moabi Slough (R2UB2x), Looking west from the confluence with the Colorado River

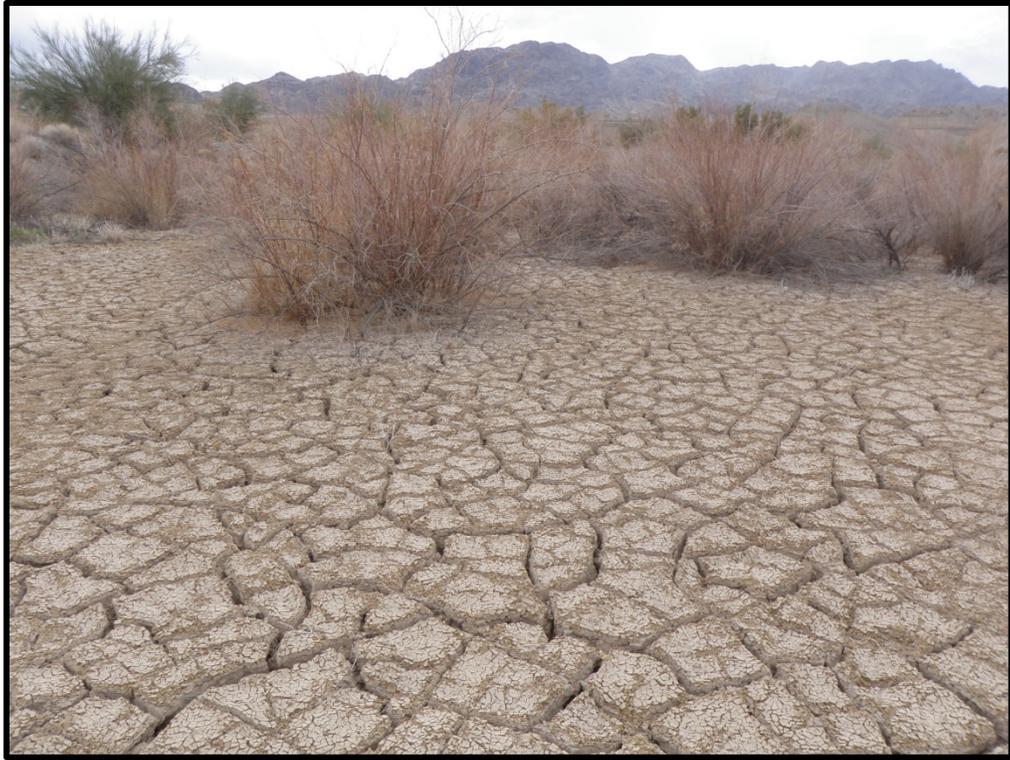
Soil Cracks in Detention Basin area South of Park Moabi (PSSA)

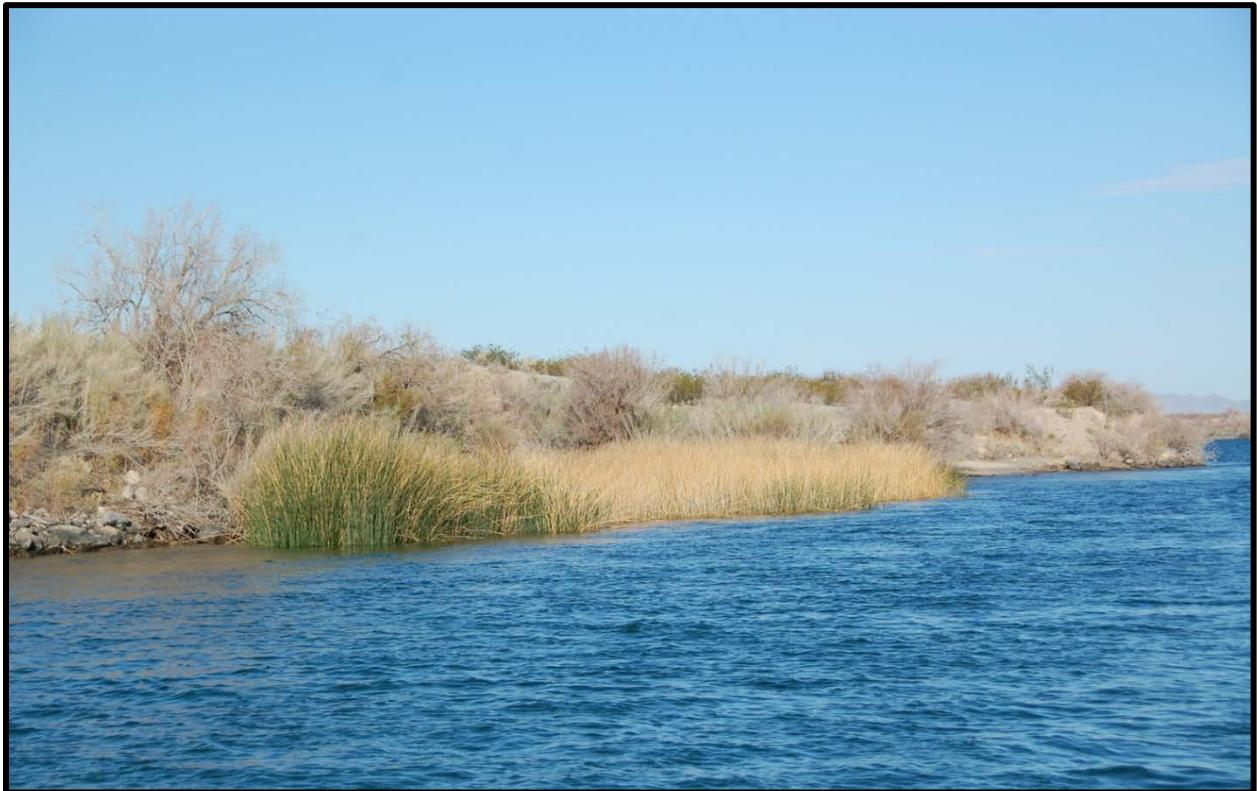
Shore Zone Wetland (PEMH)

Shore zone emergent wetlands include scattered patches of southern cattail, southern bulrush, common reed and giant reed growing along the edges of the Colorado River and Park Moabi Slough, below the ordinary high water line. As previously noted these wetlands are classified separately from the open water Riverine wetlands in which they occur (Cowardin et al., 1979). All of the shore zone wetlands in the survey area are classified as Palustrine Emergent Permanently Flooded (PEMH) wetlands. These wetlands are most common along the southern banks of the Park Moabi Slough, but are also found along the north banks of the slough in the western most part of the survey area. Shore zone wetlands are less common along the Colorado River and occur in scattered locations along the south/west bank as well as in the vicinity of the Topock Marina. Also included are areas with California bulrush along the outlet of Bat Cave Wash and areas with broad-leaved cattail (*Typha latifolia*) in the outlet of the East Ravine near the southern boundary of the survey area.

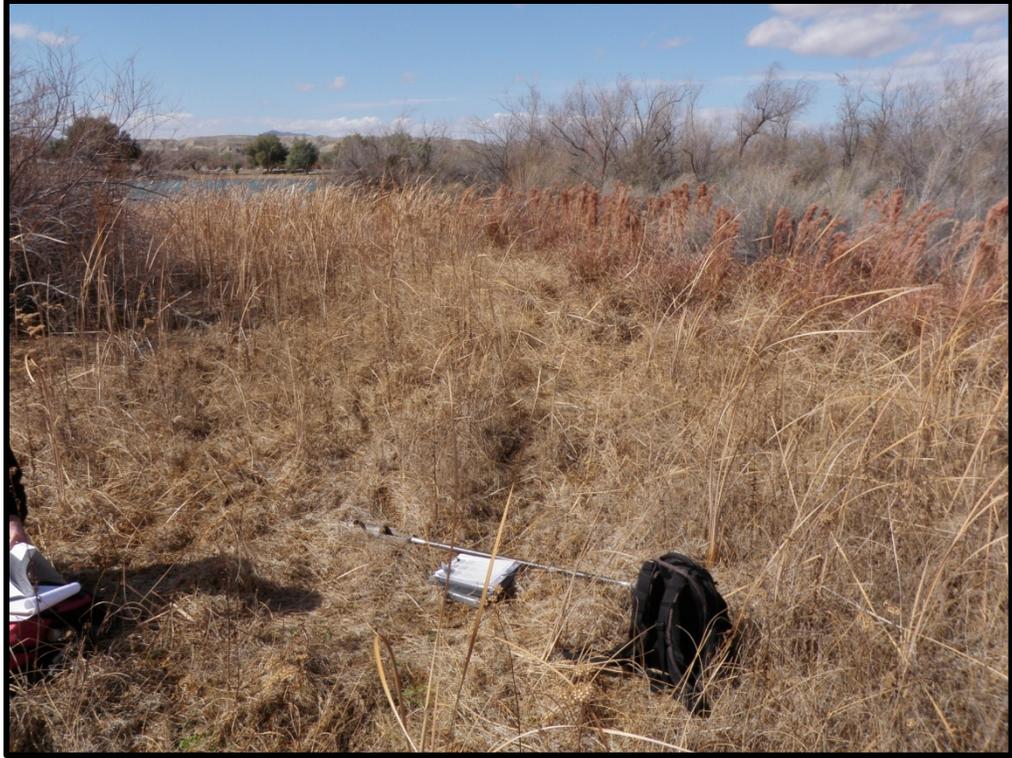
Adjacent Wetland (PEMC)

The third adjacent wetland (EM-5) is on the south bank of the Colorado River, approximately 600 feet downstream of the confluences of the Park Moabi Slough and the Colorado River. This low depression area is filled with dense growth of southern cattail. Soil in this area is a yellowish brown (10 YR 5/4) sandy loam to a depth of 24 inches. No redoximorphic features were observed. At the time of the February 2012 survey, shallow groundwater and saturated soils were present at a depth of 10 inches below the ground surface. A culvert connects this area to a pond on the south side of the National Trails Highway. Given the low topographic position, hydrologic connection to the pond south of the road, and shallow ground water noted at the time of the survey, it is likely that this area is subject to shallow seasonal flooding for part of the year. This feature was classified as a Palustrine, Emergent, Seasonally Flooded wetland (PEMC).

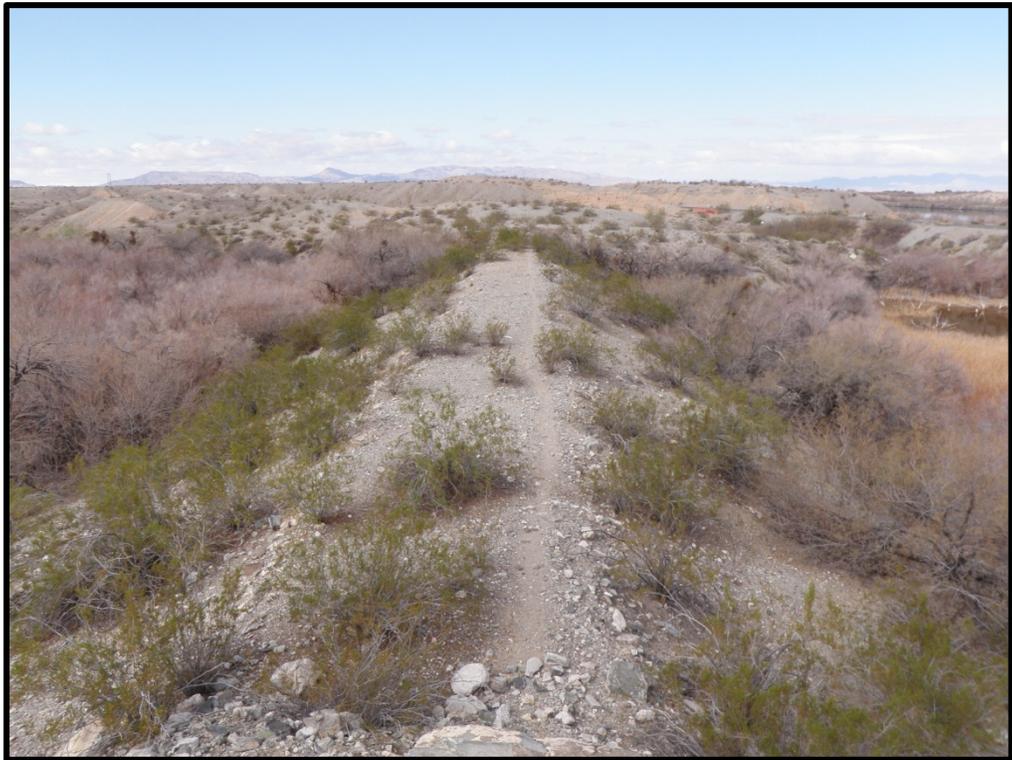
Earthen dam on south side of the pond

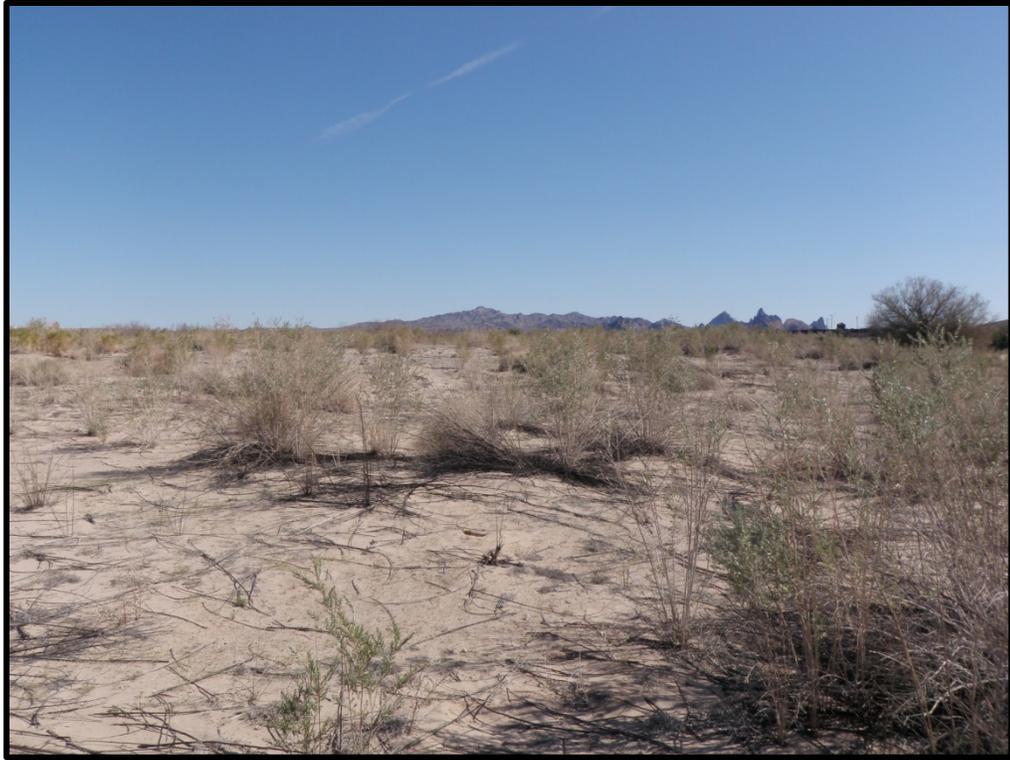
Scattered (poor condition) arrow weed on low terrace along the Colorado River

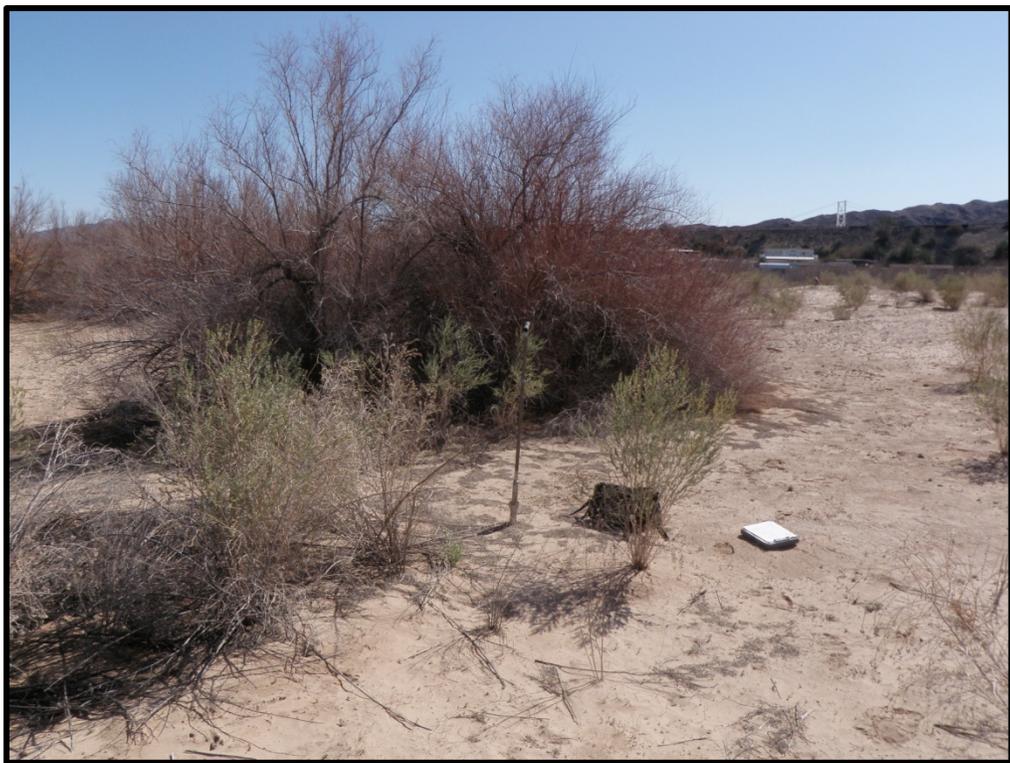
Arrow weed, salt cedar and honey mesquite - low terrace along the Colorado River

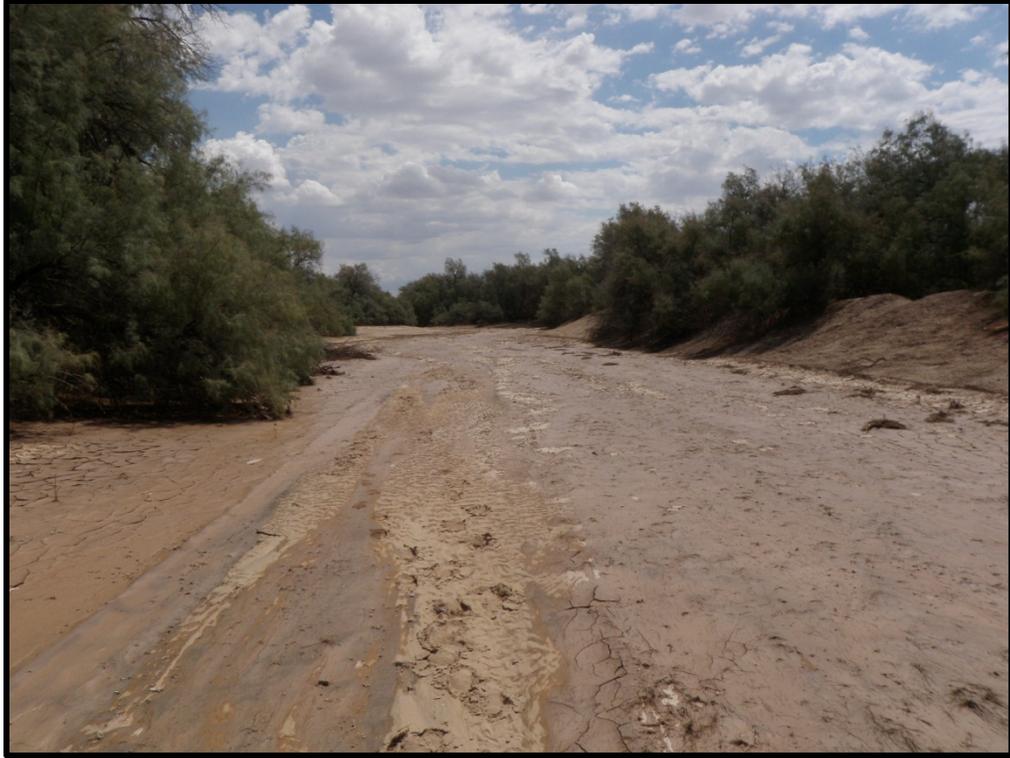
Sacramento Wash (R4SB3A) after significant rainfall in July 2012

Immediately prior to the July 2012 delineation, significant rainfall was recorded in the regional vicinity that affected conditions in the Sacramento Wash. Between July 12 and July 14, 2012 a total of 1.08 inches of rainfall was recorded in Lake Havasu City, Arizona and a total of 1.60 inches of precipitation was measured in Kingman, Arizona. These summer rainstorms resulted in high flows within the Sacramento Wash and short duration flooding in some areas of east of the Topock Marsh. Storm water flow in the Sacramento Wash was high enough to cause flooding and deposition of a large amount of sand along a section of Highway 95, temporarily closing the roadway in this area.

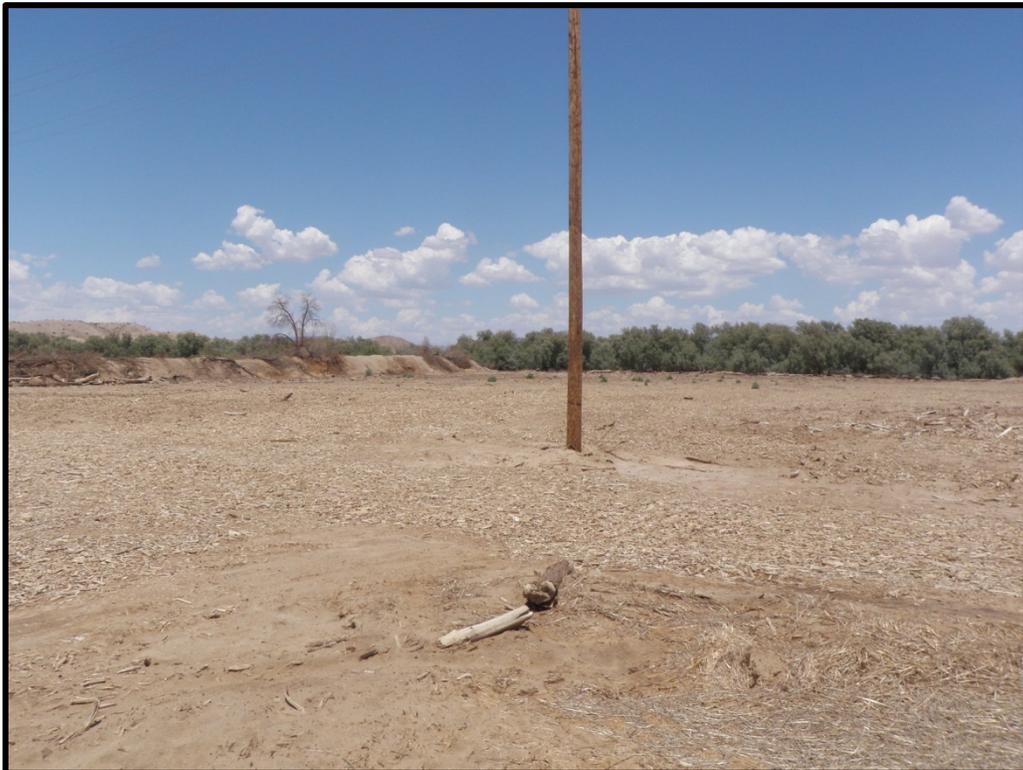
Former athel tamarisk area on the Havasu National Wildlife Refuge south of the Sacramento Wash, burned in 2008 wildfire and cleared by the US Fish and Wildlife Service

Both disturbance history and rainfall conditions were significant prior to the July 2012 delineation of the 182.7-acre area along Highway 95 in Arizona (Site B). In October of 2008, a wildfire burned 240 acres of dense tamarisk in the Havasu National Wildlife Refuge on the west side of the highway in this area. After the fire, the U.S. Fish and Wildlife Service began clearing the area of dead trees, logs and woody debris. In the spring of 2011, a portion of the burn area was planted with a variety of native trees, shrubs, and grasses. At the time of the July 2012 delineation, most of the burned area west of the highway was devoid of vegetation, with the exception of the revegetation area planted in 2011.

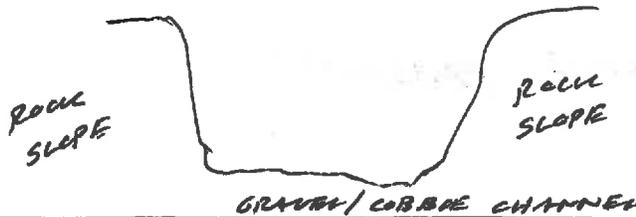
STEEP VERTICAL BANKS
ALONG SIDES OF THE
CHANNEL - NO LOW
TERRACE

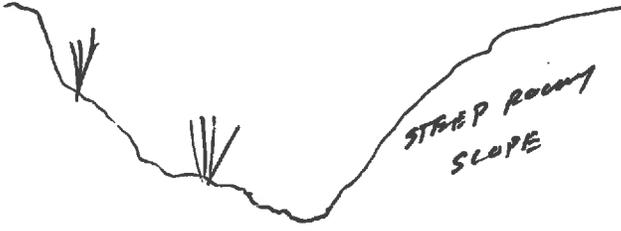
Project: PG&E Topock Compressor Station	Date: 2/13/2012	Time: 10:46 AM
Investigators: R. Huddleston, K Steiner	City: Needles	State: CA
Y <input checked="" type="checkbox"/> N <input type="checkbox"/> Normal Circumstances	Sample Point: 7B-2	Photos: 358, 360 ³⁵⁹
Y <input type="checkbox"/> N <input checked="" type="checkbox"/> Significantly Disturbed	GPS: 34.715529	Datum: NGS 84
Geomorphic Feature: DRAINAGE	-114.494982	Width: 7.8 FT
Flow Regime: EPHEMERAL		
Substrate: PEBBLE - COBBLE ; SOME BOULDER - DS MORE SAND		
Indicators: ERODED CHANNEL DEVOID OF VEGETATION		
Cross-Section:

Vegetation in Channel: NONE		
Low Terrace and Adjacent Vegetation:	SCATTERED LARREA TRIDENTATA ENCHELIA FARINOSA	
Notes:	TRIBUTARY TO BAT CAVE WASH - ERODED/DISSECTED ROCKY SLOPE ABOVE THIS POINT

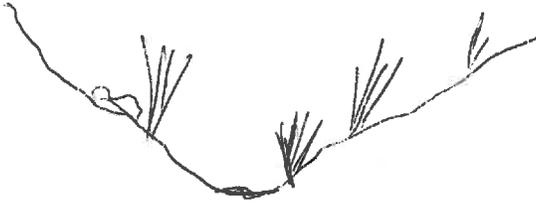
Project: PG&E Topock Compressor Station	Date: 2/13/2012	Time: 2:28 PM
Investigators: R. Huddleston, K Steiner	City: Needles	State: CA
Y <input checked="" type="checkbox"/> N <input type="checkbox"/> Normal Circumstances	Sample Point: TB-8	Photos: 388-389
Y <input type="checkbox"/> N <input checked="" type="checkbox"/> Significantly Disturbed	GPS: 34.720611	Datum: WGS84
Geomorphic Feature: DRAINAGE	- 114.498922	Width: 5.3 FT
Flow Regime: EPHEMERAL		
Substrate: SAND - PEBBLE w/ SOME COBBLE, BOULDER		
Indicators: CHANGE IN SUBSTRATE, GENERALLY ABSENT VEGETATION		
Cross-Section:

Vegetation in Channel: GENERALLY ABSENT - SPARSE CHAMAESYCE		
Low Terrace and Adjacent Vegetation: LARREA TRIDENTATA, AMBROSIA DUMOSA, KRAMERIA GRAYI, BEBBIA JUNCEA, HYPTIS EMORYI ALONG THE EDGES OF THE EROSIONAL CHANNEL AND ON SIDE SLOPES		
Notes:

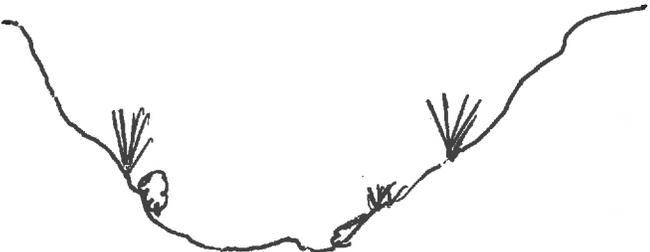
Project: PG&E Topock Compressor Station	Date: 2/13/2012	Time: 3:14 PM
Investigators: R. Huddleston, K Steiner	City: Needles	State: CA
Y <input checked="" type="checkbox"/> N <input type="checkbox"/> Normal Circumstances	Sample Point: T-B 12	Photos: 402-403
Y <input type="checkbox"/> N <input checked="" type="checkbox"/> Significantly Disturbed	GPS: 34.721803	Datum: NAD 84
Geomorphic Feature: DRAINAGE	-114.496667	Width: 7 FT
Flow Regime: EPHEMERAL		
Substrate: FINE -MID PEBBLE		
Indicators: FLOW LINES, SCOURING ABSENCE OF VEGETATION		
Cross-Section:

Vegetation in Channel:	<p>- SCATTERED VEGETATION ALONG THE EDGES OF CHANNEL - LARREA TRIDENTATA, AMBROSIA DUMOSA, KRAMERIA GRAYI AND BEBBIA JUNCEA</p> <p>- SPARSE: CHAMAESTYCE, PALAFOXIA ARIDA</p>	
Low Terrace and Adjacent Vegetation:	<p>- VEGETATION IN AREAS ALONG CHANNEL SIMILAR - LARREA, AMBROSIA AND KRAMERIA</p>	
Notes:

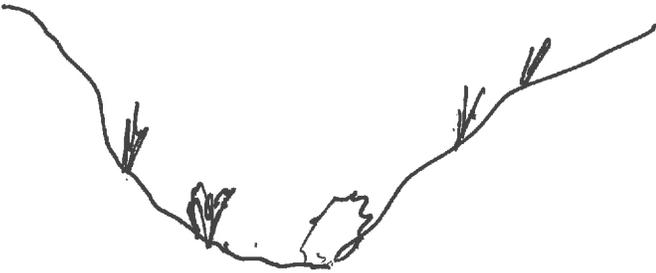
Project: PG&E Topock Compressor Station	Date: 2/13/2012	Time: 3:41 PM
Investigators: R. Huddleston, K Steiner	City: Needles	State: CA
Y <input checked="" type="checkbox"/> N <input checked="" type="checkbox"/> Normal Circumstances	Sample Point: TB-14	Photos: 410-411
Y <input type="checkbox"/> N <input checked="" type="checkbox"/> Significantly Disturbed	GPS: 34.719043	Datum: NAD83
Geomorphic Feature: DRAINAGE - SWALE	-114.497465	Width: 11 FT
Flow Regime: EPHEMERAL		
Substrate: FINE GRAVEL		
Indicators: CHANGE IN SUBSTRATE - MORE FINES IN THIS AREA		
Cross-Section:

Vegetation in Channel:	- SPARSE CHAFF CHAMAESTICE IN LOW FLOW CHANNEL - ALONG EDGES FENCEA FARINOSA, LARREA TRIDENTATA, AMBROSIA DUMOSA	
Low Terrace and Adjacent Vegetation:	LARREA TRIDENTATA	
Notes:	FEATURE TERMINATES UP SLOPE AT RR TRACKS

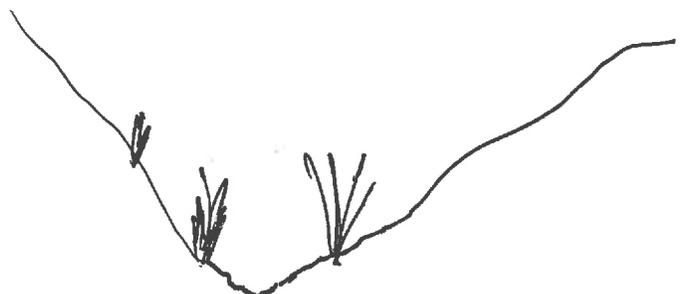
Project: PG&E Topock Compressor Station	Date: 2/14/2012	Time: 8:08 am
Investigators: R. Huddleston, K Steiner	City: Needles	State: CA
Y <input checked="" type="checkbox"/> N <input type="checkbox"/> Normal Circumstances	Sample Point: TB-17	Photos: 347-348
Y <input type="checkbox"/> N <input checked="" type="checkbox"/> Significantly Disturbed	GPS: 34.722031	Datum: NGS 84
Geomorphic Feature: DRAINAGE	-114.499021	Width: 5 1/2 FT
Flow Regime: EPHEMERAL		
Substrate: FINE GRAVEL w/ COBBLE	- ROCK	
Indicators: LOW EROSIONAL CHANNEL -		
Cross-Section:

Vegetation in Channel: BEBBIA JUNCEA, HYPTIS EMORYI, POROPHYLLUM GRACILE, AND CHAMAESYCE SP.		
Low Terrace and Adjacent Vegetation: LARREA TRIDENTATA, KRAMEERIA GRAYI, AMBROSIA DUMOSA, AND CYLINDROPUNTIA SP.		
Notes:

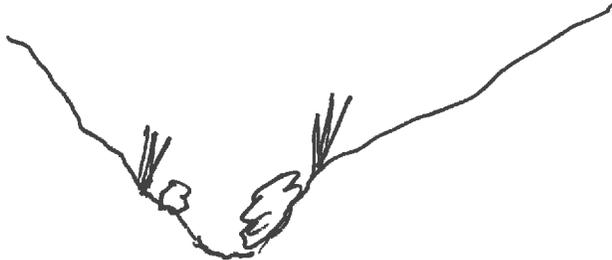
Project: PG&E Topock Compressor Station	Date: 2/14/2012	Time: 8:20AM
Investigators: R. Huddleston, K Steiner	City: Needles	State: CA
Y <input checked="" type="checkbox"/> N <input type="checkbox"/> Normal Circumstances	Sample Point: TB18	Photos: 349-350
Y <input type="checkbox"/> N <input checked="" type="checkbox"/> Significantly Disturbed	GPS: 34.723239	Datum: NGS 84
Geomorphic Feature: DRAINAGE	-114.498031	Width: 3 1/2 FT
Flow Regime: EPHEMERAL		
Substrate: SAND / GRAVEL / COBBLE		
Indicators: LOW FLOW EROSIONAL CHANNEL		
Cross-Section:

Vegetation in Channel:	MOSTLY UNVEGETATED - SPARSE BOUTELOUA ARISTIDOIDES - UPSLOPE OF THIS POINT SOME ACACIA GREGGII	
Low Terrace and Adjacent Vegetation:	LARREA TRIDENTATA, AMBROSIA DUMOSA, KERAMERIA GRAYI	
Notes:

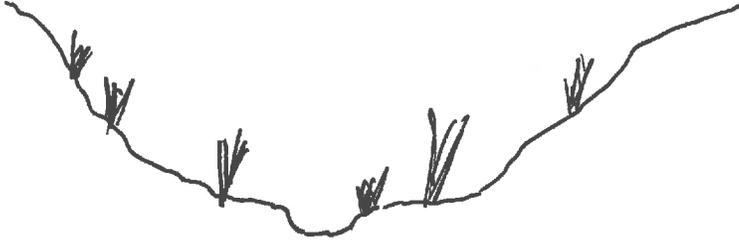
Project: PG&E Topock Compressor Station	Date: 2/14/2012	Time: 8:38 am
Investigators: R. Huddleston, K Steiner	City: Needles	State: CA
Y <input checked="" type="checkbox"/> N <input type="checkbox"/> Normal Circumstances	Sample Point: TB-20	Photos: 353-354
Y <input type="checkbox"/> N <input checked="" type="checkbox"/> Significantly Disturbed	GPS: 34.723302	Datum: WGS 84
Geomorphic Feature: DRAINAGE	-114.498879	Width: 7 1/2 FT
Flow Regime: EPHEMERAL		
Substrate: GRAVEL - COBBLE		
Indicators: SCOUR CHANNEL, SAND DEPOSITS		
Cross-Section:

Vegetation in Channel:	SPARSE HERBACEOUS VEG. ONLY: CHAMAESYCE SP. BOUTELOUA ARISTIDOIDES	
Low Terrace and Adjacent Vegetation:	LARREA TRIDENTATA, AMBROSIA DUMOSA, KRAMERIA GRAYI	
Notes:

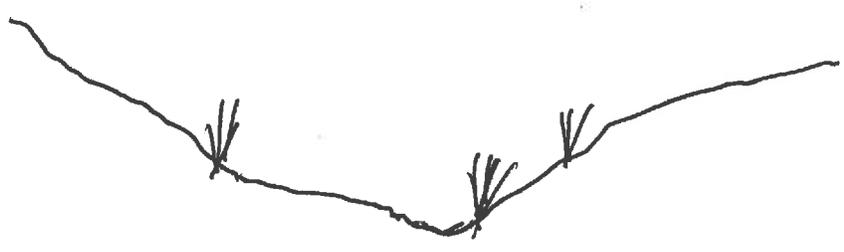
Project: PG&E Topock Compressor Station	Date: 2/14/2012	Time: 8:50 AM
Investigators: R. Huddleston, K Steiner	City: Needles	State: CA
Y <input checked="" type="checkbox"/> N <input type="checkbox"/> Normal Circumstances	Sample Point: TB-22	Photos: 357, 358
Y <input type="checkbox"/> N <input checked="" type="checkbox"/> Significantly Disturbed	GPS: 34.722292 -114.500327	Datum: WGS 84
Geomorphic Feature: DRAINAGE / EROSIONAL CHANNEL	Width: 1 FT	
Flow Regime: EPITEMERAL		
Substrate: COBBLE - GRAVEL		
Indicators: LOW FLOW EROSIONAL CHANNEL - ABSENCE OF VEGETATION		
Cross-Section:

Vegetation in Channel: NONE		
Low Terrace and Adjacent Vegetation: LARREA TRIDENTATA, OPUNTIA BASILARIS		
Notes:

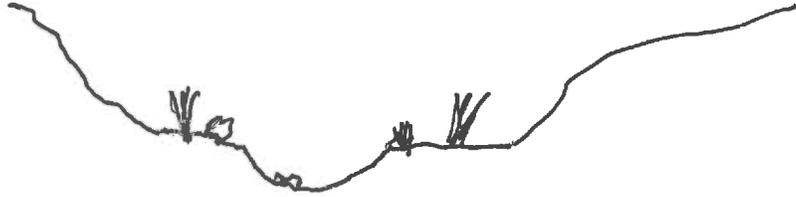
Project: PG&E Topock Compressor Station	Date: 2/14/2012	Time: 9:41 am
Investigators: R. Huddleston, K Steiner	City: Needles	State: CA
Y <input checked="" type="checkbox"/> N <input type="checkbox"/> Normal Circumstances	Sample Point: TB-23	Photos: 368-369
Y <input type="checkbox"/> N <input checked="" type="checkbox"/> Significantly Disturbed	GPS: 34.721222 -114.502552	Datum: WGS 84
Geomorphic Feature: <u>EROSIONAL CHANNEL</u>	Width: <u>5 FT</u>	
Flow Regime: <u>EPHEMERAL</u>		
Substrate: <u>GRAVEL-LOBBLIE (ROCKY)</u>		
Indicators: <u>LOW FLOW EROSIONAL CHANNEL</u>		
Cross-Section:

Vegetation in Channel:	<u>SPARSE CHAMAESYSE SP., PHACELIA SP.</u> <u>PLANTAGO OVATA, ERIOGONUM INFLATUM,</u> <u>BOUTELOUA ARISTIDOIDES</u>	
Low Terrace and Adjacent Vegetation:	<u>LARREA TRIDENTATA, AMBROSIA DUMOSA,</u> <u>BEBBIA TUNCEA, KRAMERIA GRAYI, CYLINDROPUNTIA SP.</u>	
Notes:

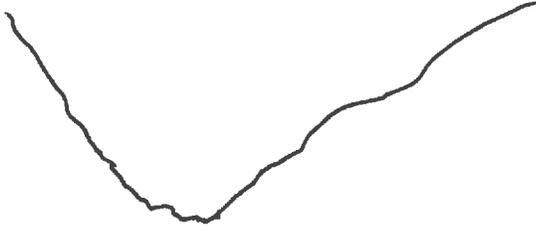
Project: PG&E Topock Compressor Station	Date: 2/16/2012	Time: 9:08am
Investigators: R. Huddleston, K Steiner	City: Needles	State: CA
Y <input checked="" type="checkbox"/> N <input type="checkbox"/> Normal Circumstances	Sample Point: 7B-32	Photos: 378-381
Y <input type="checkbox"/> N <input checked="" type="checkbox"/> Significantly Disturbed	GPS: 34.713524	Datum: 106584
Geomorphic Feature: DRAINAGE	-114.484575	Width: 10 FT
Flow Regime: EPHEMERAL		
Substrate: BEDROCK - COBBLE		
Indicators: CULVERT, DEFINED BED-BANK CHANNEL		
Cross-Section:

Vegetation in Channel:	PERITOME EMORYI, GERAEA CANSESCENS	
Low Terrace and Adjacent Vegetation:	ENCELIA FARINOSA, HYPTIS EMORYI LARREA TRIDENTATA	
Notes:
