FIGURE 2
SCHEMATIC DIAGRAM OF PGE-6
DECOMMISSIONING
 PG&E TOPOCK COMPRESSOR STATION
 NEEDLES, CALIFORNIA

FIGURE 2
SCHEMATIC DIAGRAM FOR INACTIVE
SUPPLY WELL PGE-6
 PG&E TOPOCK COMPRESSOR STATION
 NEEDLES, CALIFORNIA

VIDEO SURVEY REPORT

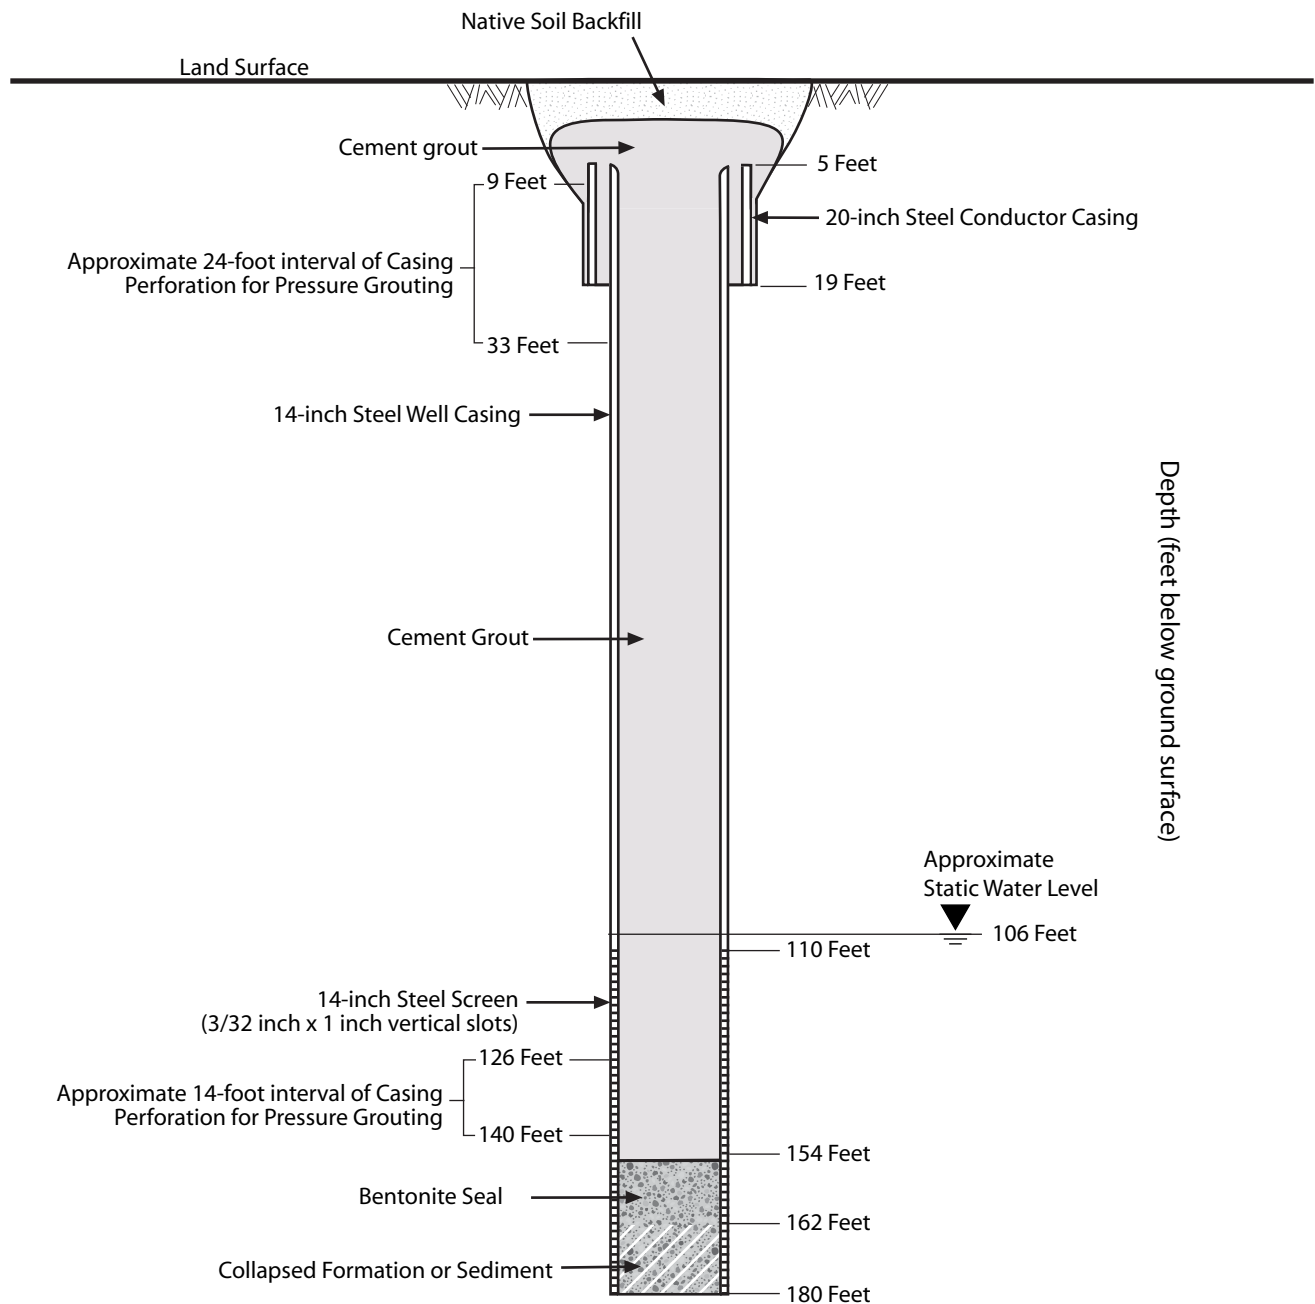
NOT TO SCALE

Revised 6/19/07
