### Subject: May 2019 Monthly Progress Report for the Final Groundwater Remedy Construction and Startup, PG&E Topock Compressor Station, Needles, California (Document ID: TPK Monthly Progress Rpt MAY 2019 20190610 Final)

# May 2019 Monthly Progress Report for the Final Groundwater Remedy Construction and Startup

PG&E Topock Compressor Station Needles, California

Document ID: TPK\_Monthly\_Progress\_Rpt\_MAY\_20190610\_Final

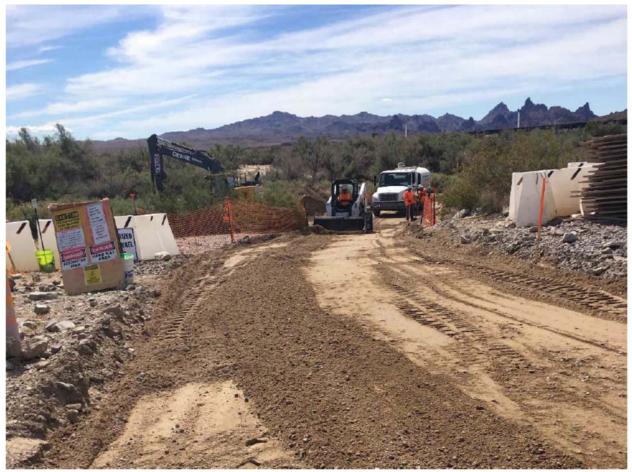
Placement of aggregate base along IRZ access road north of Pipeline C3

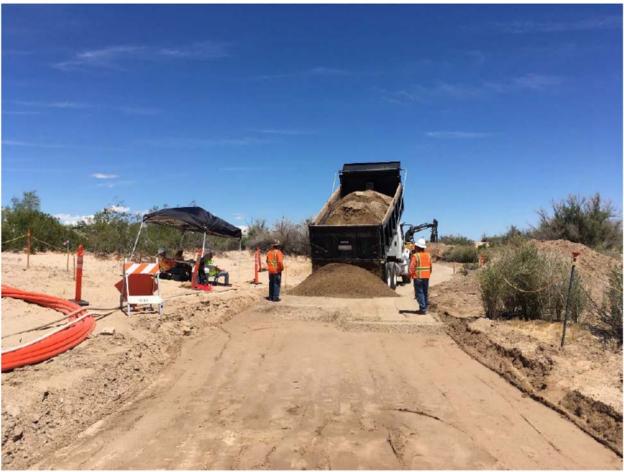
Delivery of aggregate base from SPY for IRZ access road installation north of Pipeline C3.

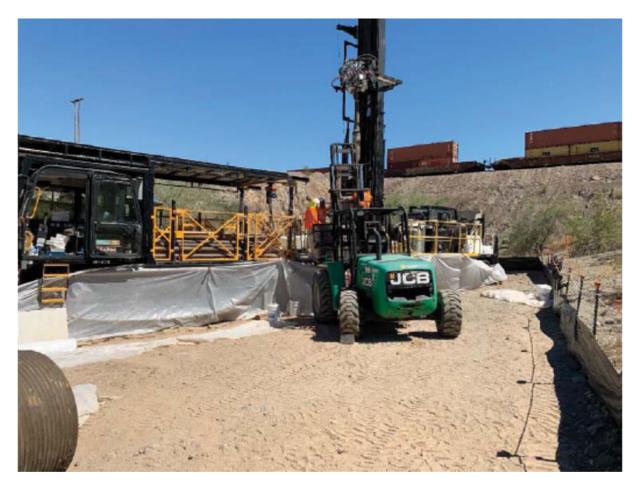
MW-M Well Installation.

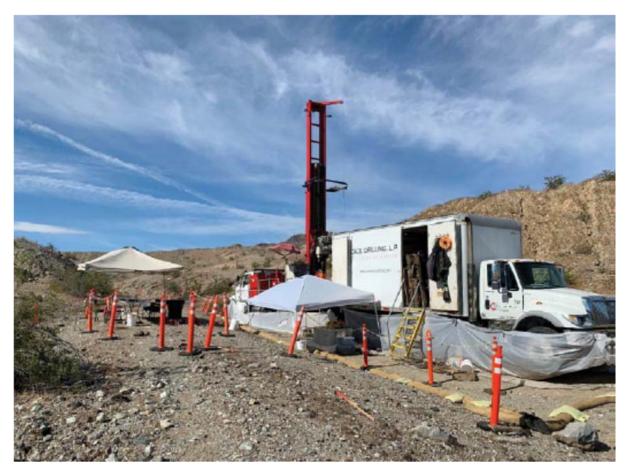
MW-R Well Installation.

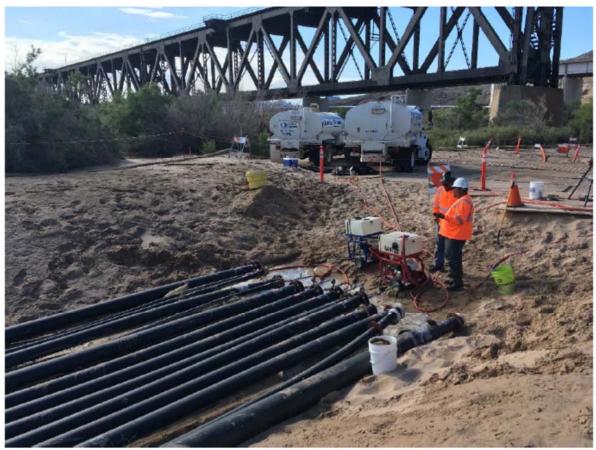
Filling and leak testing of HDPE pipelines at C5 pipeline end.

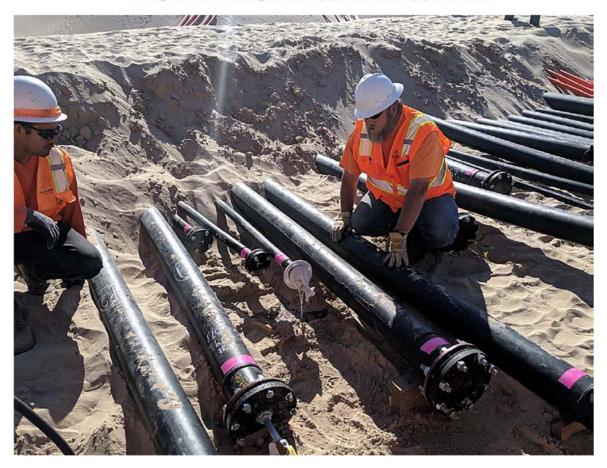
Freshwater used for pipe flushing discharged to ground, inside pipe trench, through a sock.

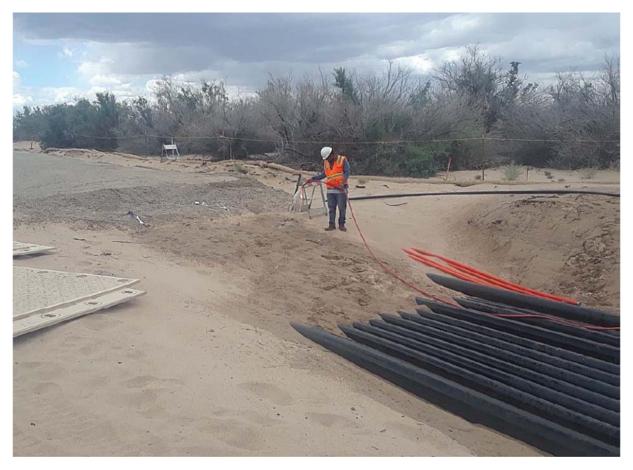
Freshwater used for hydrostatic testing discharged to ground, inside pipe trench, through a sock.
