Figure 1-5b
Incidental Release Locations,
Expanded Area
RFI/RI Report, Volume 3 —
Results of Soil and Sediment Investigation
PG&E Topock Compressor Station, Needles, California

Figure 3-15a
Arsenic
Soil Sample Results
AOC 15
RFI/RI Report, Volume 3 —
Results of Soil and Sediment Investigation
PG&E Topock Compressor Station, Needles, California

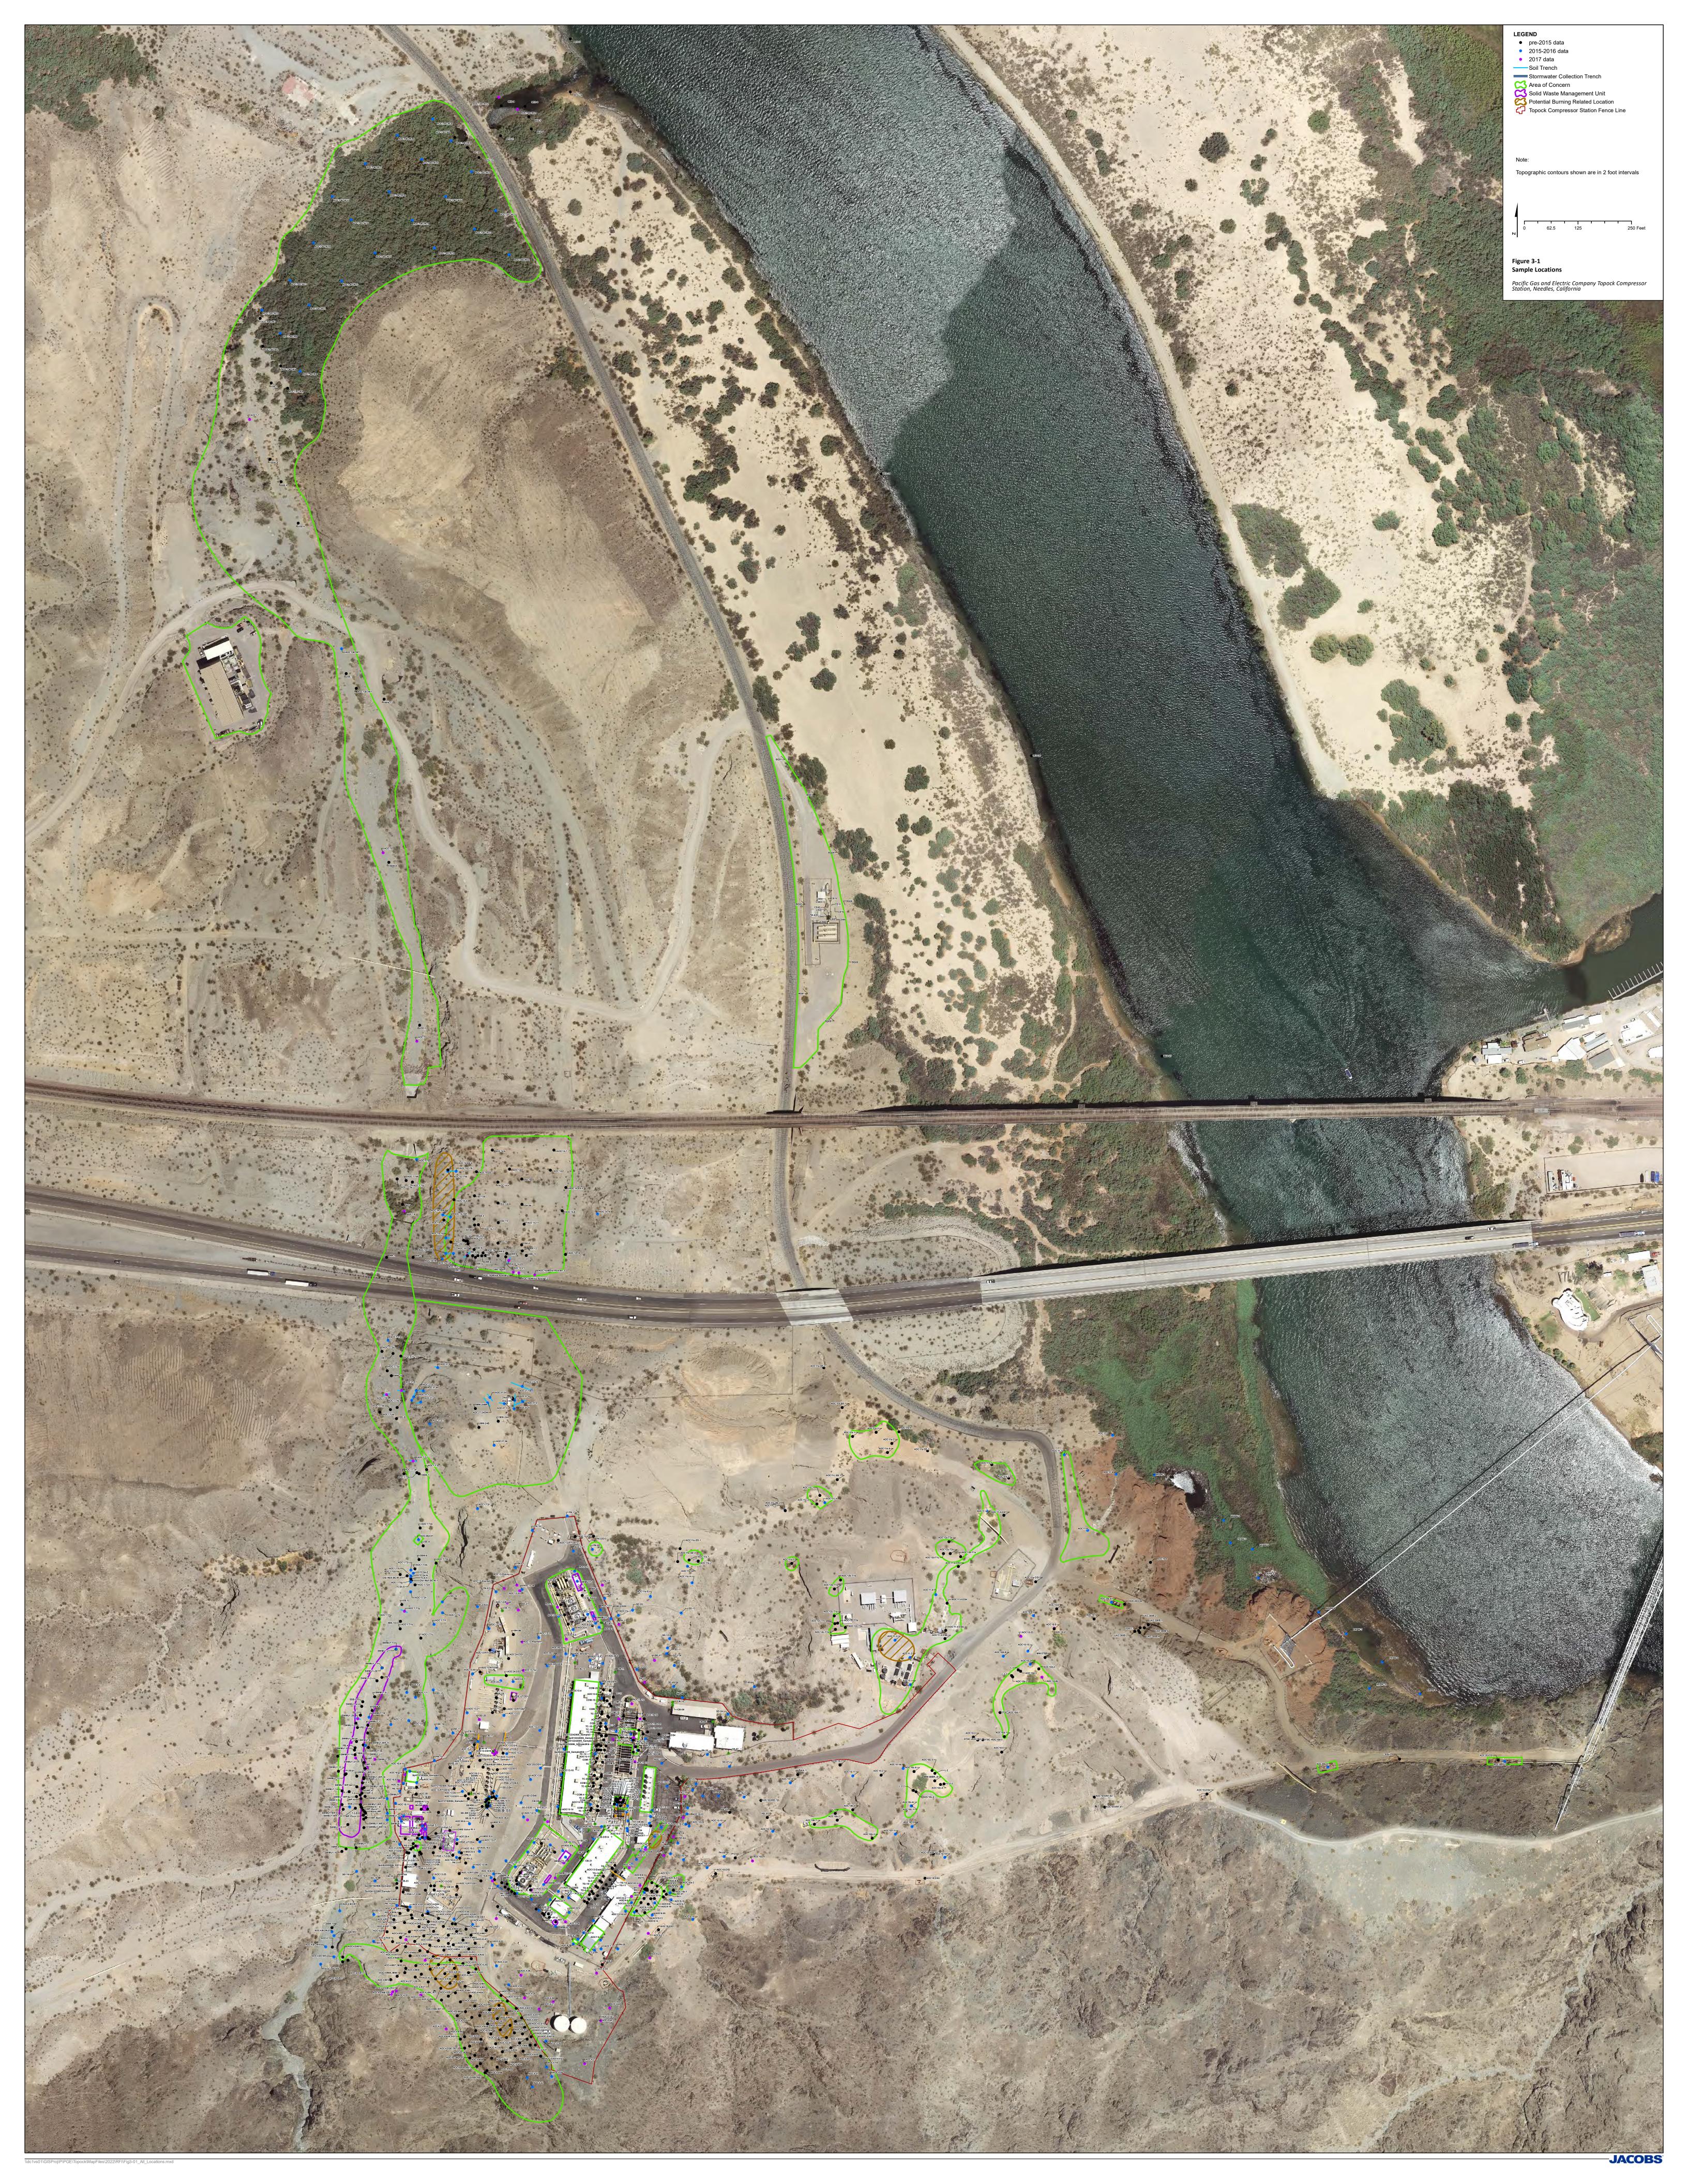
A pre-1995 release from Cooling Tower B to the Northeast Ravine was also identified; however, the exact path and extent of the release are unknown

The Dec 2005 Bat Cave Wash Wastewater Release originated further west than is depicted on this map

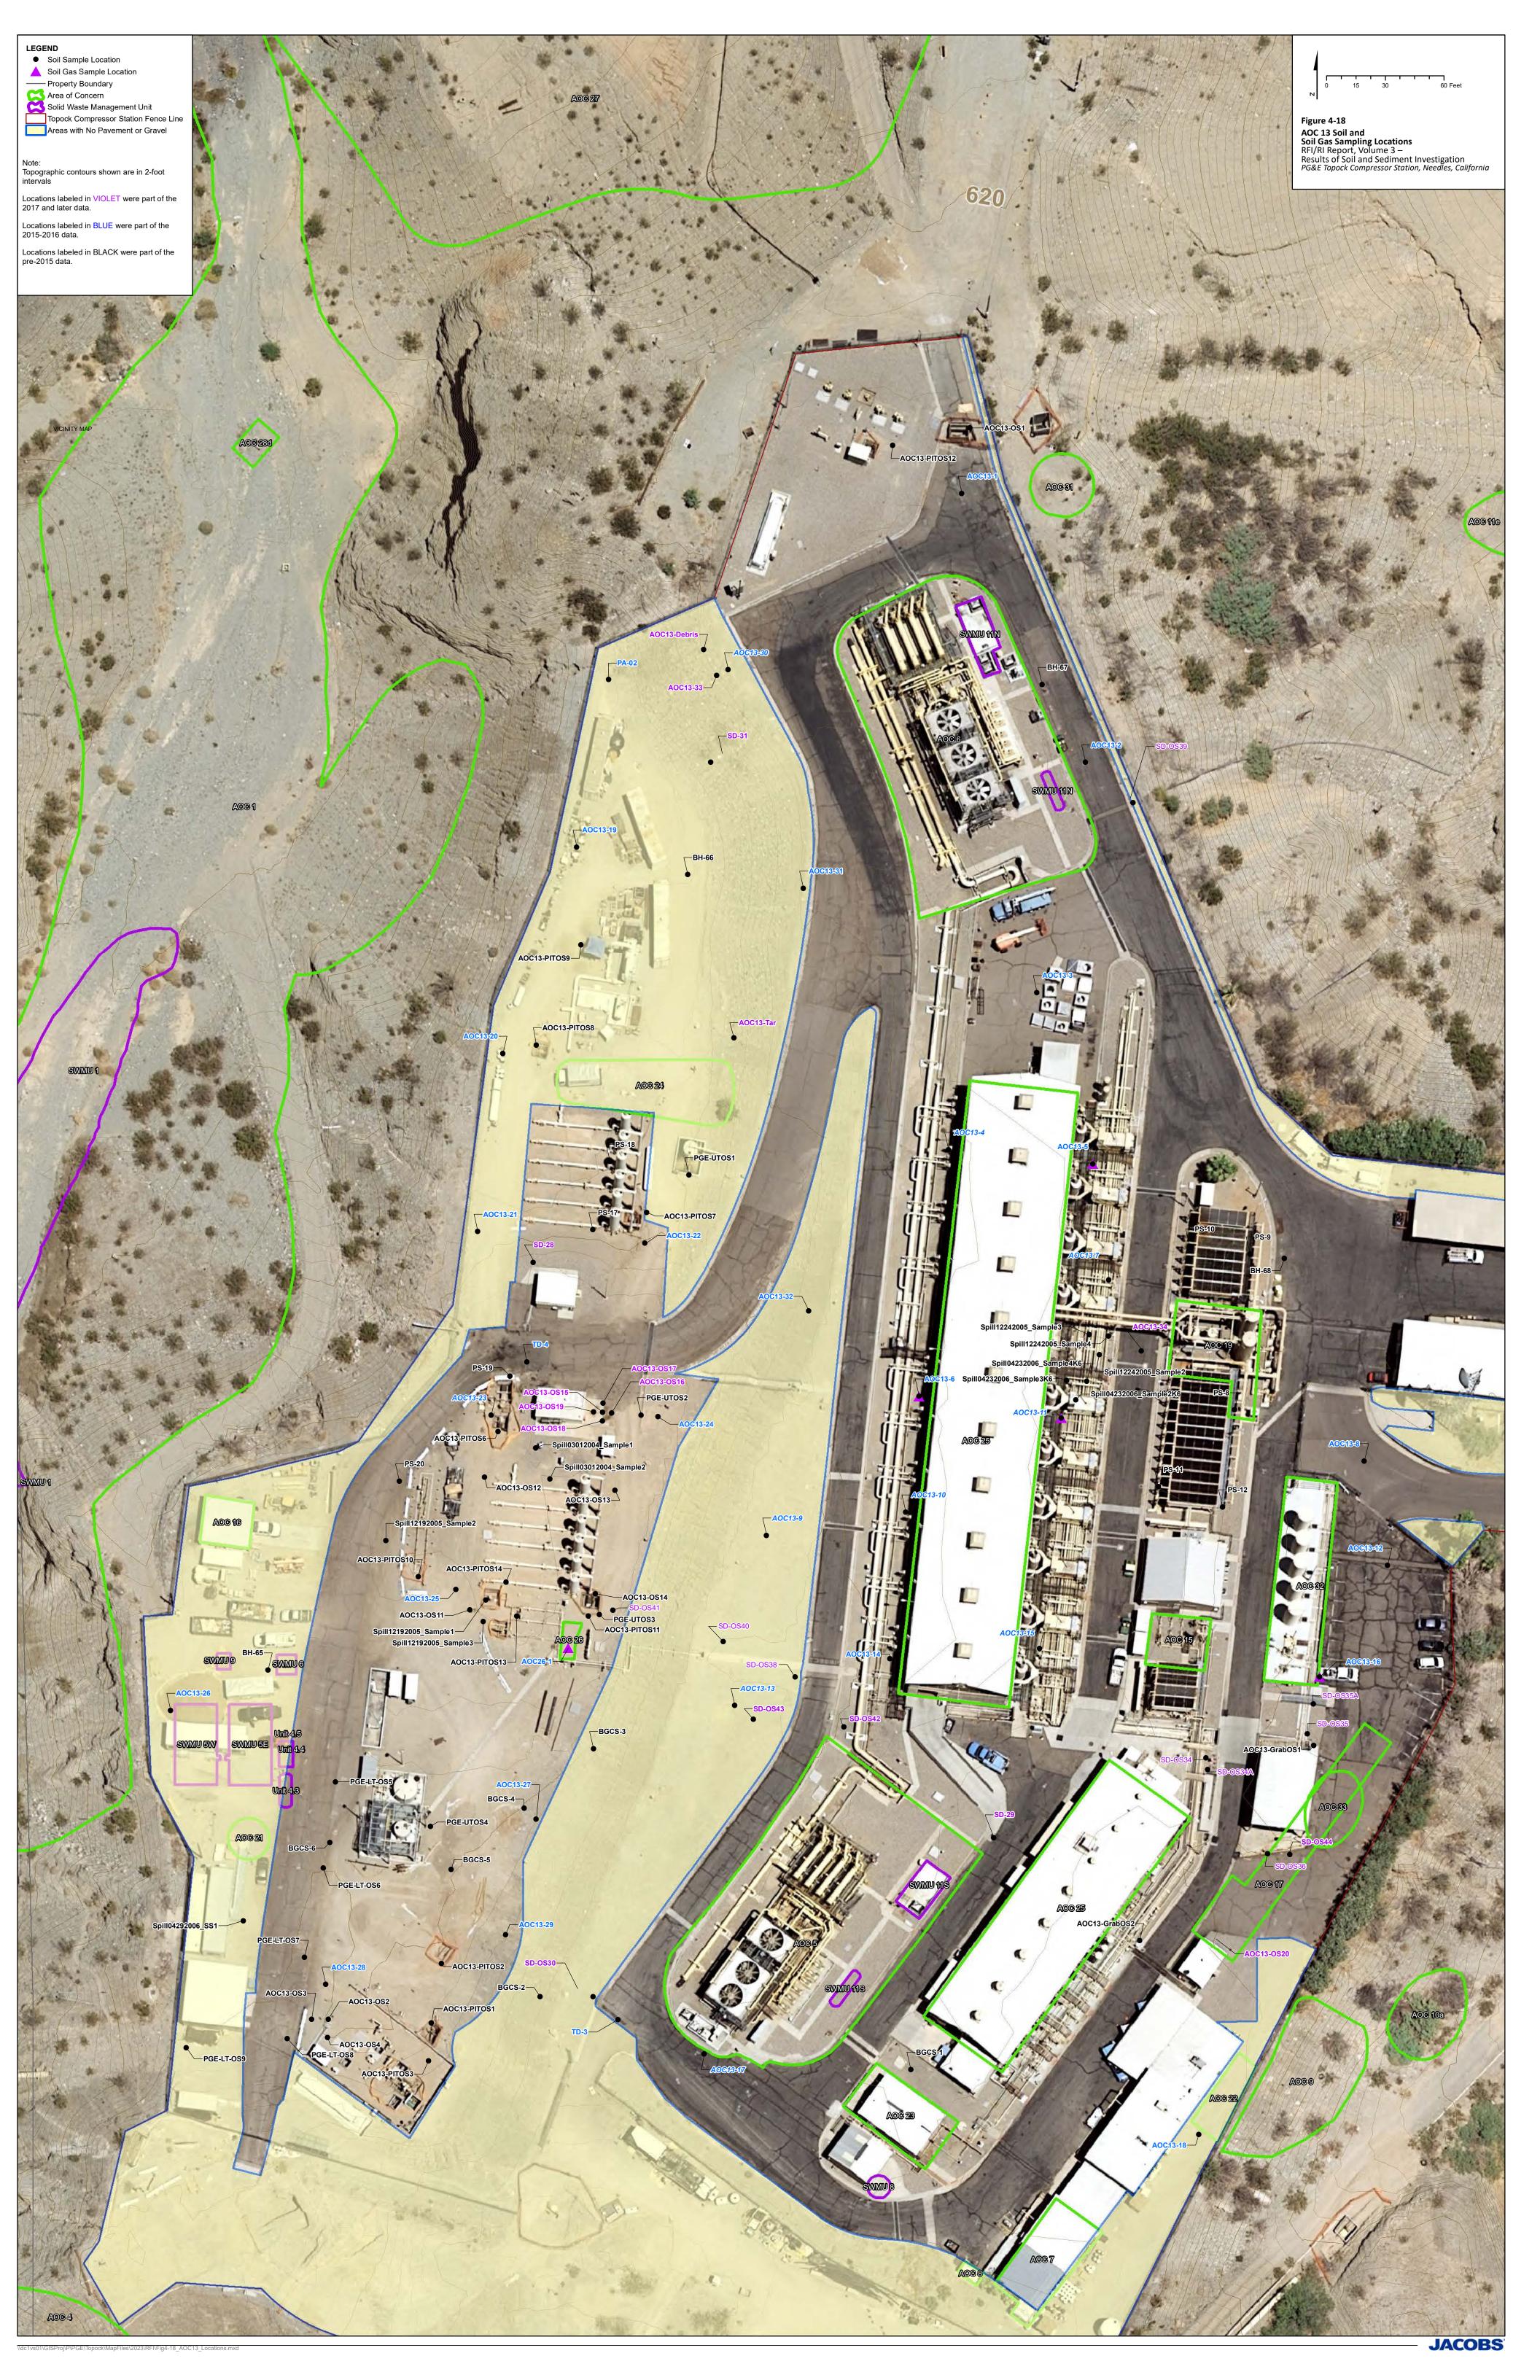
#### Note:

-Drawing of aboveground piping is schematic and is not representative of actual piping.

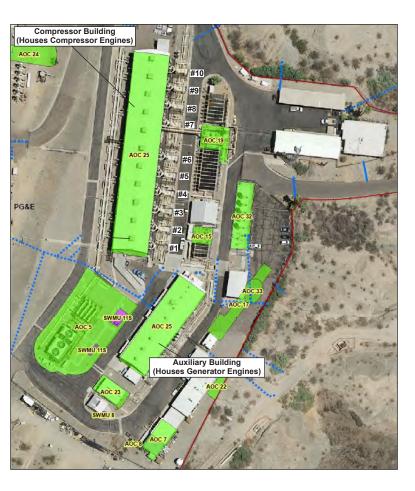
# Compressor Engine Schematic

-Engine number designations are shown next to the respective compressor engines.
