**BIOLOGICAL RESOURCES COMPLETION REPORT FOR THE TOPOCK REMEDIATION
PROJECT: SOIL INVESTIGATIONS BETWEEN 2015 AND 2017**

Blue Rock Services, Inc.
1745 South Alma School Road, Suite 220
Mesa, Arizona 85210

June 2017

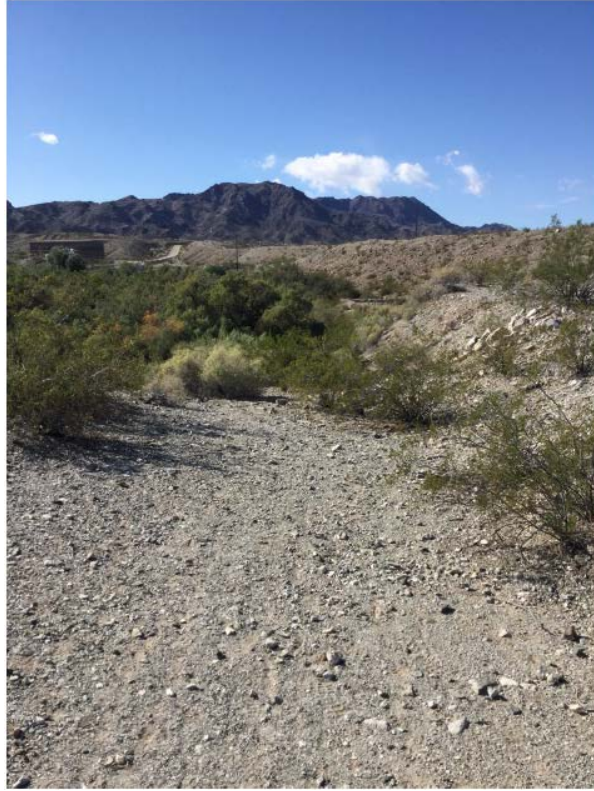
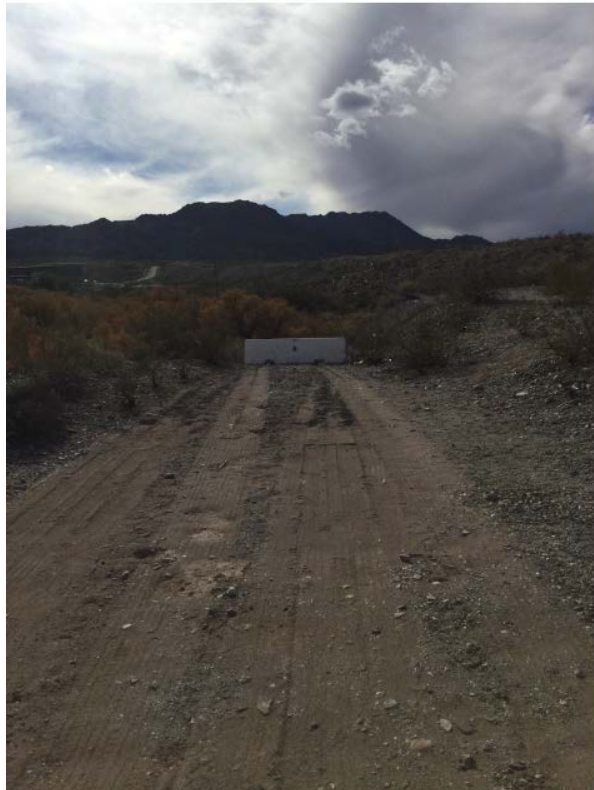
The entrance into the Mouth of Bat Cave wash resulted in 0.022 acre of Upland disturbance (Appendix B, Photos 1 and 2), as a result of trimming and minor grading along the access path.

Photo-1: Before grading and trimming the access path to the Mouth of Bat Cave Wash entrance

Photo-2: After grading and trimming the access path to the Mouth of Bat Cave Wash entrance

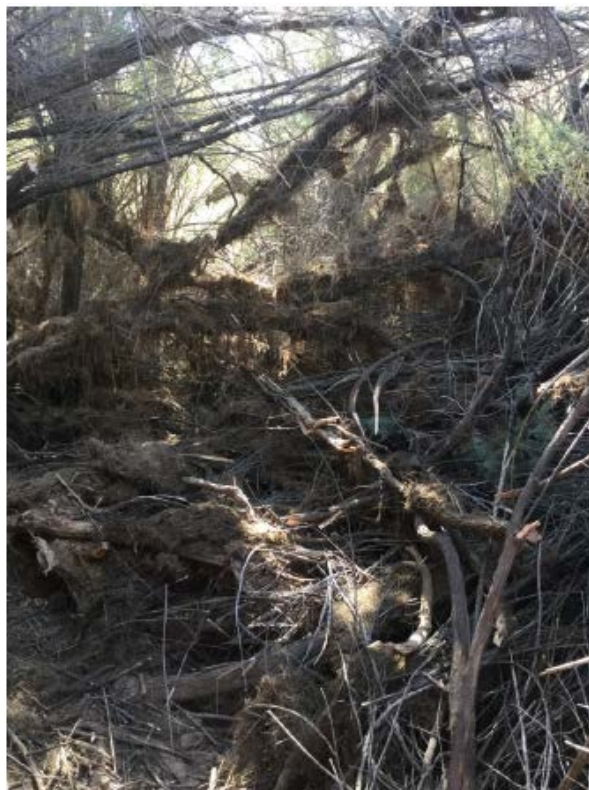
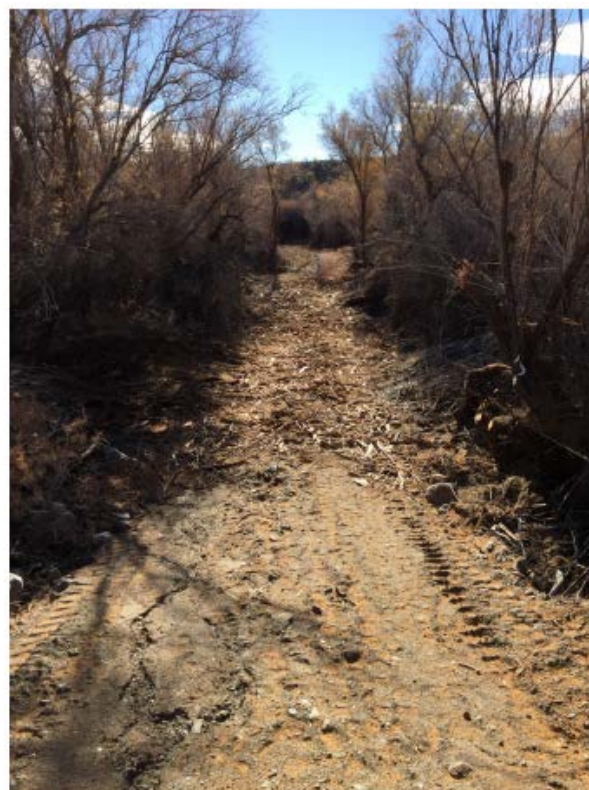
Within the 100-year floodplain, tamarisk was removed to allow access to 23 bore sample sites. Within the dense tamarisk thicket, 20-foot-wide corridors were cleared for access to the sites in this area (Appendix B, Photos 3 and 4). Tamarisk trees were cleared by cutting trees at base and leaving the root ball intact for resprouting. This resulted in 0.941 acre of total disturbance, of which, 0.505 acre was within floodplain habitat (see Appendix A, Figure 3). Since tamarisk is an invasive species and regrowth is anticipated, the impacts are considered temporary. Therefore, this disturbance was not included in the overall disturbance for floodplain habitat.

Photo-3: Before tamarisk removal for bore sample sites in Mouth of Bat Cave Wash.

Photo-4: After tamarisk removal for bore sample sites in Mouth of Bat Cave Wash.

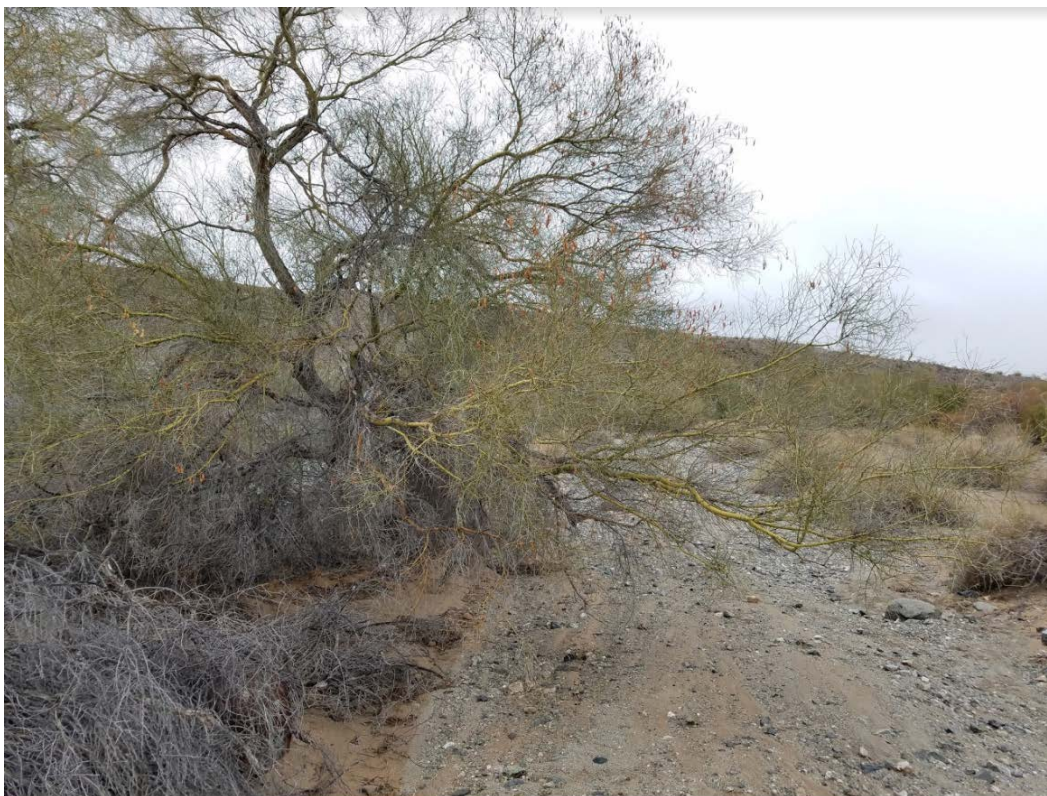
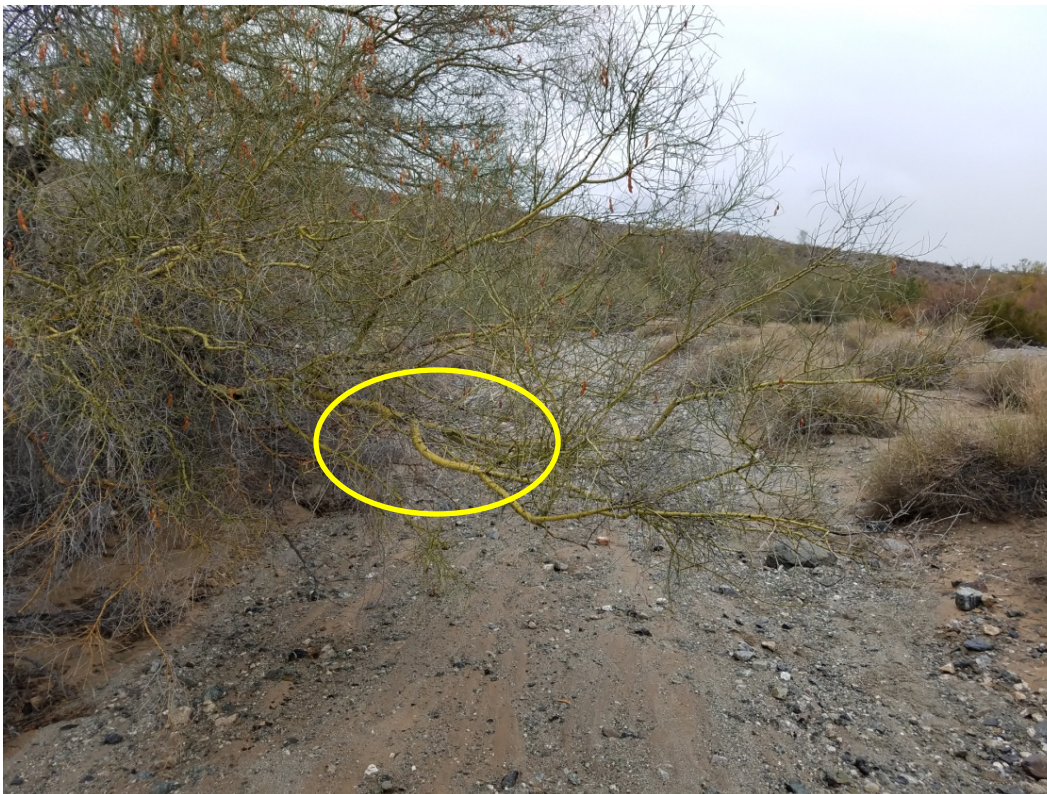
Trimming of creosote or cheese-bush (*Ambrosia salsola*) was required at two of the sites AOC 1-1 and AOC 1-T6D. The trimming of one palo verde was required to access AOC 1-7 (Appendix B, Photos 5 and 6). In order to reduce the amount of trimming required, the branches of the palo verde were pulled back and tied off at the base of the tree so that the overall trimming needed was less than 1% of the overall crown of the tree.

Photo-5: Before palo verde was trimmed for access to AOC 1-7 drill site.

Photo-6: After trimming the palo verde for access to AOC 1-7 drill site.

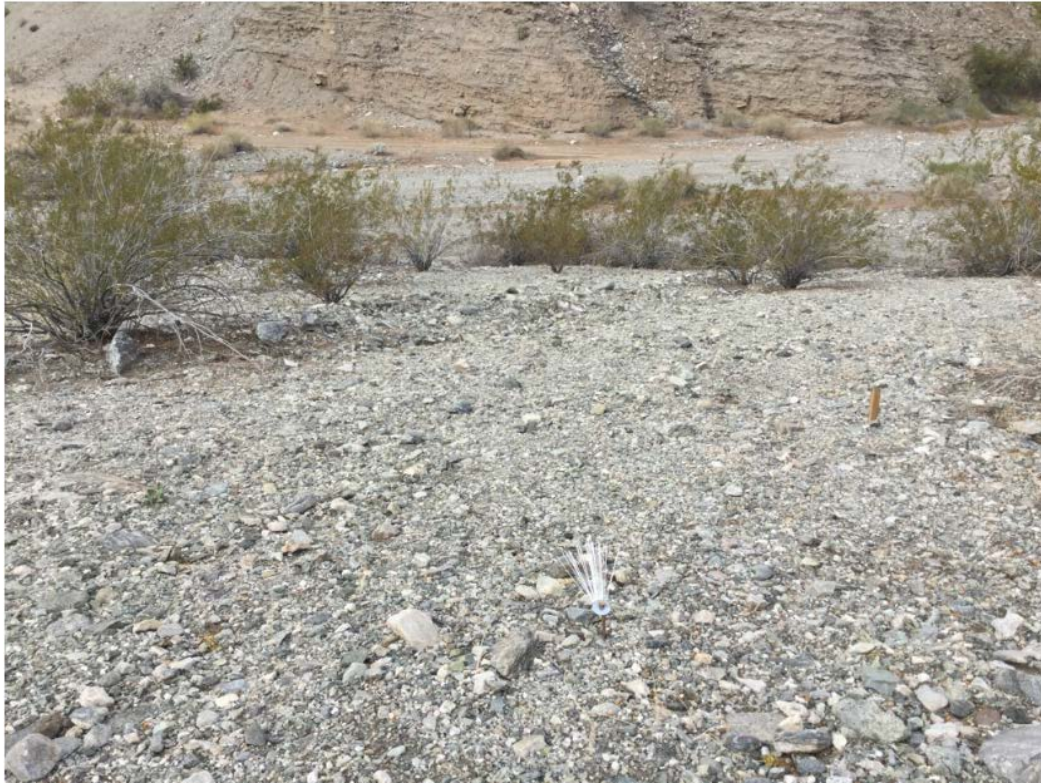
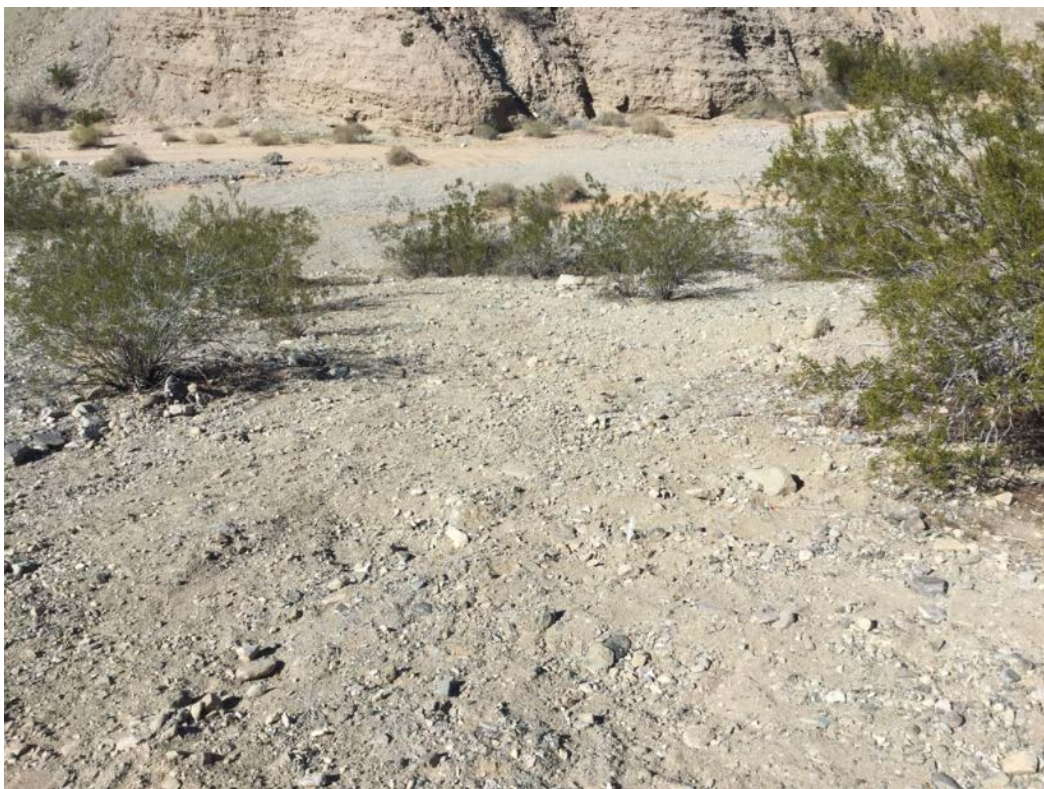
Three sites within Bat Cave Wash, AOC 1-1 (Appendix B, Photos 7 and 8), AOC 1-T7 (Appendix B, Photos 9 and 10), and SD 19 (Appendix B, Photos 11 and 12), resulted in disturbance of 0.018 acre of Upland habitat. Ground disturbance occurred as a result of trenching with a backhoe.

Photo-7: AOC 1-1 before creosote removal and grading

Photo-8: AOC 1-1 after creosote removal and grading.

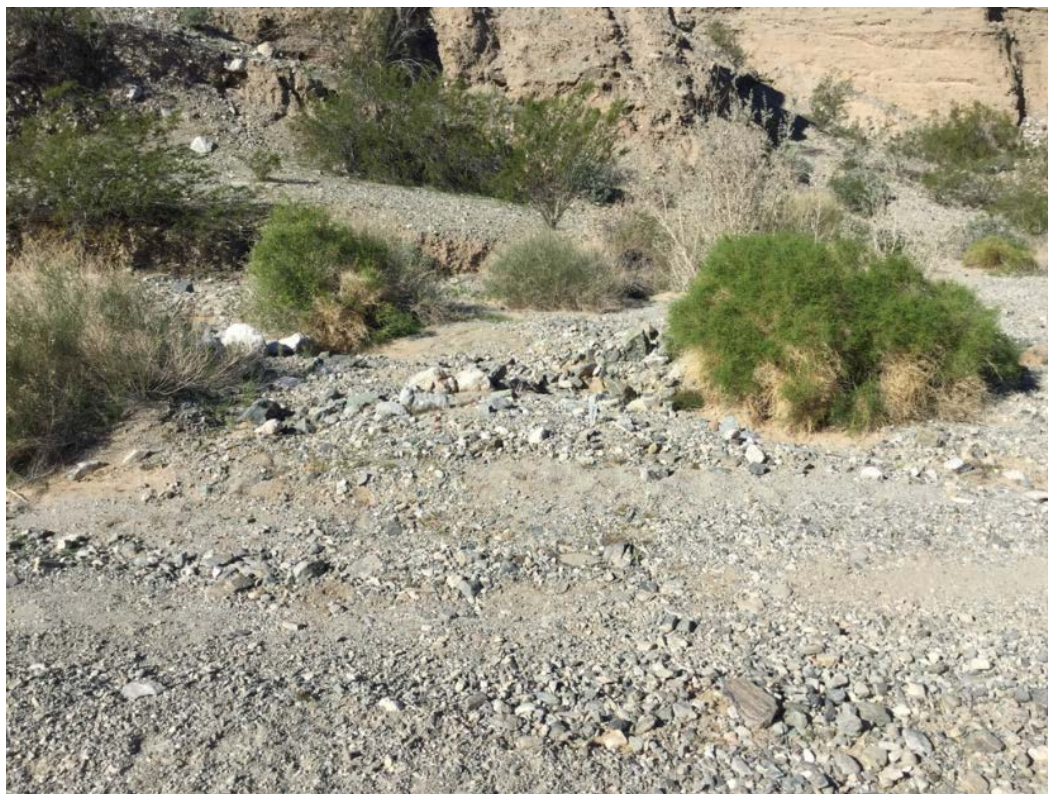
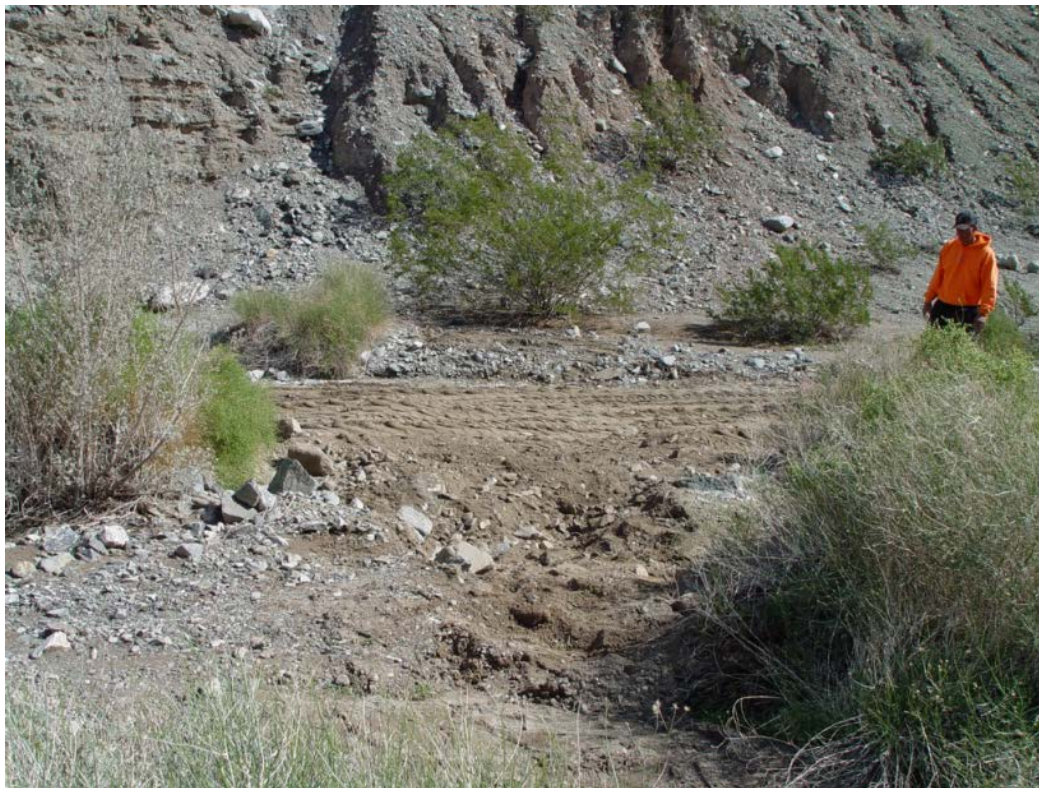
Photo-9: AOC 1-T7 before trenching with backhoe.

Photo-10: AOC 1-T7 after trenching with backhoe.

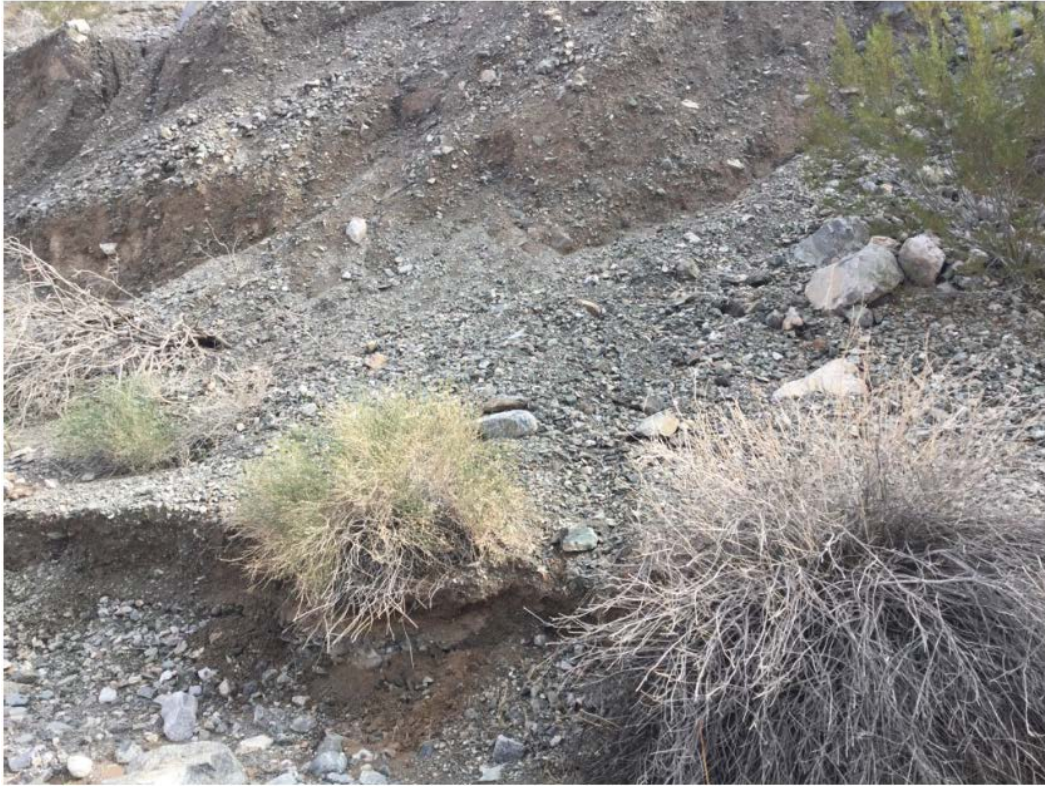
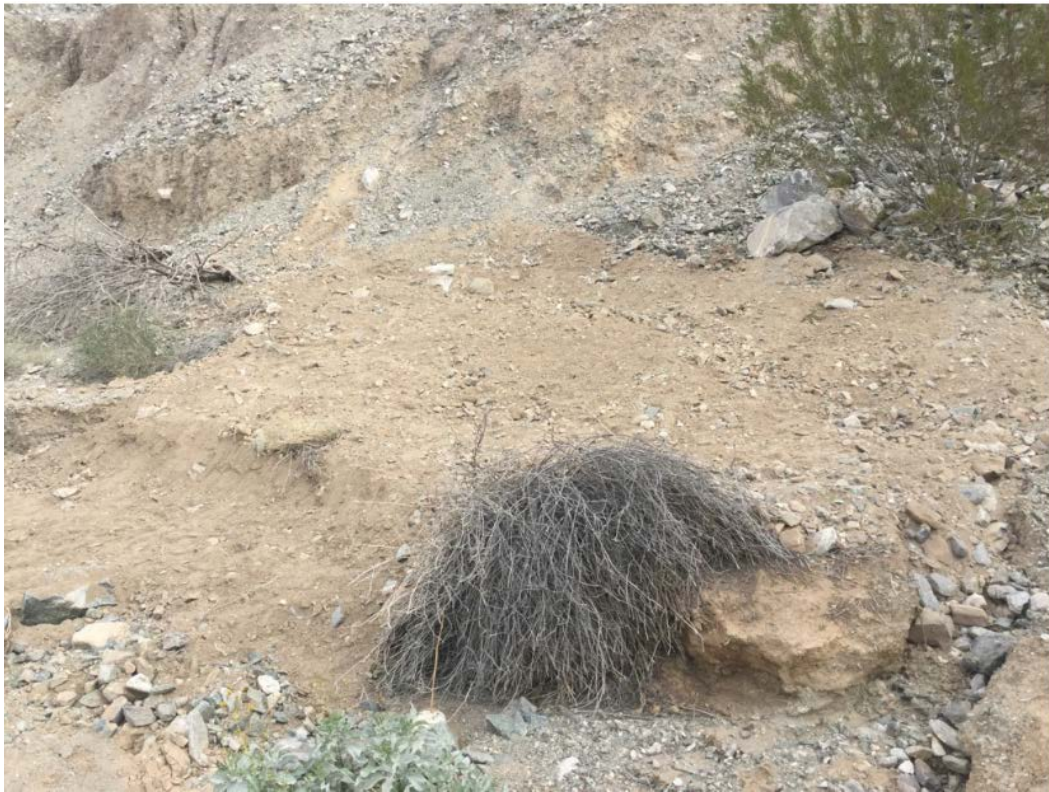
Photo-11: SD-19 before using backhoe for a storm drain inspection.

Photo-12: SD-19 after backhoe for a storm drain inspection.

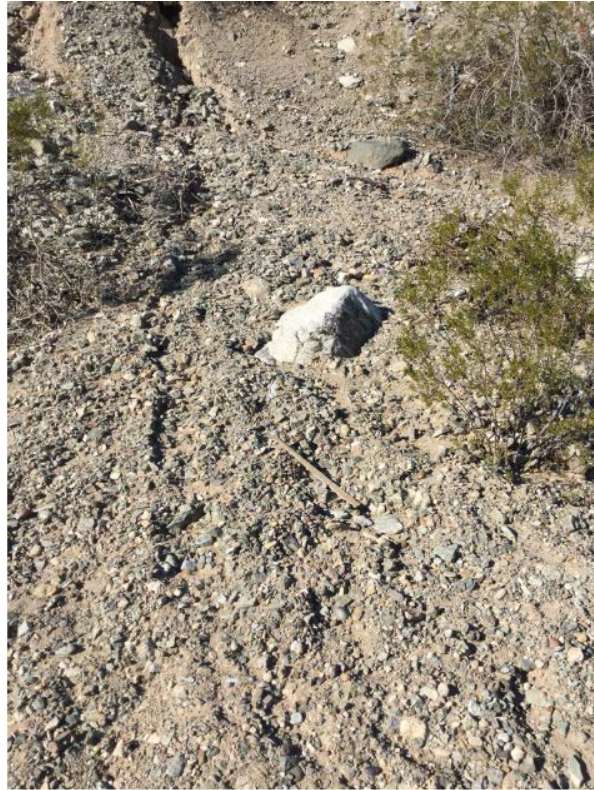
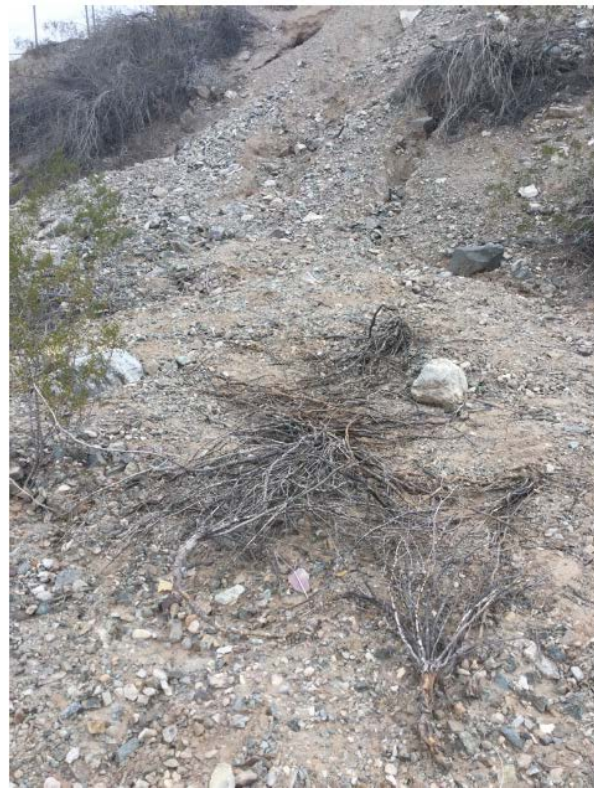
Photo-13: Example of AOC 9-20 work before hand-sampling.

Photo-14: Example of AOC 9-20 work after hand-sampling.

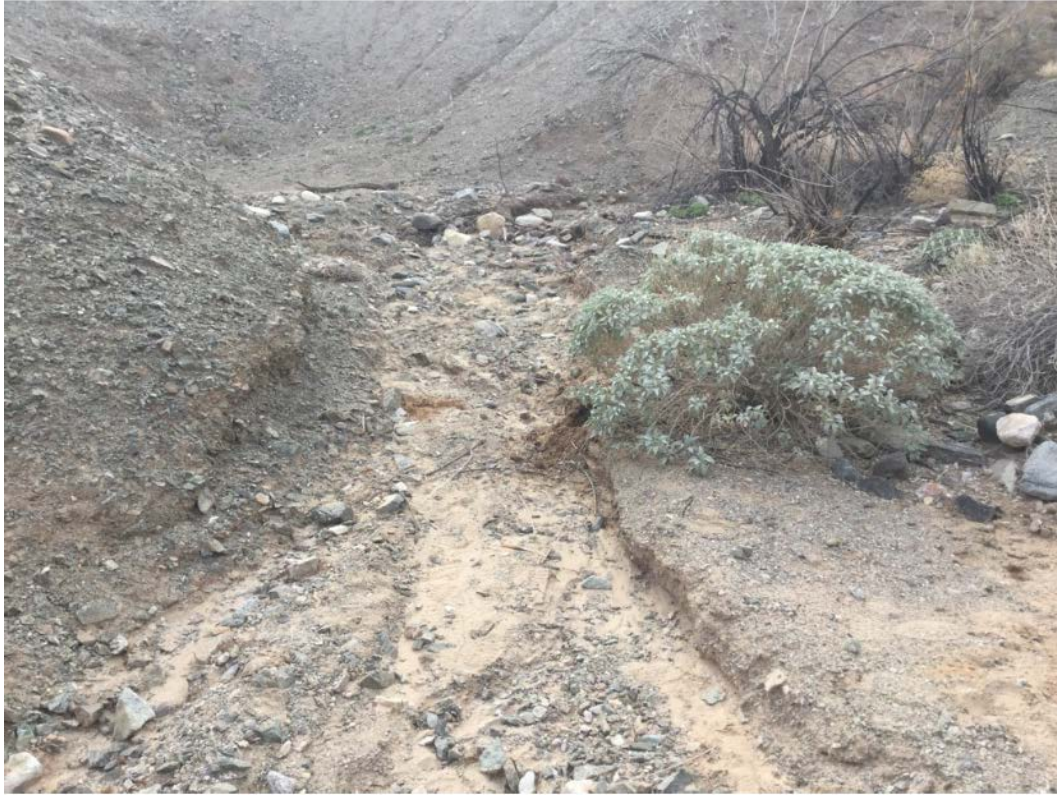
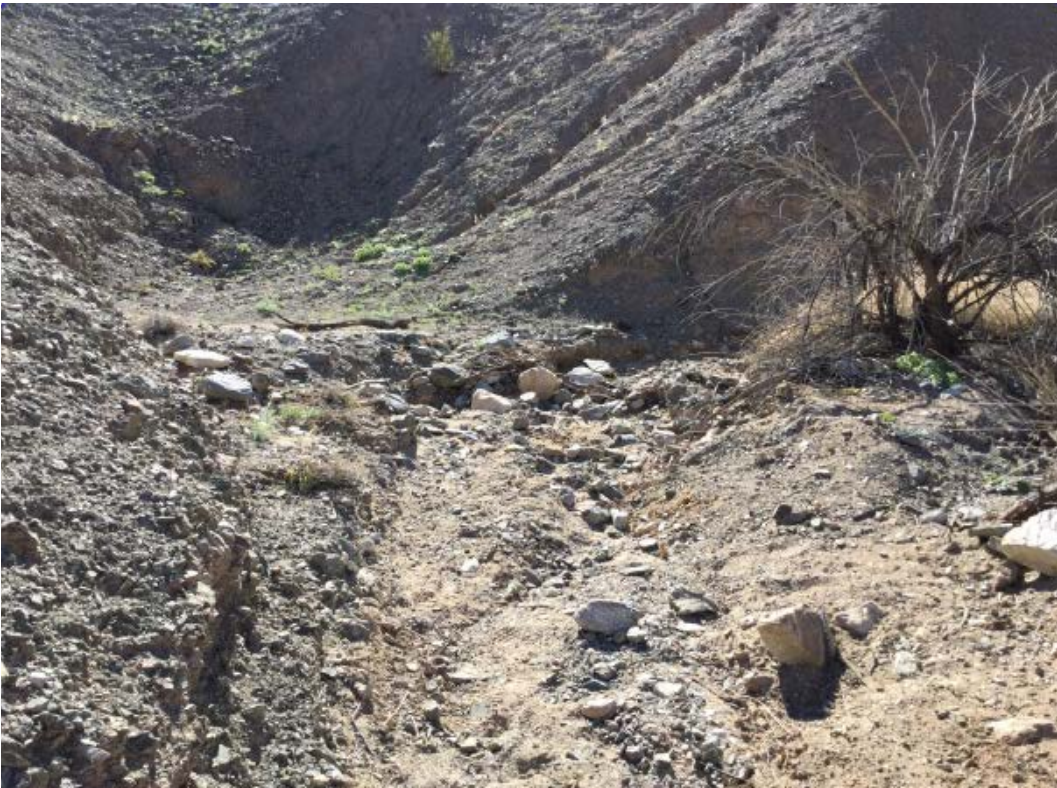
Prior to work activities, vegetation trimming was required at two of the sites. An access path to AOC10-10 (Appendix B, Photos 15 and 16), located west of the unpaved access road, required the trimming of three brittle bush. This site resulted in a disturbance of 0.008 acre of Upland habitat. Disturbance occurred as a result of vegetation areas being disturbed by the drill rig.

Photo-15: AOC 10-10 before brittle-bush trimming to gain site access for borehole sample.

Photo-16: AOC 10-10 after brittle-bush trimming to gain site access for borehole sample.

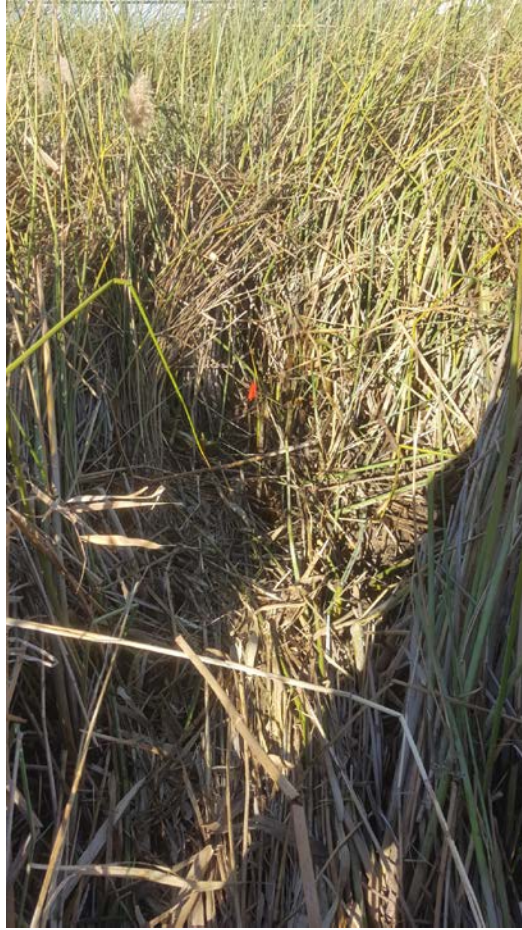
Prior to sampling for the ten pore water sites, limited clearing of tules (*Schoenoplectus californicus*) was required. To gain access to the river sediment for these pore water samples, an area of approximately five by five feet was created by pushing over the tules rather than cutting them. Only the tules that were in the immediate location around the sample hole were cut to permit access to the pore water sample location. No more than 10 tules stems at each sample location were cut just above ground level with the root balls

left intact. All pre-clearing activities were conducted under the supervision of the authorized biologist and, by leaving the tules roots intact, these activities did not result in floodplain habitat loss or permanent disturbance (Appendix B, Photo 17).

Photo-17: East Ravine Pore Water sample site 8 after clearance.

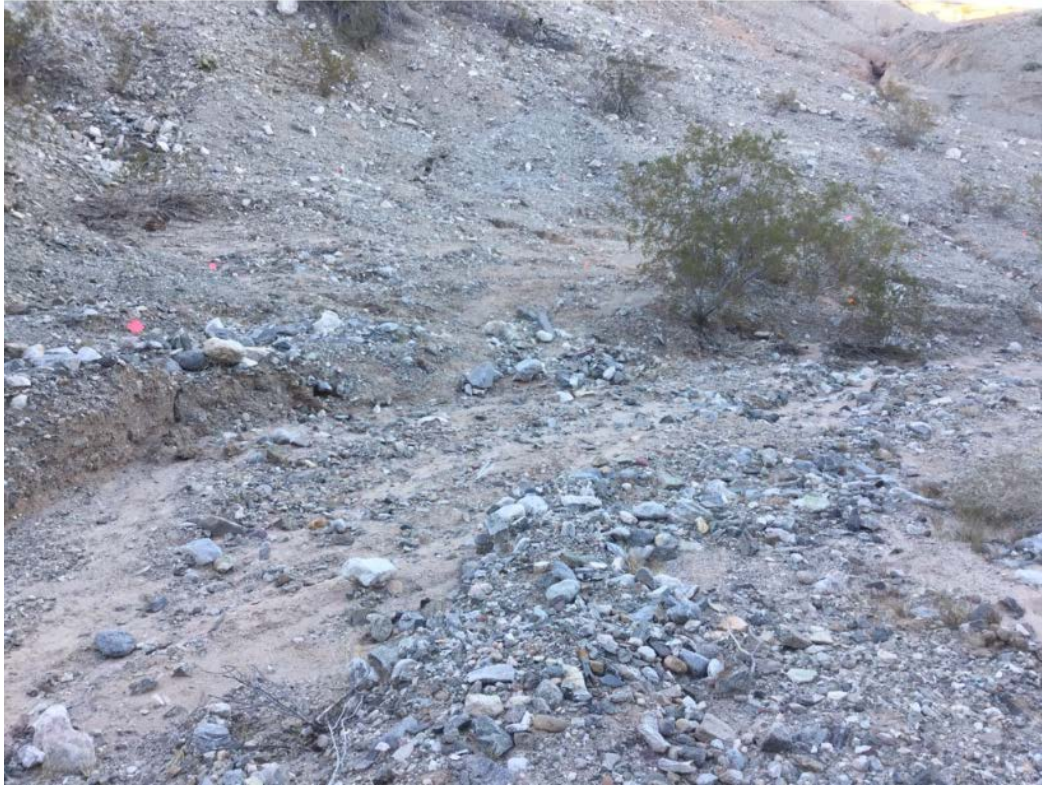
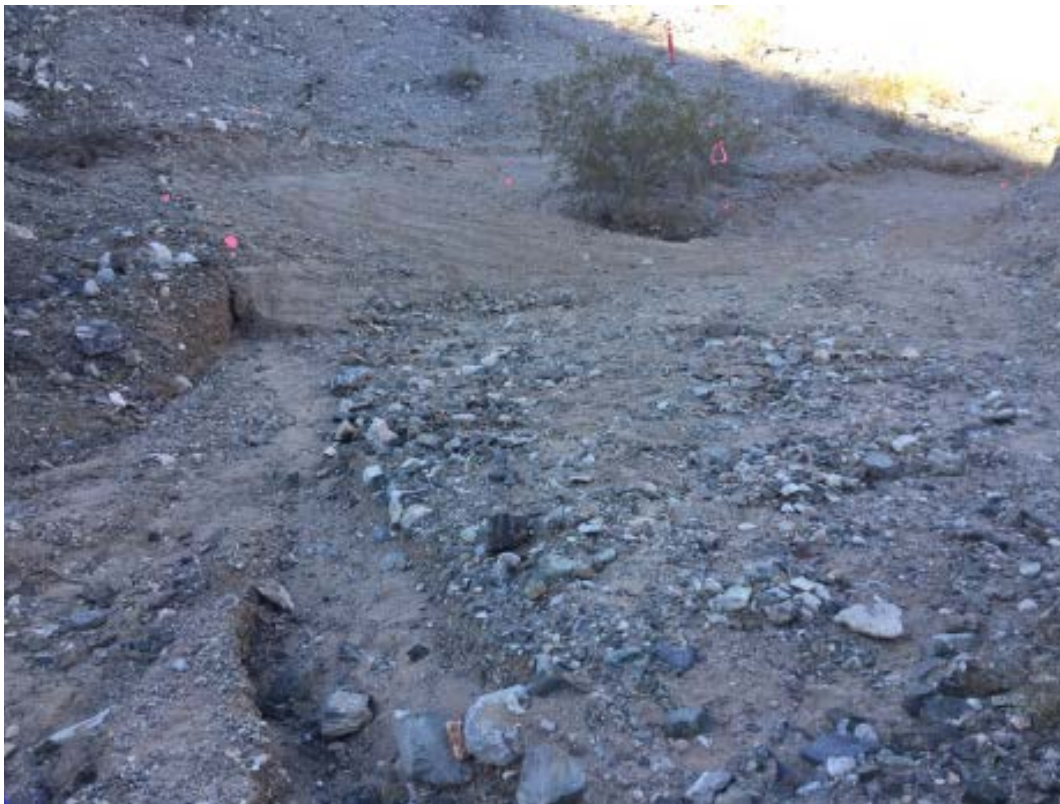
Prior to work activities, vegetation trimming was required at two of the sites. An access path to and a pad site for AOC 11e-4 (Appendix B, Photos 18 and 19) and AOC 11e-5 (Appendix B, Photos 20 and 21) was graded by backhoe resulting in permanent disturbance, in order for the drill rig to access these bore hole samples; trimming of five creosote shrubs was required along the AOC11e-4 access path. These two sites resulted in a disturbance of 0.059 acre of Upland habitat.

Photo-18: AOC 11e-4 before grading the access road and pad sites for access to the bore sample site.

Photo-19: AOC 11e-4 after grading the access road and pad sites for access to the bore sample site.

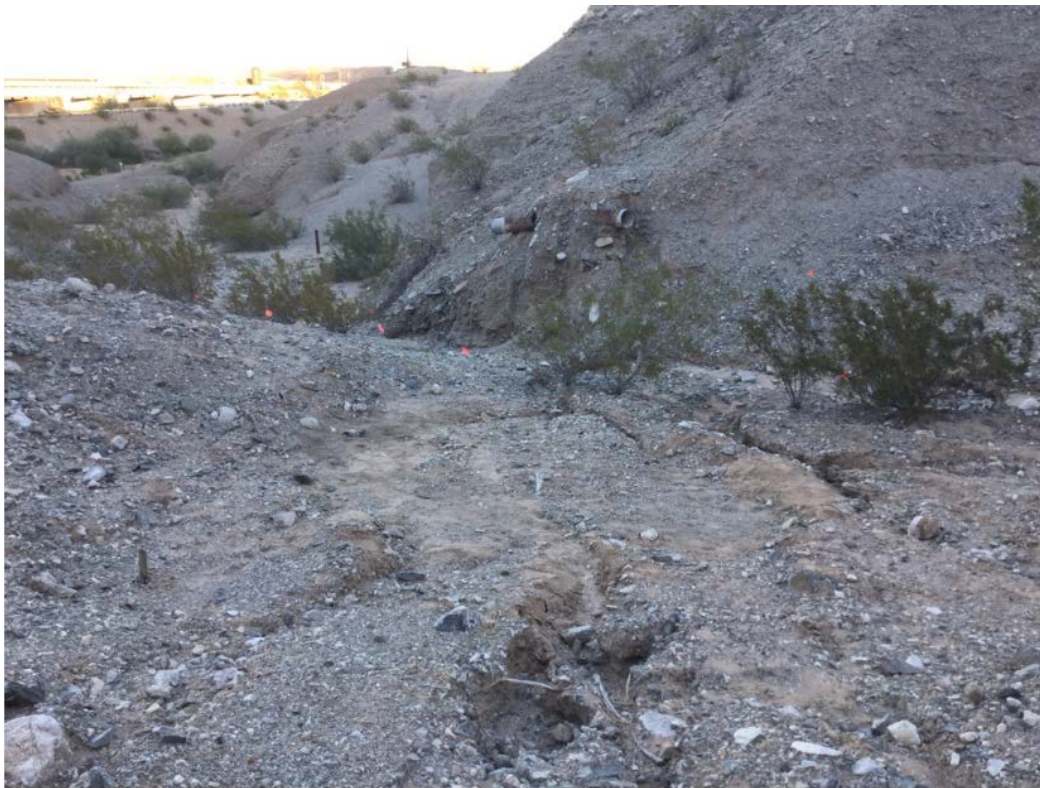
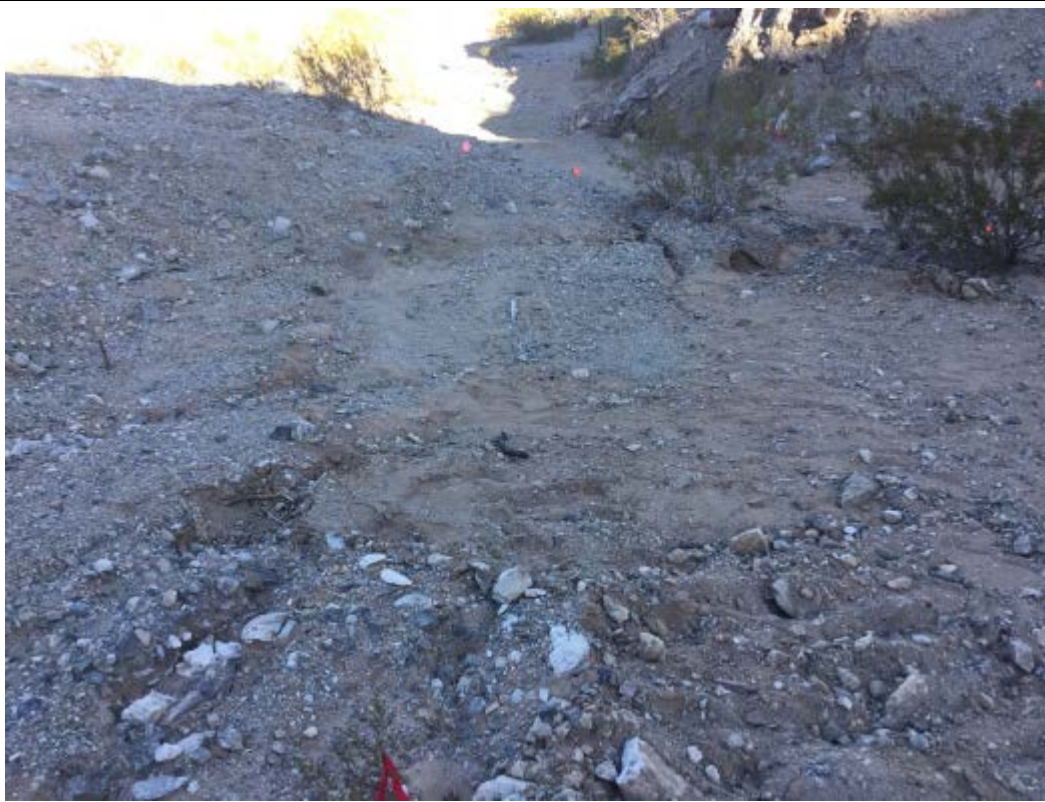
Photo-20: AOC 11e-5 before pad grading for access to bore sample site.

Photo-21: AOC 11e-5 after pad grading for access to bore sample site.

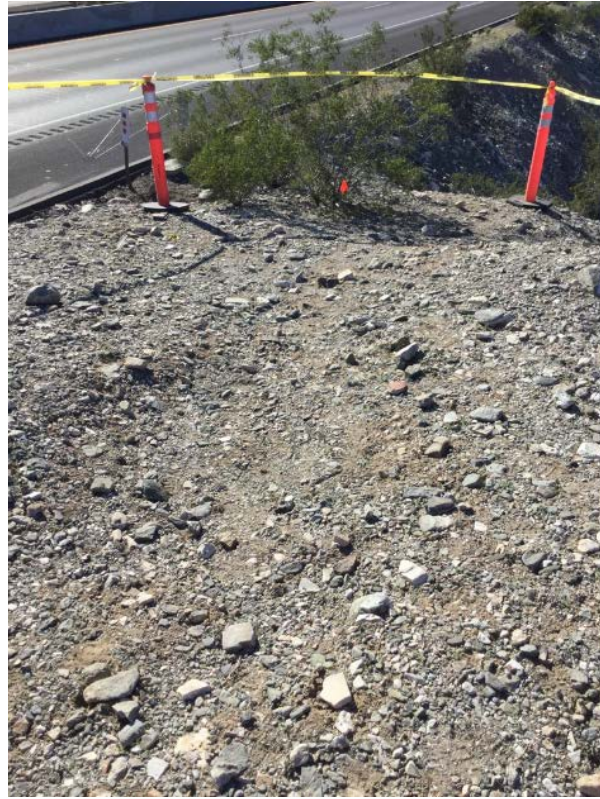
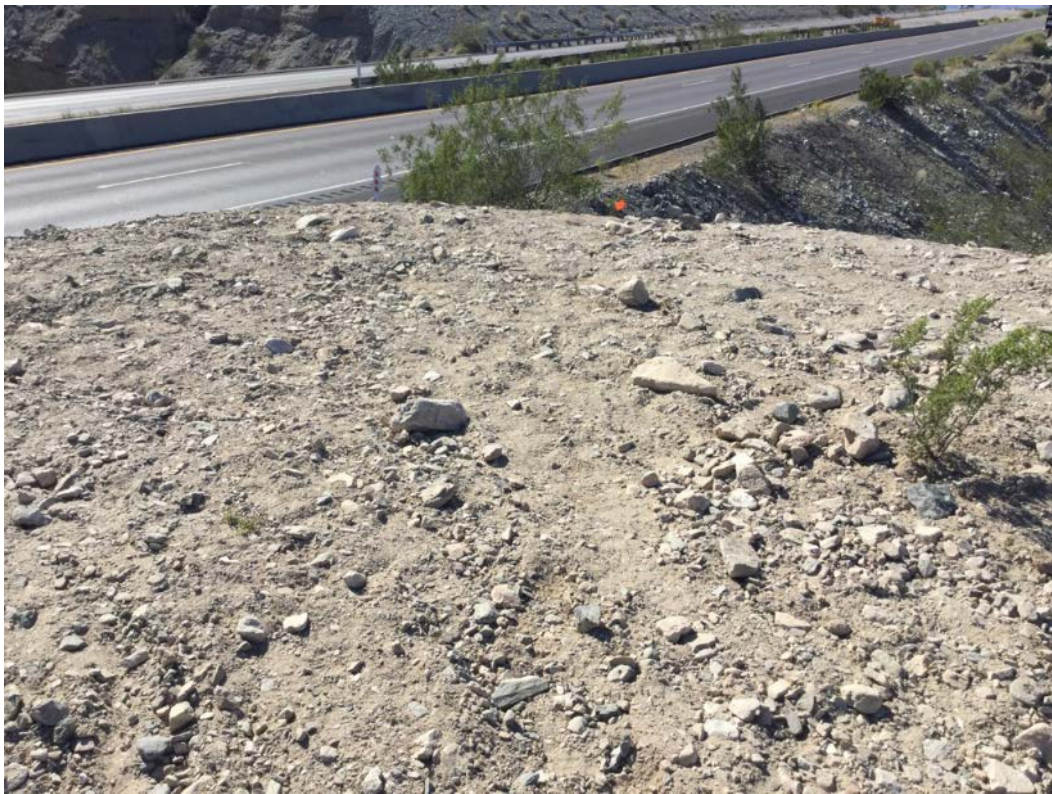
Prior to work activities, vegetation trimming was required at one site. AOC 14-14 required the trimming of two creosotes to allow the backhoe to access the site. Five sites within AOC 14, AOC 14-14 (Appendix B, Photos 22 and 23), AOC14-15 (Appendix B, Photos 24 and 25), AOC14-16 (Appendix B, Photos 26 and 27), AOC 14-17 (Appendix B, Photos 28 and 29), AOC 14-20 (Appendix B, Photos 30 and 31), and AOC 14-21 (Appendix B, Photos 32 and 33), resulted in a disturbance of 0.048 acre of Upland habitat. Ground disturbance occurred while trenching with a backhoe resulting in permanent disturbance.

Photo-22: AOC 14-14 before creosote were trimmed and trenching with a backhoe.

Photo-23: AOC 14-14 after creosote were trimmed and trench was back filled.

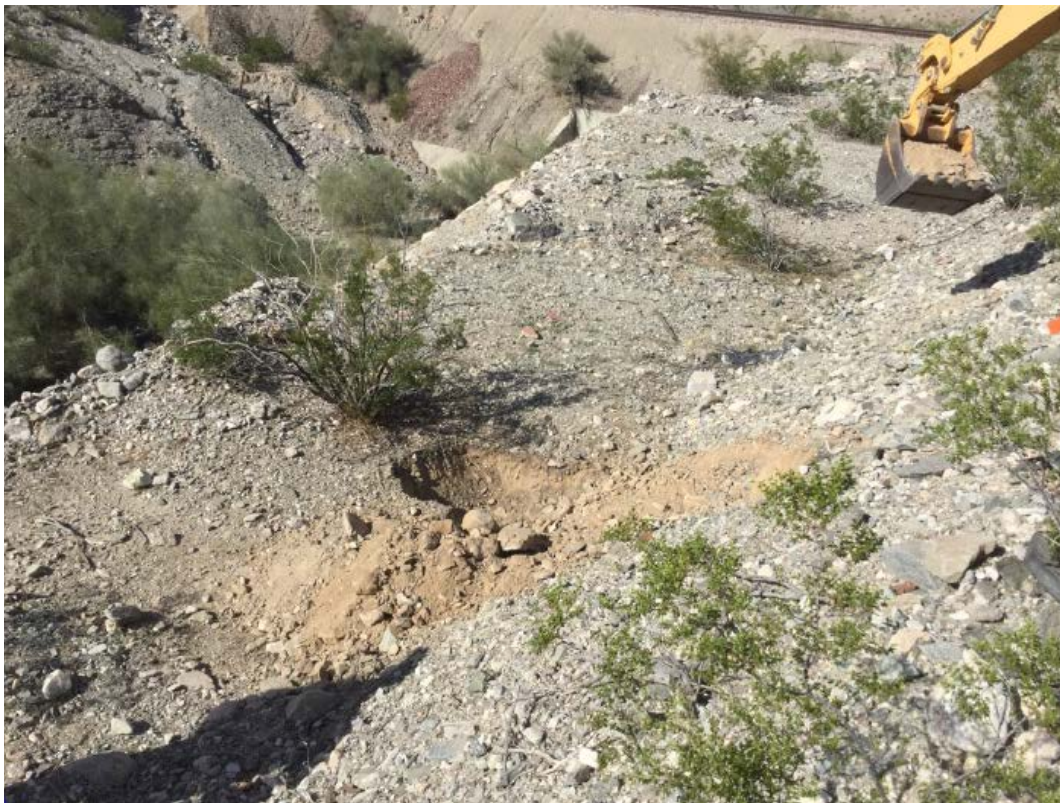
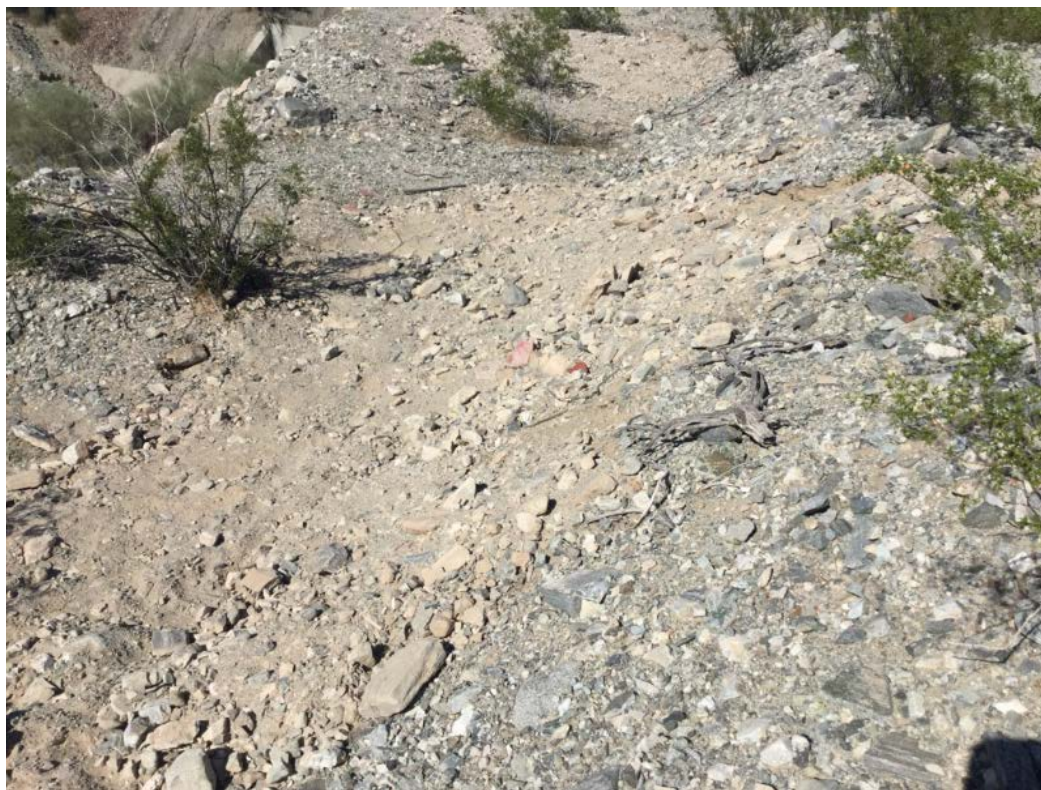
Photo-24: AOC 14-15 before trenching with a backhoe.

Photo-25: AOC 14-15 after the trench was backfilled.

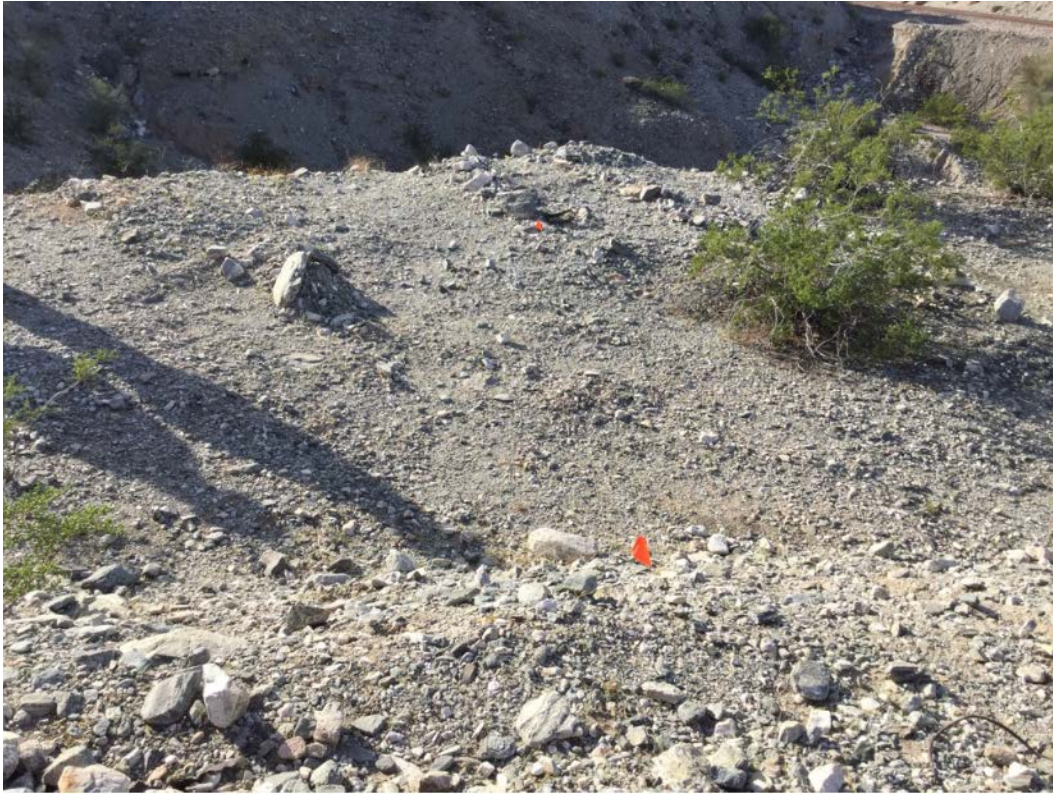
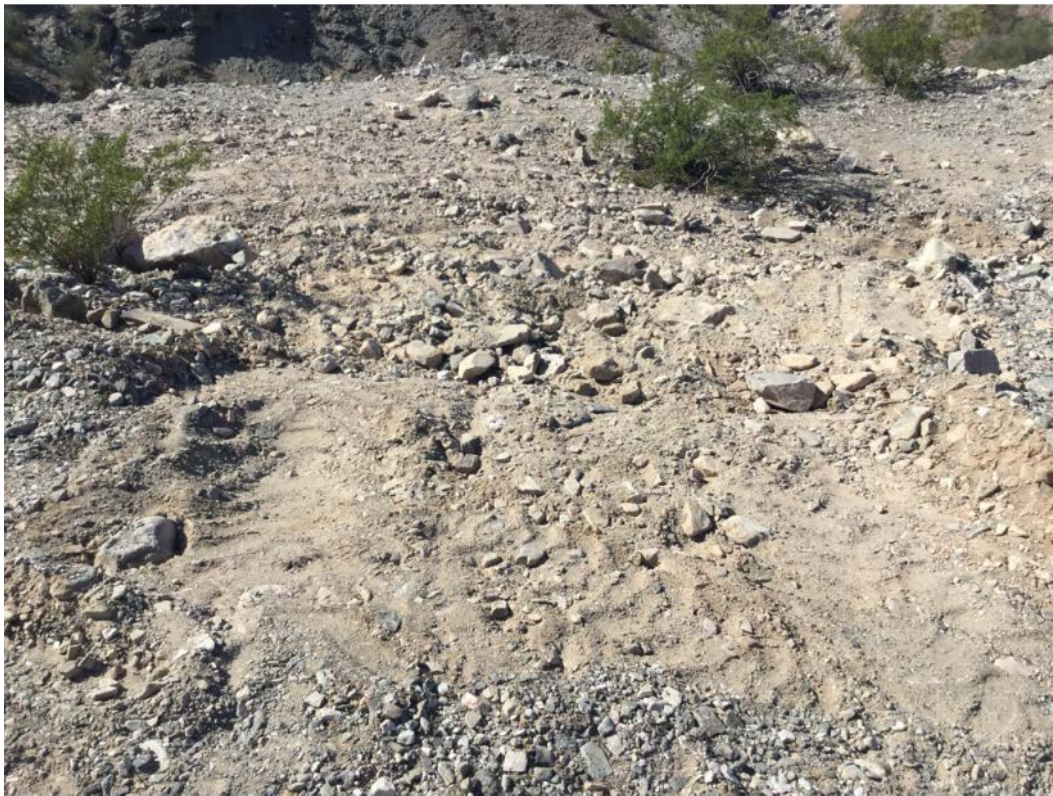
Photo-26: AOC 14-16 before trenching with a backhoe.

Photo-27: AOC 14-16 after the trench was backfilled.

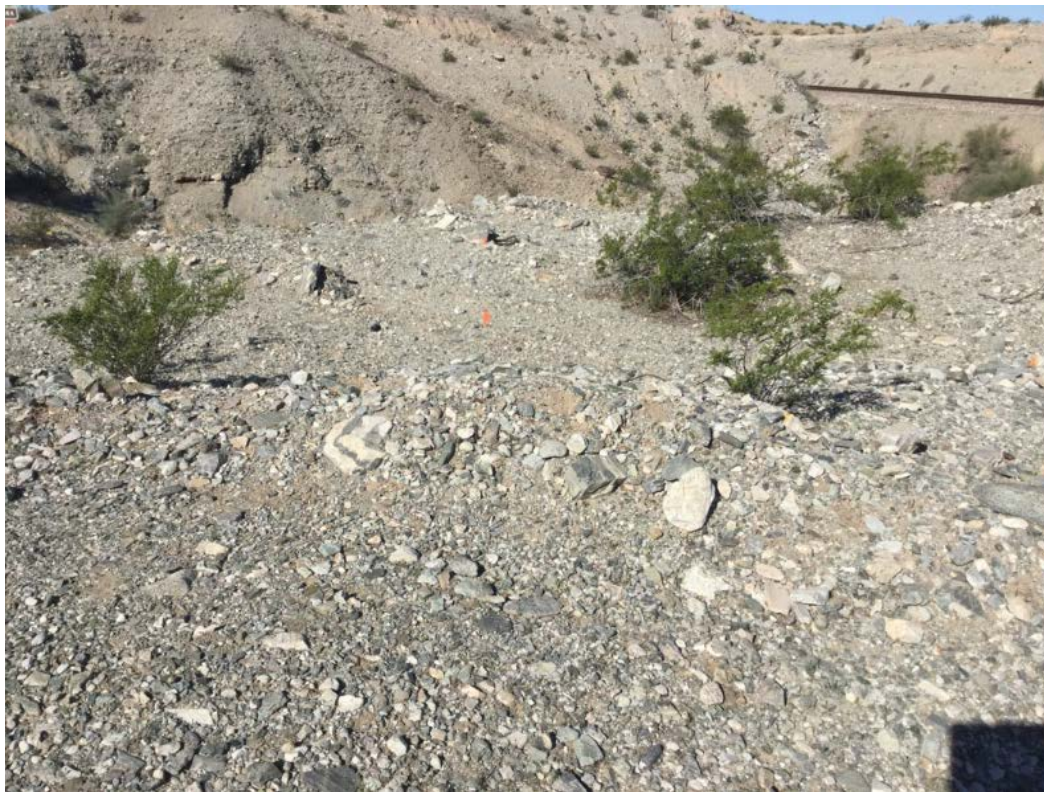
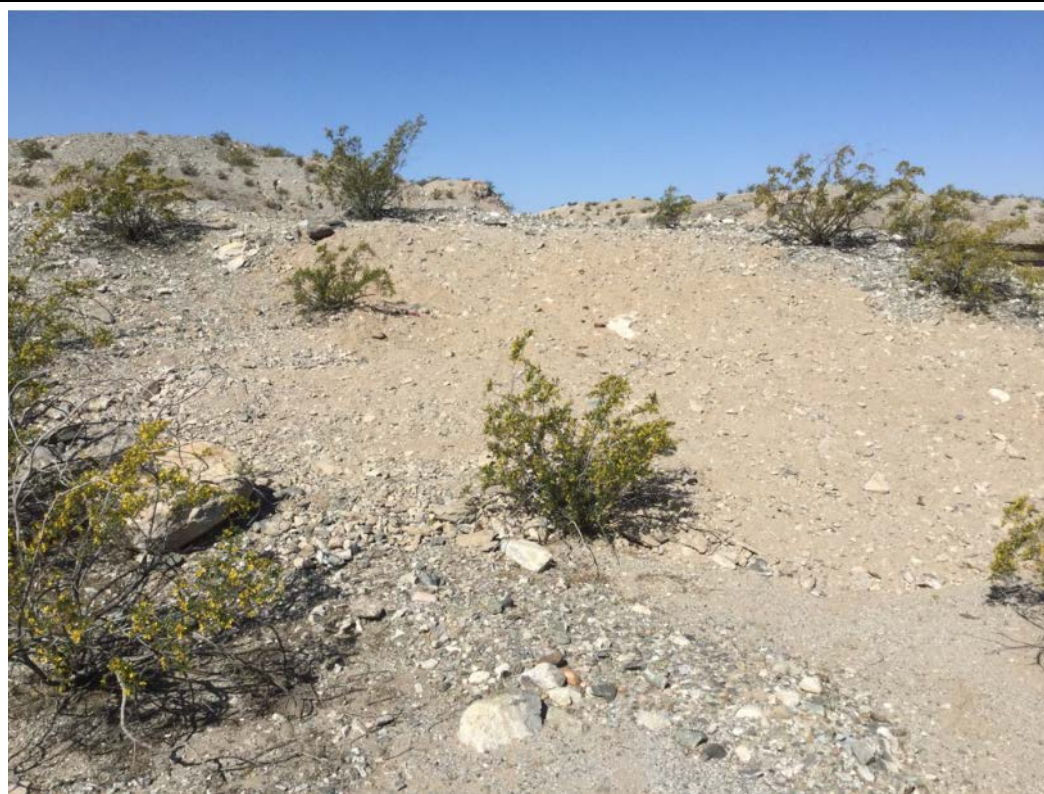
Photo-28: AOC 14-17 before trenching with a backhoe.

Photo-29: AOC 14-17 after the trench was backfilled.
