**BIOLOGICAL RESOURCES COMPLETION REPORT FOR THE TOPOCK REMEDIATION
PROJECT: SOIL INVESTIGATIONS BETWEEN 2015 AND 2017**

Blue Rock Services, Inc.
1745 South Alma School Road, Suite 220
Mesa, Arizona 85210

June 2017

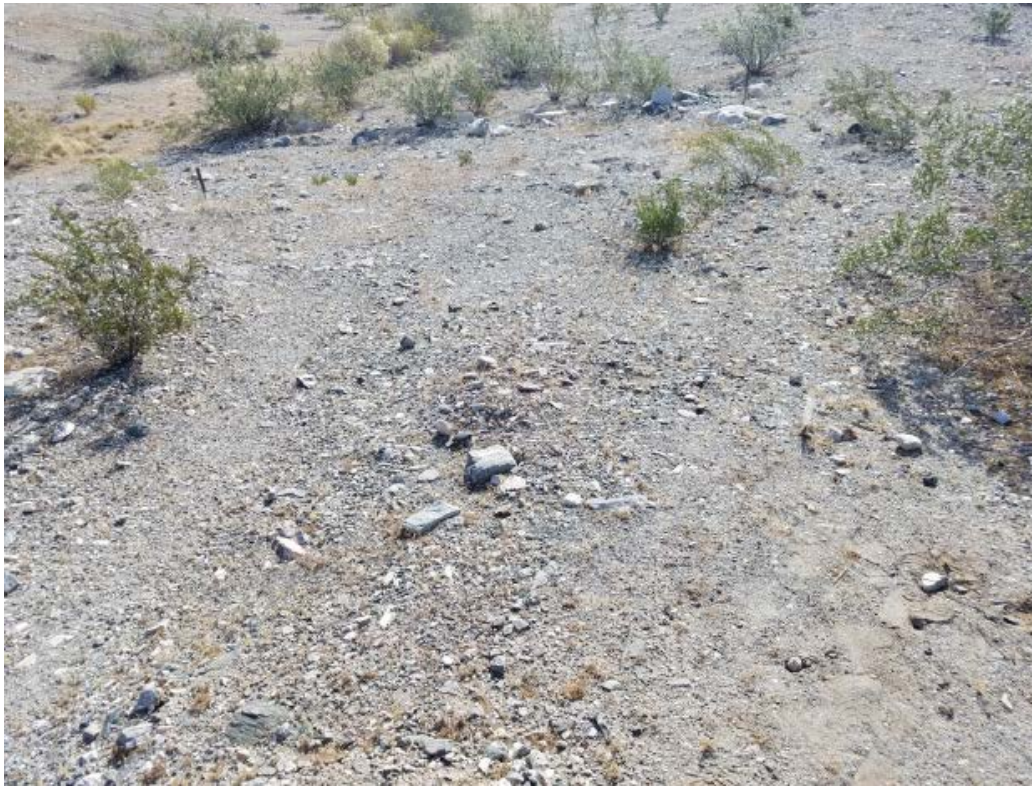
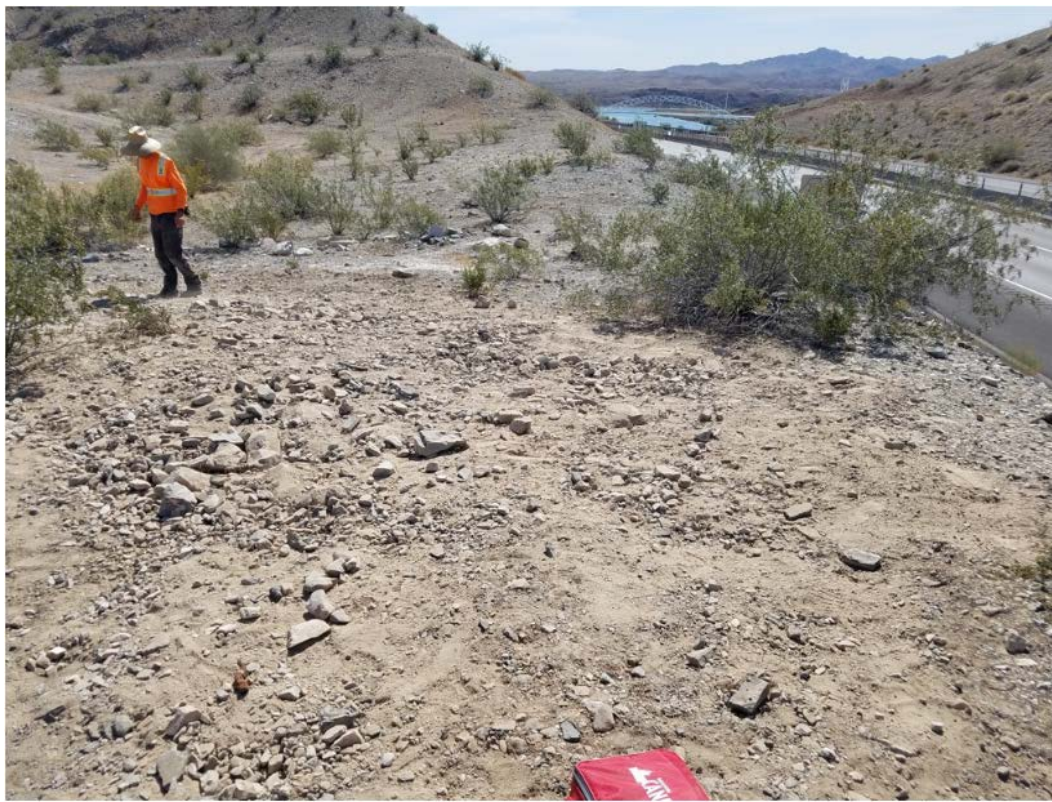
Photo-30: AOC 14-20 before trenching with a backhoe.

Photo-31: AOC 14-20 after the trench was backfilled.

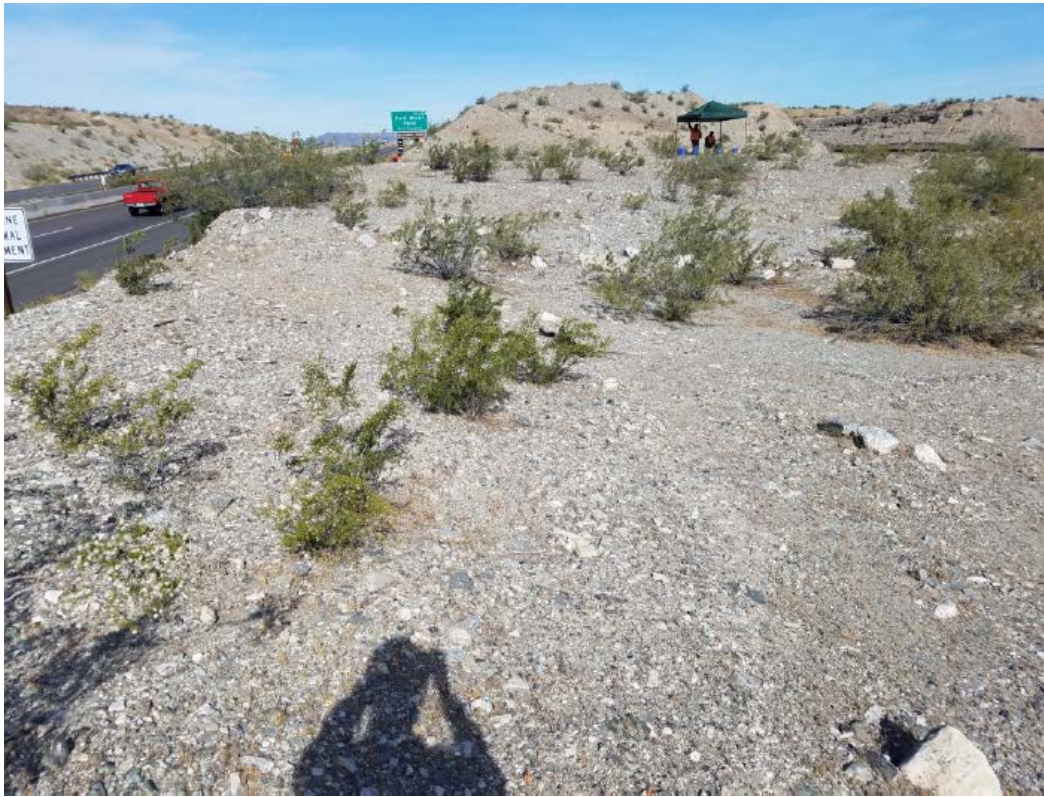
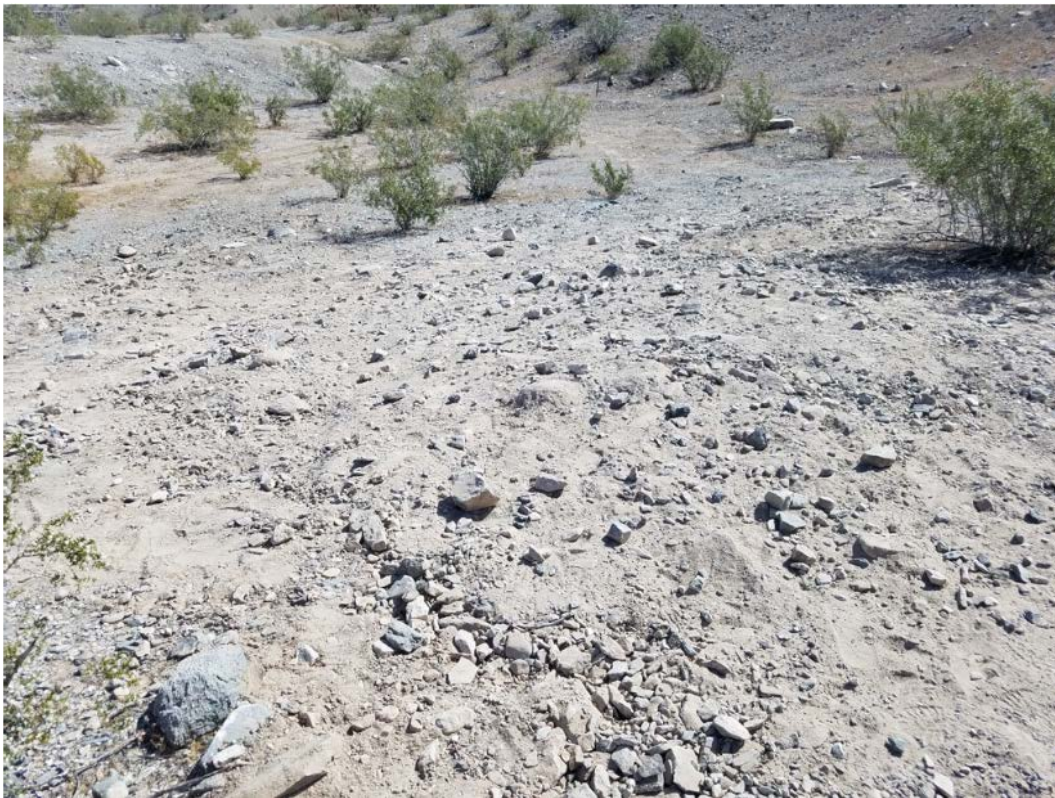
Photo-32: AOC 14-21 before trenching with a backhoe.

Photo-33: AOC 14-21 after the trench was backfilled.

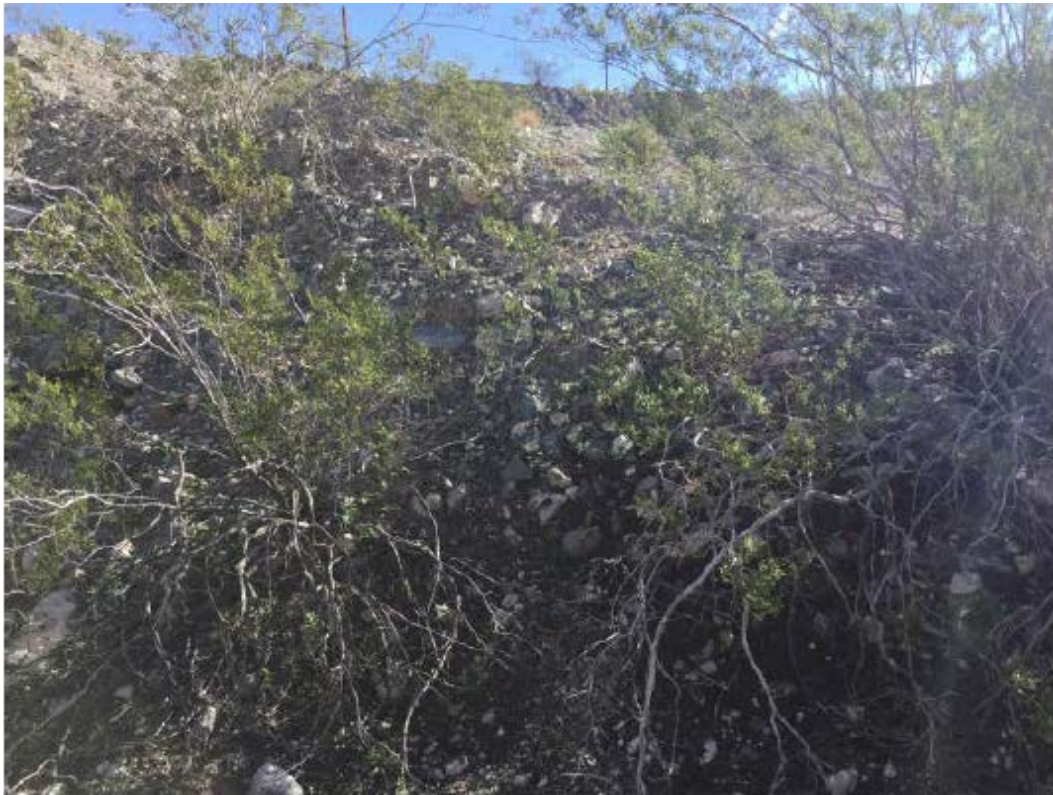
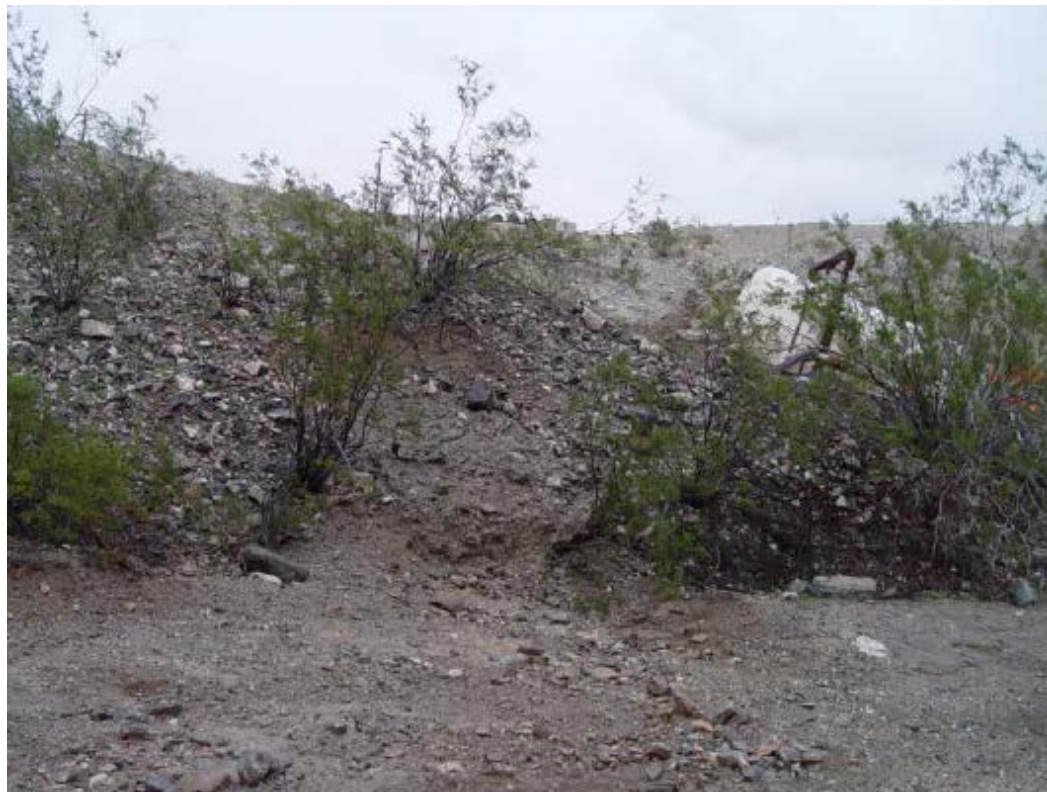
Photo-34: Example of AOC 27-51 before trenching.

Photo-35: Example of AOC 27-51 after trenching.
