**Riparian Vegetation and California
Department of Fish and Wildlife
Jurisdiction for the Topock
Compressor Station Groundwater
Remediation Project
San Bernardino County, California**

Prepared for
Pacific Gas and Electric Company

May 2014

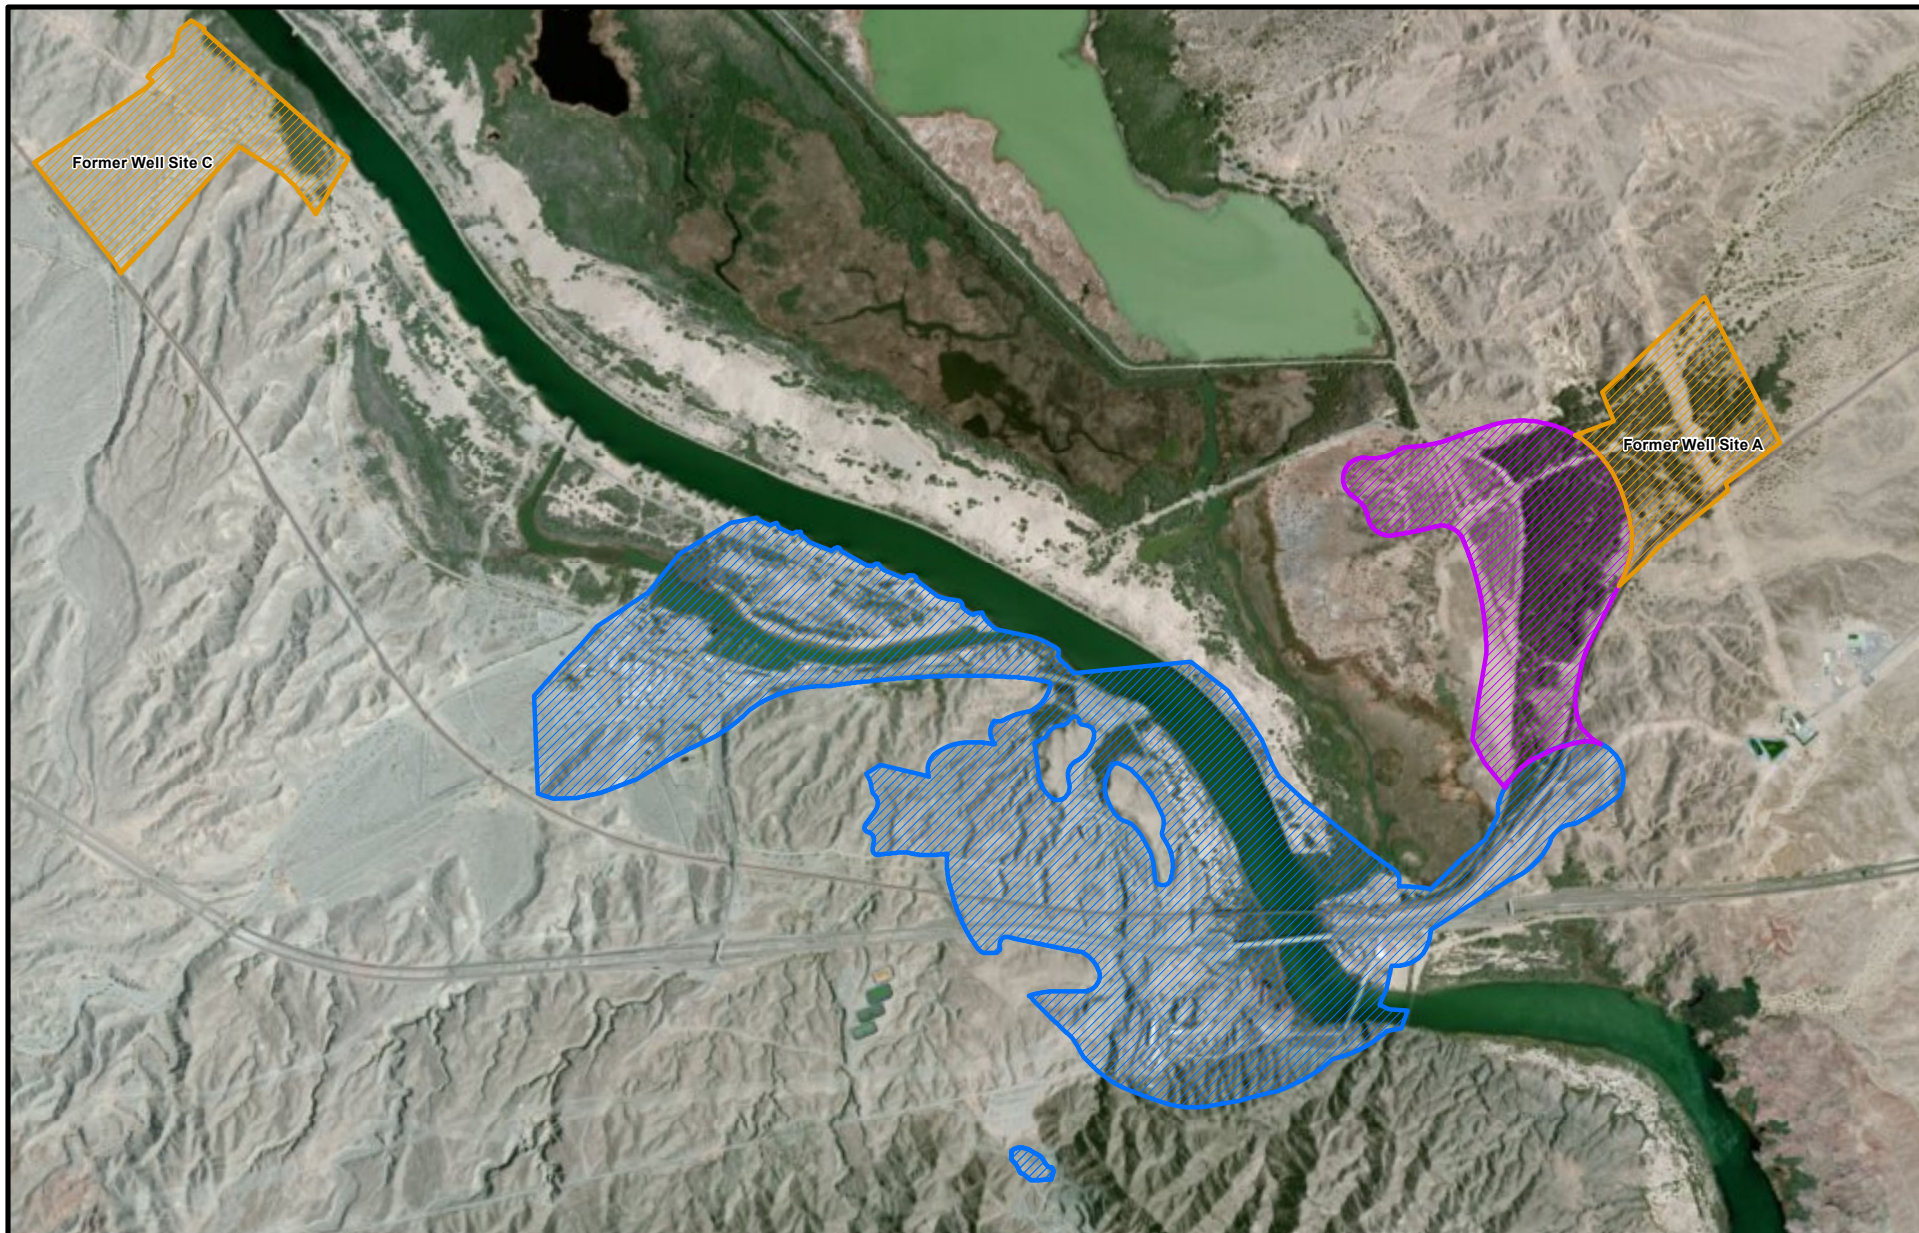
FIGURE 1-1
STUDY AREA
 PG&E Topock Compressor Station
 Needles, California

The 1,169-acre study area (Figure 1-1) includes the following sites:

- The 780-acre project area covered in the FEIR
- 182.7-acre area along Highway 95 in Arizona associated with an existing Havasu National Wildlife Refuge (HNWR) well site and potential new freshwater well site B
- 93.5 acres associated with former potential new freshwater well site A
- 112.8 acres associated with former potential new freshwater well site C

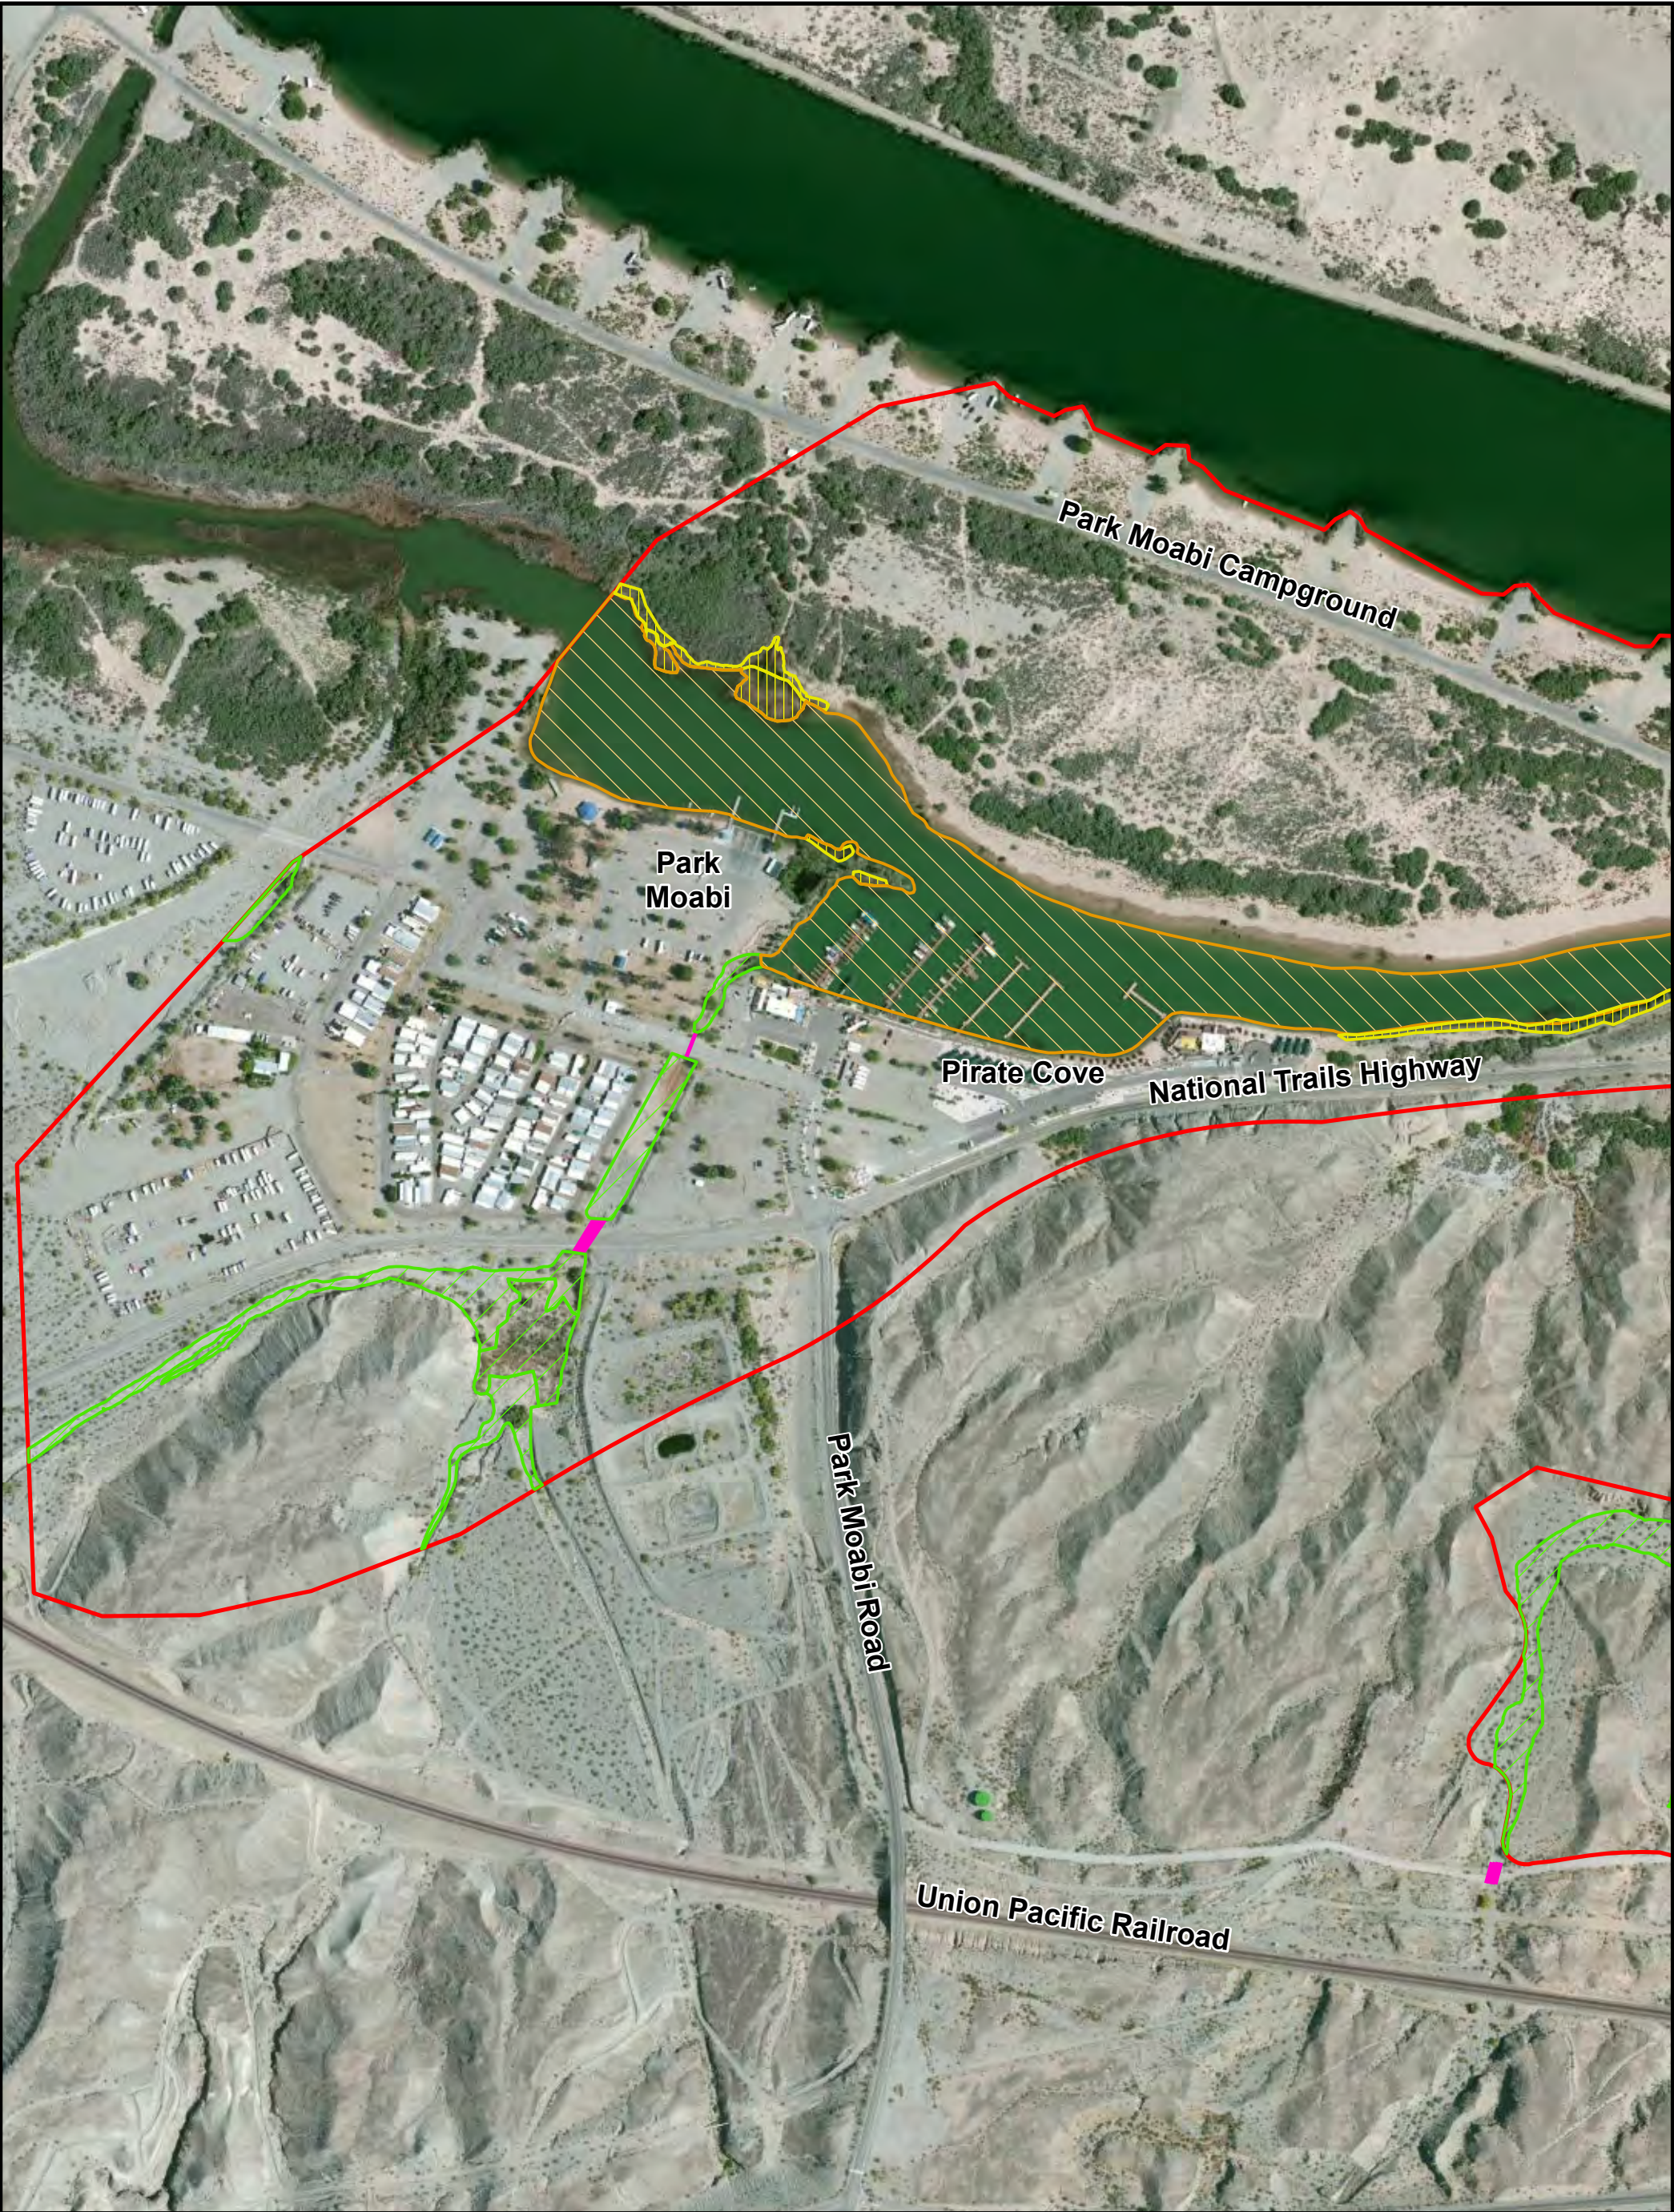
FIGURE 4-1
Rivers, Streams and Riparian Areas
Map 1 of 6
PG&E Topock Compressor Station
Needles, California

The following sections provide a description of rivers and streams as well as associated riparian habitat that are considered to be subject to regulation by CDFW. The distribution of these features is shown in Figure 4-1 and representative photographs are provided in Appendix B.

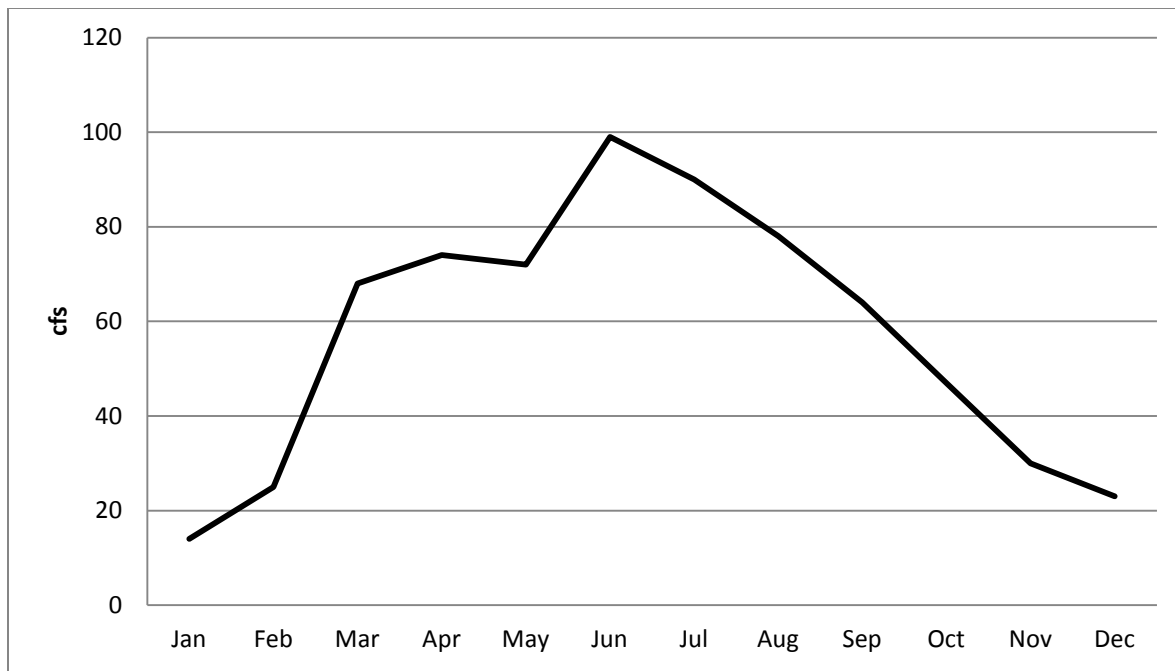
FIGURE 4-2

Overall monthly average flow rate (cfs) for the Colorado River as measured at the USGS River Gauge (09423550) at the Topock Marsh Inlet near Needles, California between January 1967 and September 2012.

The flows in this section of the Colorado River are dynamic, fluctuating seasonally and daily as a result of upstream flow regulation from the Davis Dam, located approximately 41 river miles upstream of the project area. Data from the U.S. Geological Survey (USGS) river gauge at the Topock Marsh inlet shows that average flow rate ranges from a low of 14 cubic feet per second (cfs) in January to a high of 99 cfs in June (Figure 4-2). Daily surface water elevation data for the Colorado River has been measured near the Interstate 40 Bridge since the middle of June 2003 as part of the ongoing monitoring program at the compressor station. The average water level elevation recorded for this period was 454.9 feet above mean sea level (amsl), with a minimum of 450.6 feet amsl and a maximum of 458.7 feet amsl. Average monthly flow rates measured at the Topock Marsh inlet between January 1967 and September 2012 show a fluctuating, but controlled, rate of discharge that did not exceed a mean of 193 cfs (Figure 4-3).

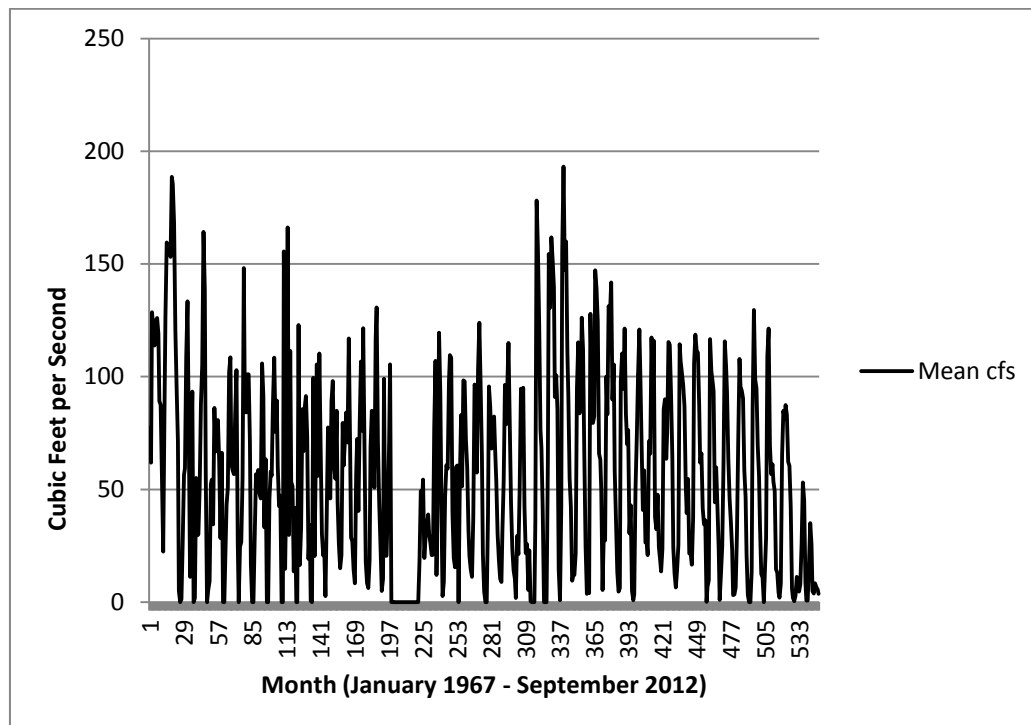
FIGURE 4-3

Monthly Average flow rate (cfs) for the Colorado River as measured at the USGS River Gauge (09423550) at the Topock Marsh Inlet near Needles, California between January 1967 and September 2012. The data gap circa 1983-4 (or circa month 200) corresponds to the Colorado River flood after which the Topock gauge was replaced.

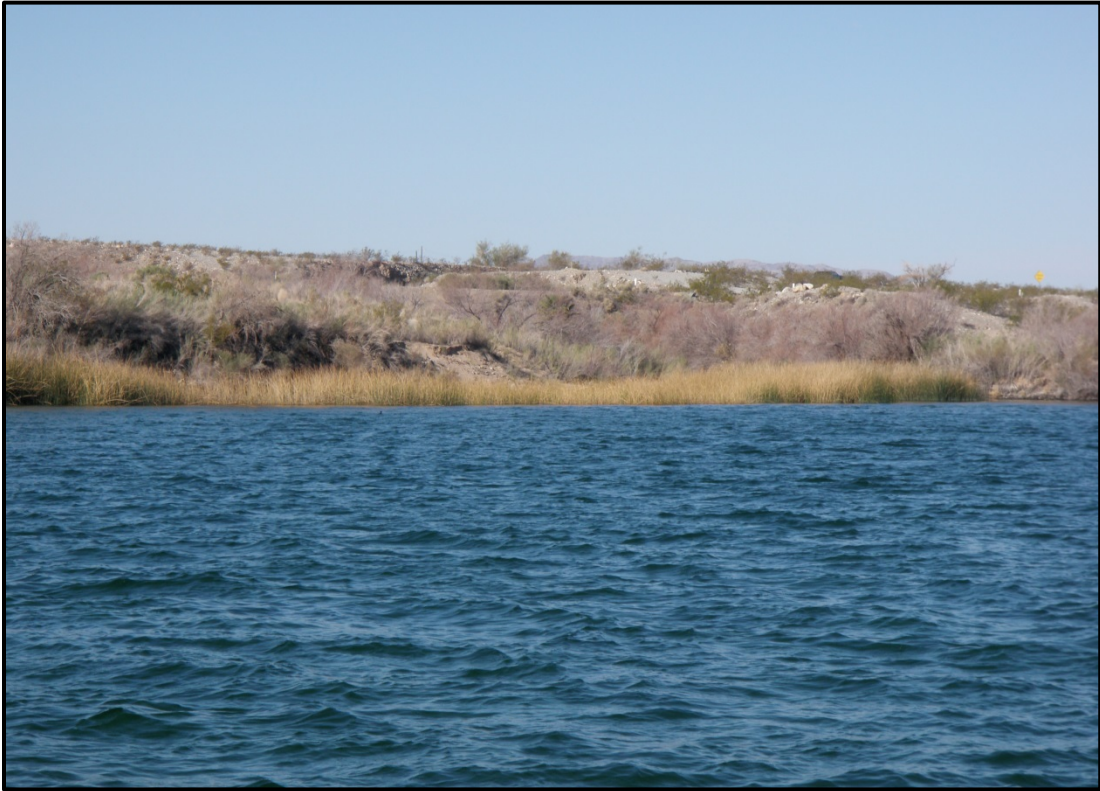
Emergent vegetation and narrow band of riparian trees and shrubs along the shore of the Colorado River

Due to controlled discharges regulated by upstream dams as well as past dredging and channelization along this reach of the Colorado River there is no longer an active floodplain in the study area and, as described below, the riparian habitat is limited to a narrow band immediately along the channel banks of the river.

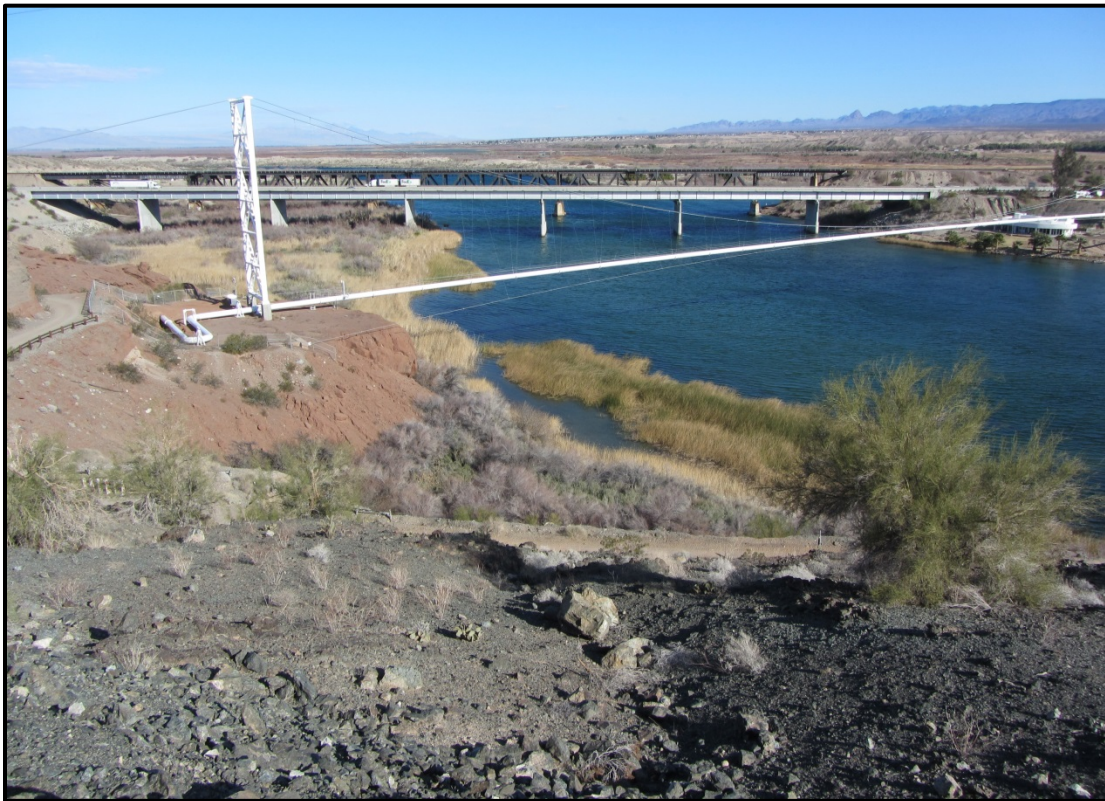
Wetlands Adjacent to the Colorado River, south of the Interstate 40 Bridge

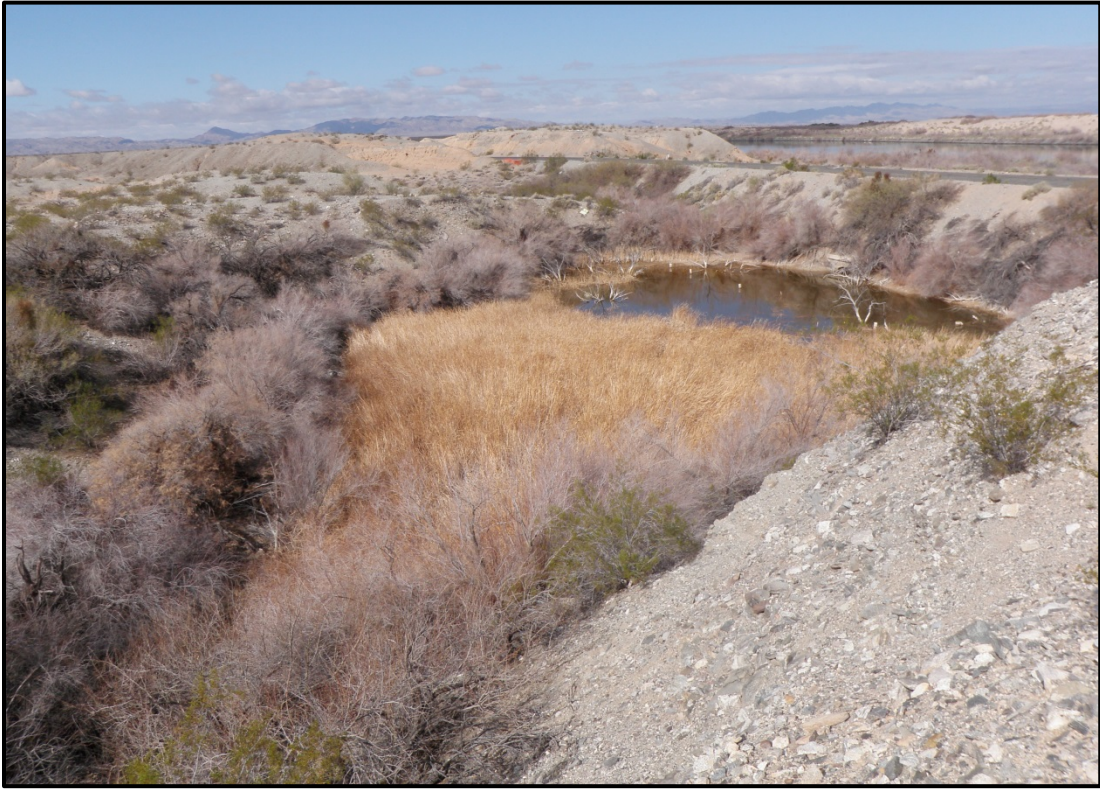
Backwater pond – connected to the Colorado River via culverts under the National Trails Highway

There is a pond on the south side of the National Trails Highway approximately 800 feet southeast of the confluence of Park Moabi Slough and the Colorado River. An earthen dam separates the pond from the ephemeral wash system that extends to the south. The pond is connected to the adjacent emergent wetland described above via a large culvert. The southern half of the pond is characterized by dense growth of southern cattail, while the northern part is open water. Several feet of water was observed in the pond during both the February and July 2012 surveys. A beaver lodge is present near the center of the pond at the edge of the cattails. It appears that this was at one time part of the larger wash system that has been cut off by the earthen dam. This area was considered to be riparian habitat as it is now functionally a small backwater area of the Colorado River (via culvert connections). The history of the dam is not well known, but it was likely built to protect the then-existing railroad bed from flood damage. It is also possible that it is associated with development of a "roadhouse" with buildings and campground that operated west of this feature when Historic Route 66 and the later National Trails Highway were in use as primary travel routes, before Interstate 40 construction.
