Soil Non-Time-Critical Removal Action Completion Report

Topock Compressor Station, Needles, California

Final

Pacific Gas and Electric Company

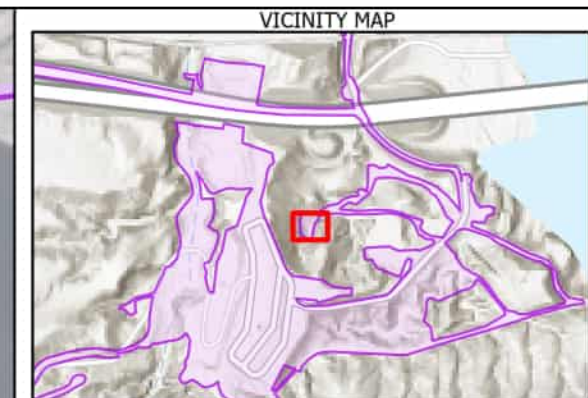
FIGURE 3-11
AOC10 TAA4 Site Map
 Soil NTCRA Completion Report
 PG&E Topock Compressor Station,
 Needles, California

Soil NTCRA removal activities were completed in June 2023 and included the removal of approximately 910 yd³ of contaminated soil. Figure 3-11 shows the full extent of the AOC10 TAA4 excavation.

Chromium- and D/F-impacted soil exceeding the numerical RAGs remains beneath the mesquite tree cluster to the west of the original TAA boundary. The remaining contamination is represented by confirmation soil samples AOC10TAA4-CW6-3 and AOC10TAA4-CW13-2 (Figure 3-11). Chromium was detected in AOC10TAA4-CW6-3 at 400 mg/kg, exceeding the RAG of 145 mg/kg. D/F TEQ concentrations were 880 and 210 ng/kg, respectively, exceeding the RAG of 190 ng/kg (Table 3-16).

Confirmation sidewall and floor soil samples were collected in accordance with the Soil NTCRA Work Plan. At AOC10 TAA4, confirmation floor samples were collected at depths of approximately 5 feet bgs on the eastern side, near the original TAA, and approximately 2 to 3 feet farther upstream of East Ravine. Sidewall confirmation soil samples in the original TAA were collected from 3 feet bgs, approximately 6 inches below the white powder lens. An additional sample of the white powder was also collected, AOC10TAA4-CW5-3. Confirmation sidewall soil samples in step-out excavations were collected from approximately 1 to 2 feet deep, the approximate midpoint of the excavation sidewall. Figure 3-11 shows the confirmation soil sample locations. Table 3-11 summarizes confirmation soil sample results.

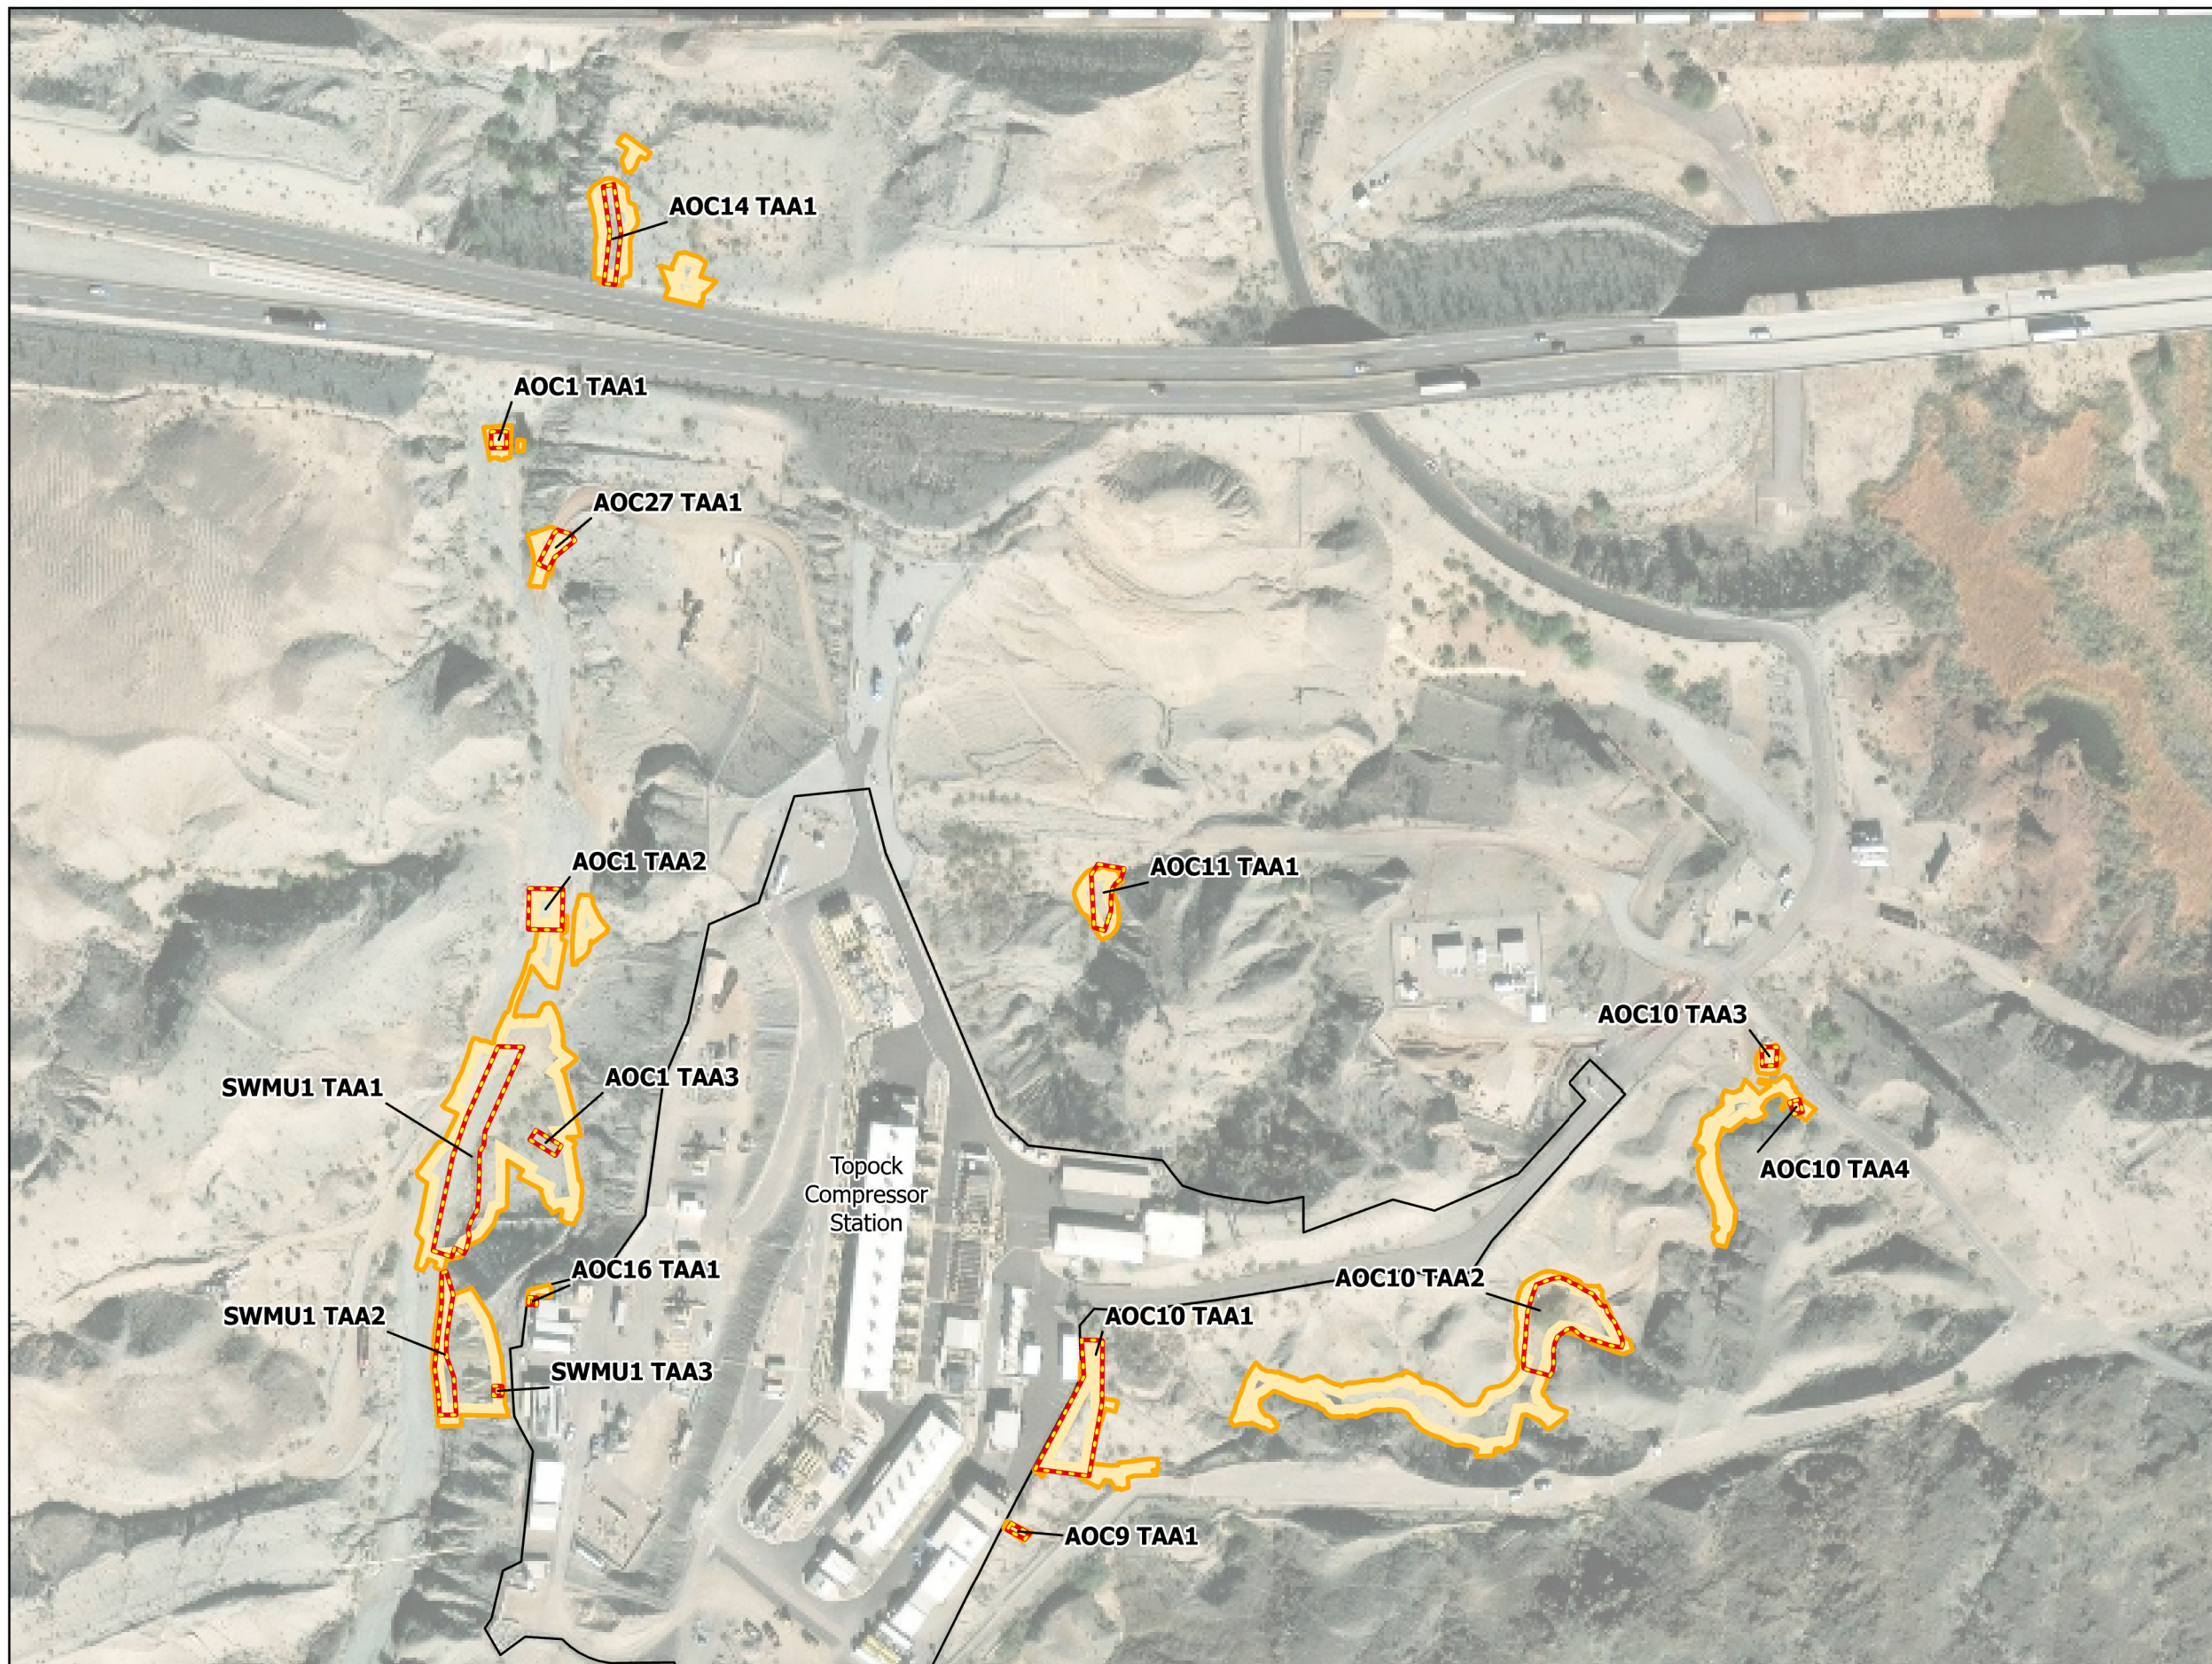
FIGURE 4-1
Post-Stockpile Confirmation
Soil Sample Locations
 Soil NTCRA Completion Report
 PG&E Topock Compressor Station,
 Needles, California

The Upper SPY confirmation sampling approach was unchanged, and the area was evenly divided into 7 approximately 10,000 ft² sampling units. Figure 4-1 presents the SPY post-stockpile confirmation soil sampling units.

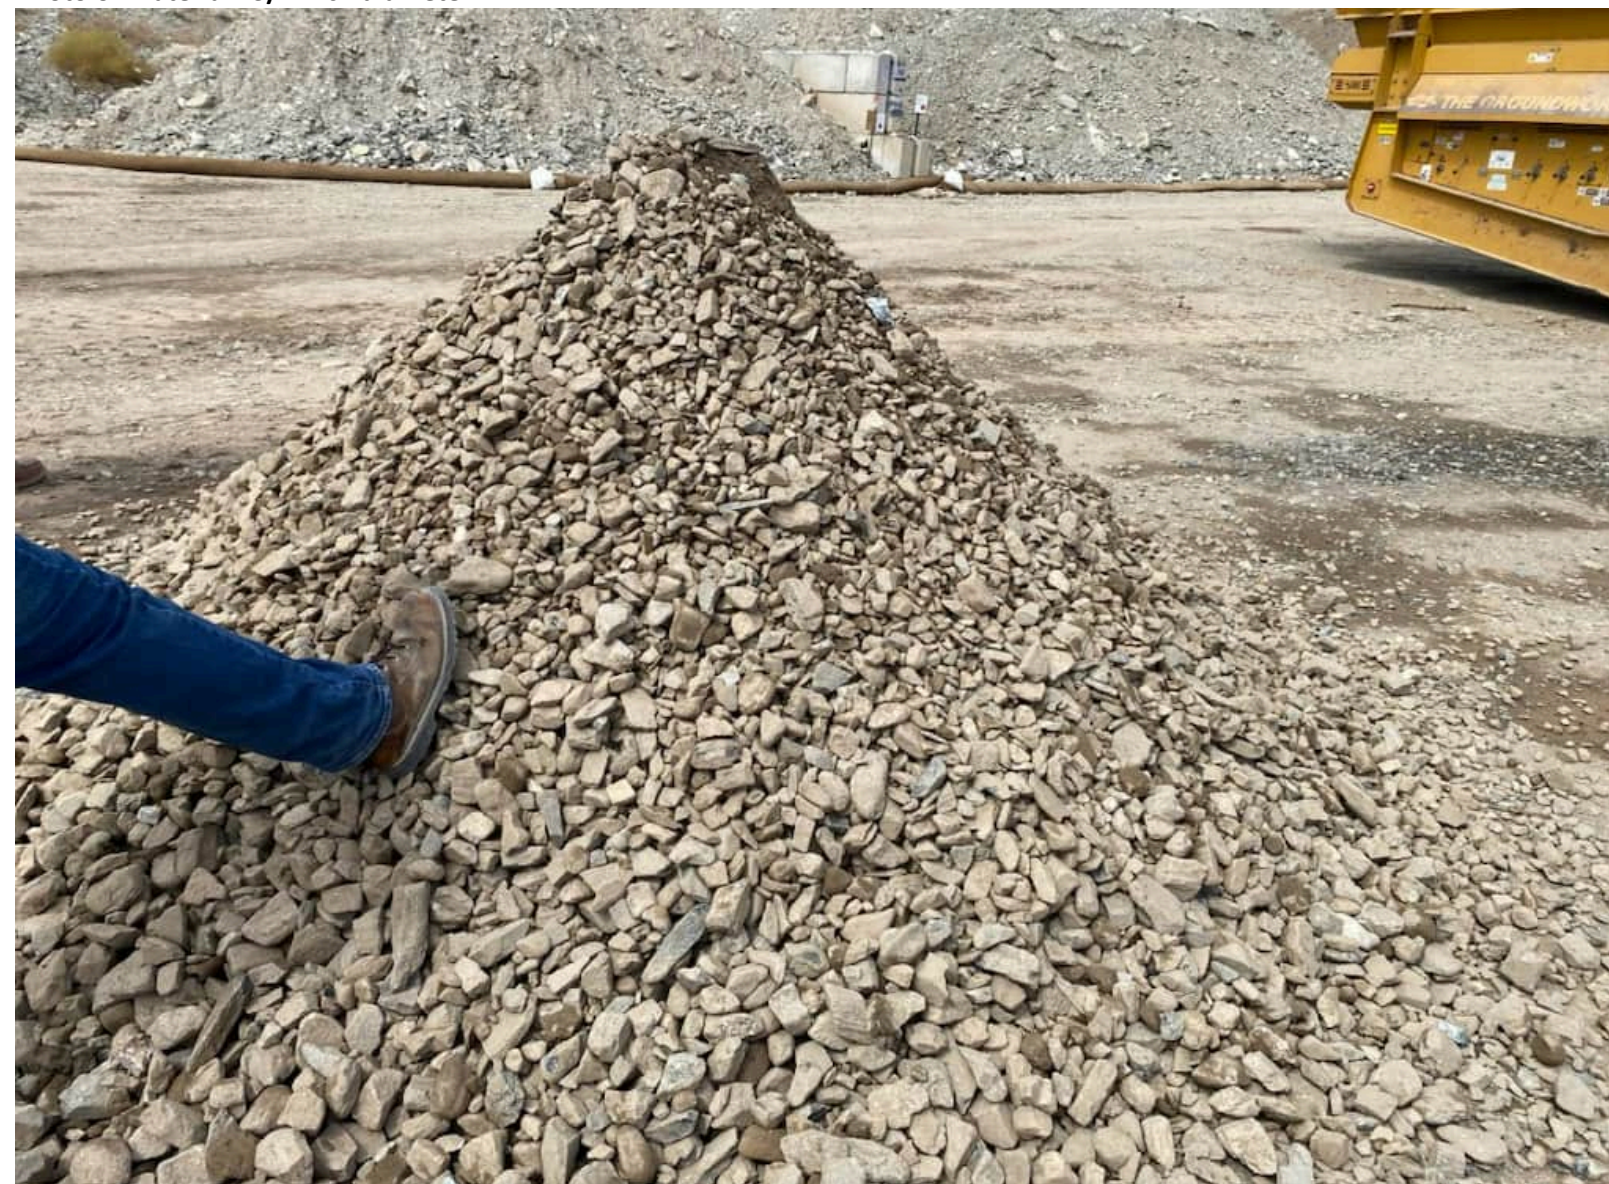
Photo of Material >3/4-inch diameter

The attached submittal notifies you of a minor revision to the Final Soil Non-Time Critical Removal Action Work Plan (NTCRA Work Plan) dated June 2022. PG&E requests a field change separating coarse from fine materials based on a particle size of 3/4-inch diameter instead of 3/8-inch in diameter. Other aspects of the mechanical separation operations will remain the same. Coarse material reuse, which is described in NTCRA Work Plan Section 2.3.5, will also change from reuse of material greater than 3/8-inch diameter to reuse of material greater than 3/4-inch diameter. Justification for the change is provided in the attached. Below are photos that illustrate the difference and the basis for the field change request.

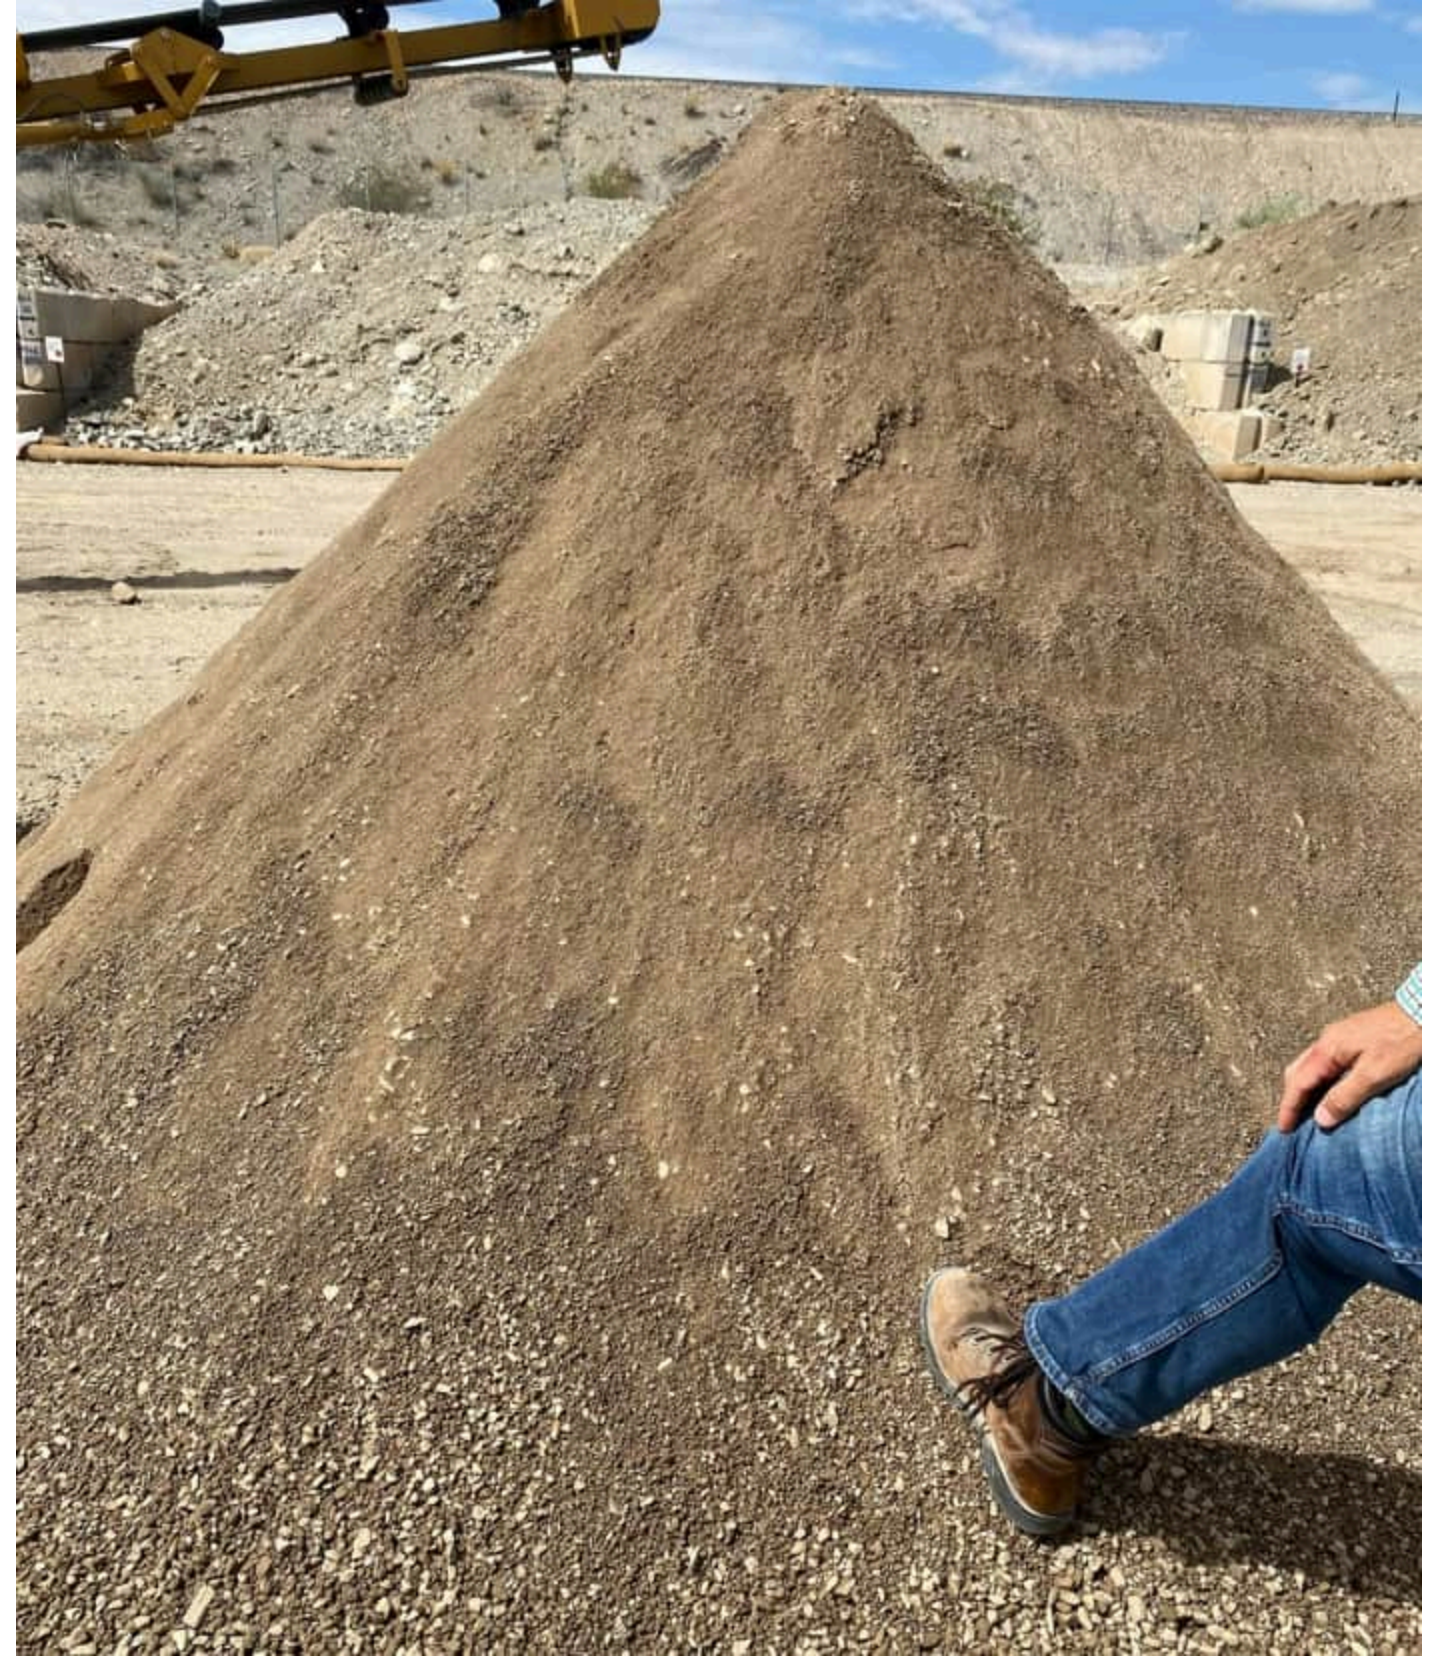
Photo of Material >3/8-inch diameter

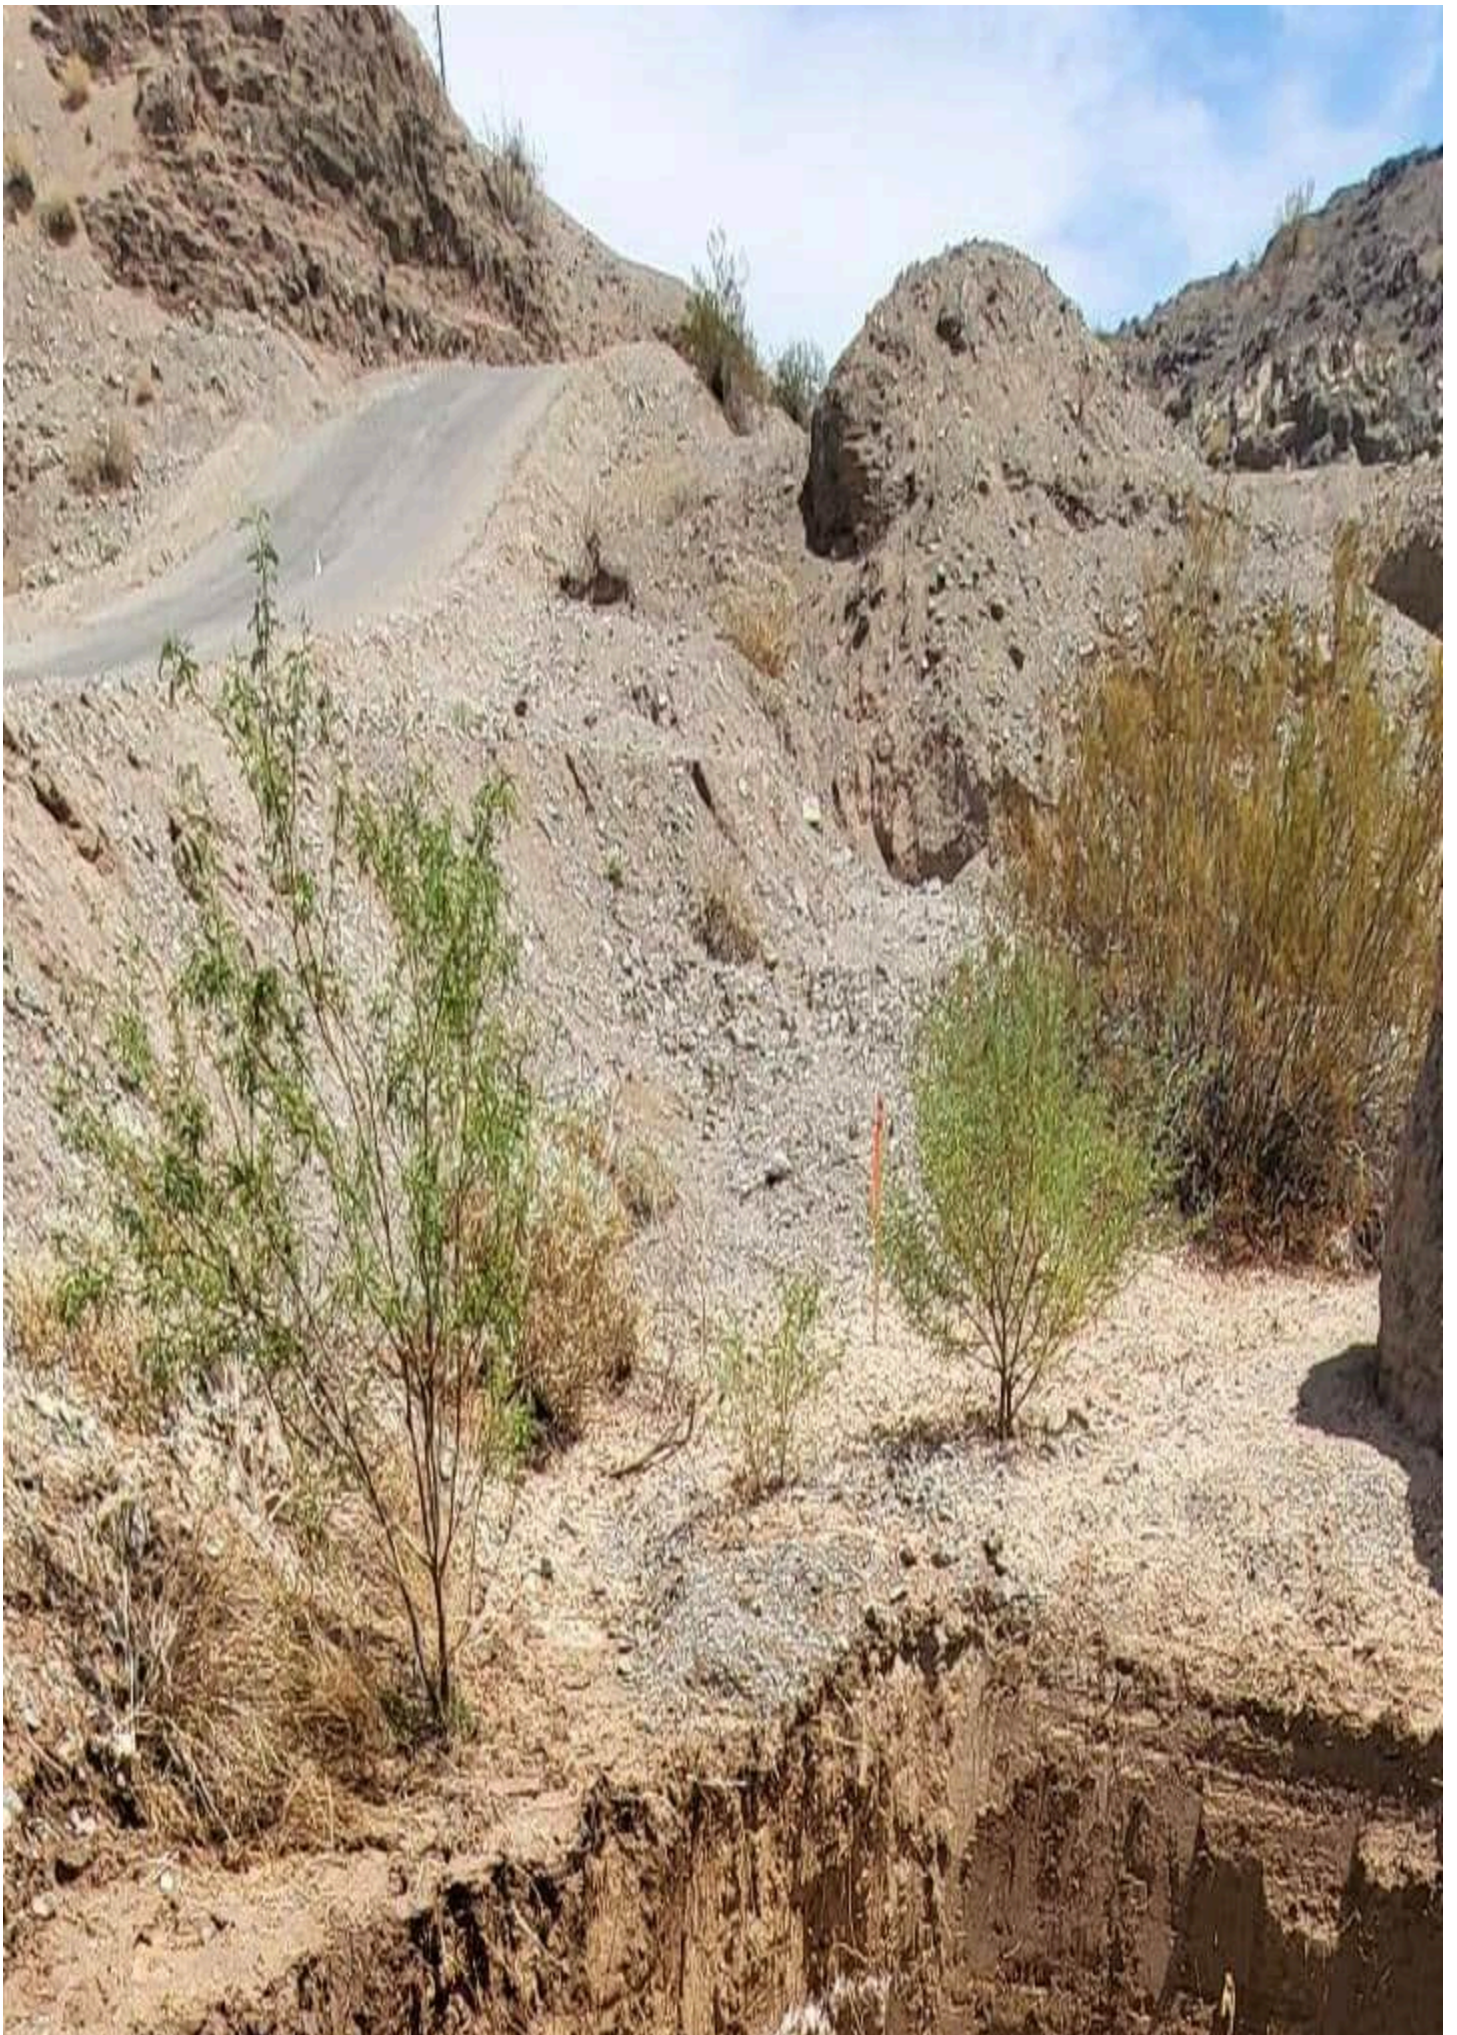
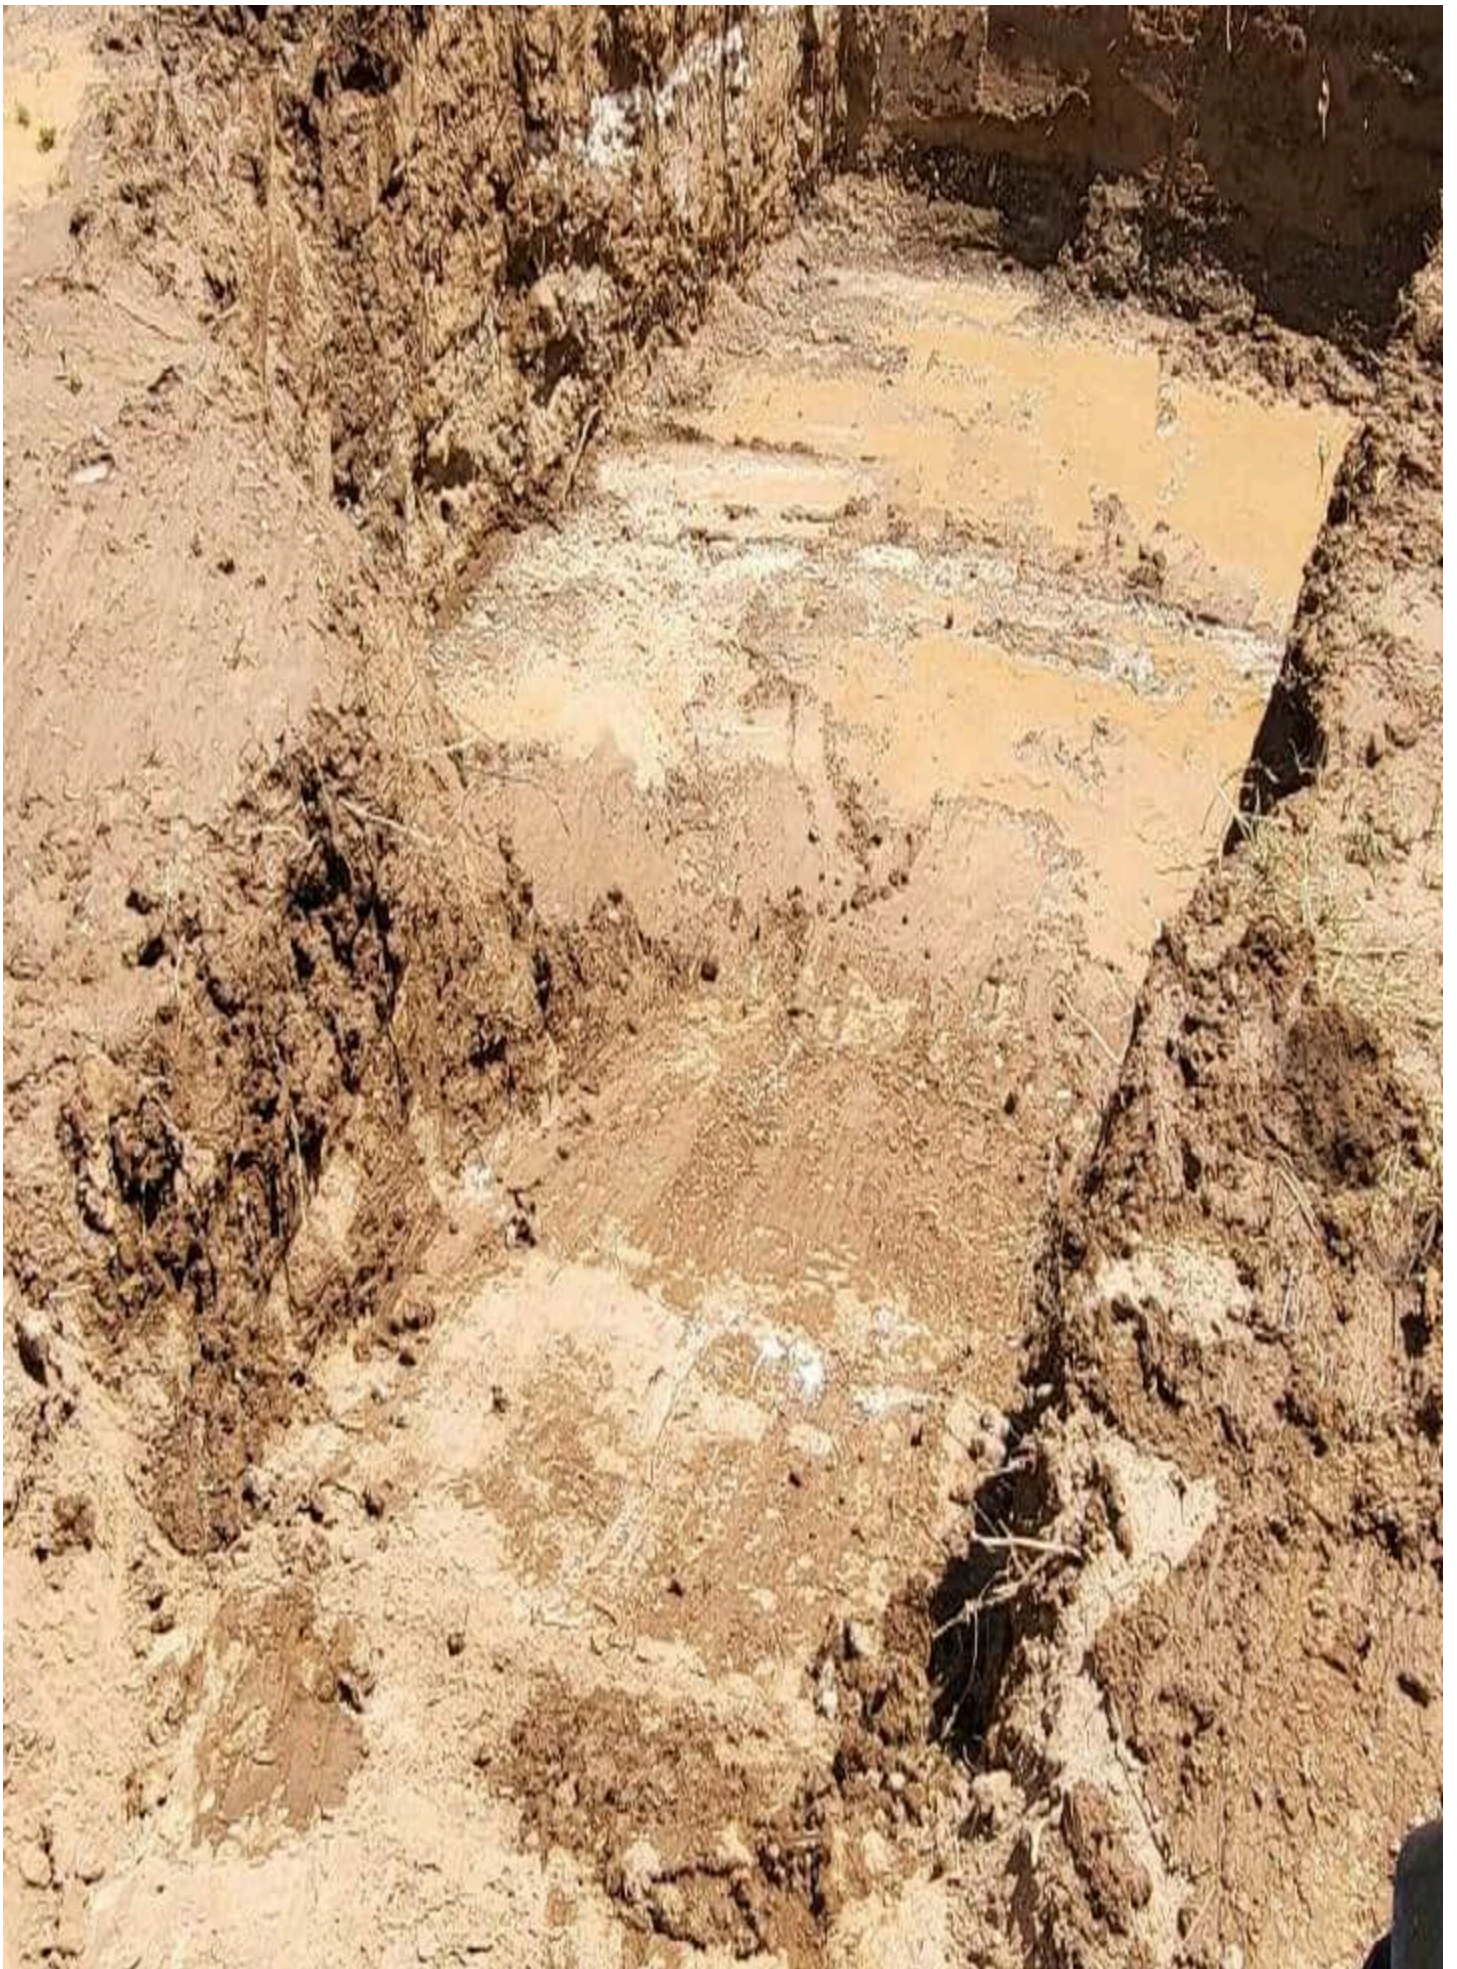
Location of Discolored Materials – A lens of white powder material (about 2-3 inches thick) was observed approximately 2.5 feet bgs. The lens appears on all sides of the excavation. Confirmation soil samples were collected from 3 feet bgs, approximately 6 inches below the white powder lens. A sample of the white powder was also collected (AOC10TAA4-CW5-3).

Sample Results – The results below showed that samples on the western sidewall (AOC10TAA4-CW3-3) and eastern sidewall (AOC10TAA4-CW5-3) at a depth of 3 feet exceed the Remedial Action Goals (RAGs). These sampling locations are shown in the map below.

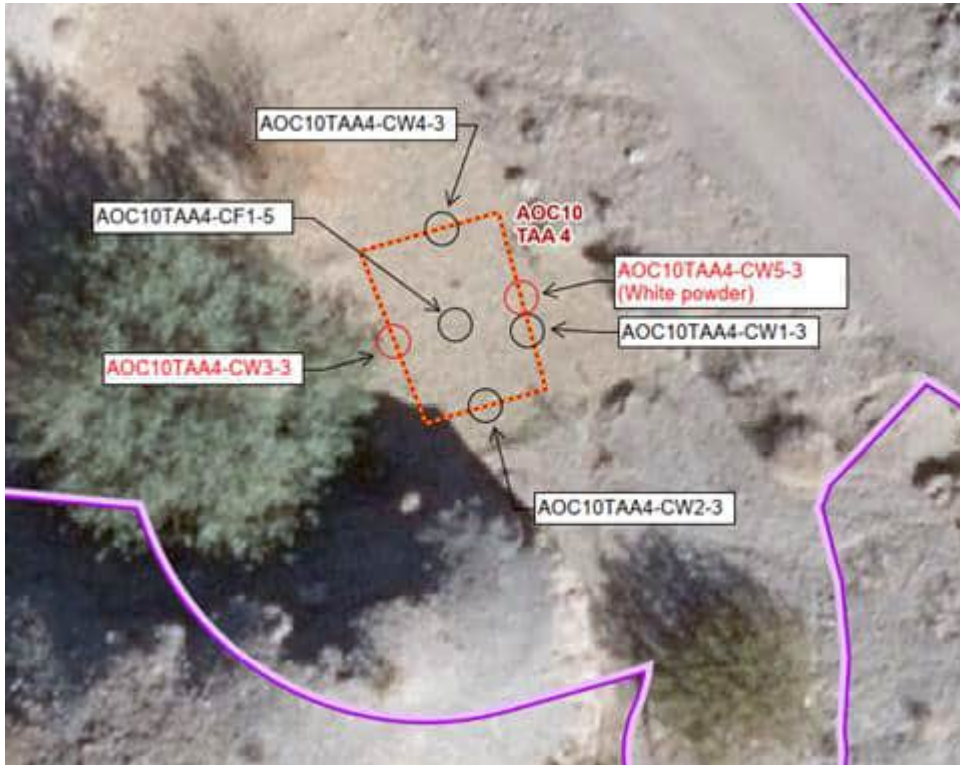
AOC10TAA4-CW5-3 (white powder) = 530 mg/kg Total Chromium, >241 ng/kg Dioxins/Furans (Immunoassay Method)

Next Steps -- PG&E proposes to step out in 1 foot increment laterally (up to the extent of the approved work area) and to 3 feet bgs to remove the white powder lens.

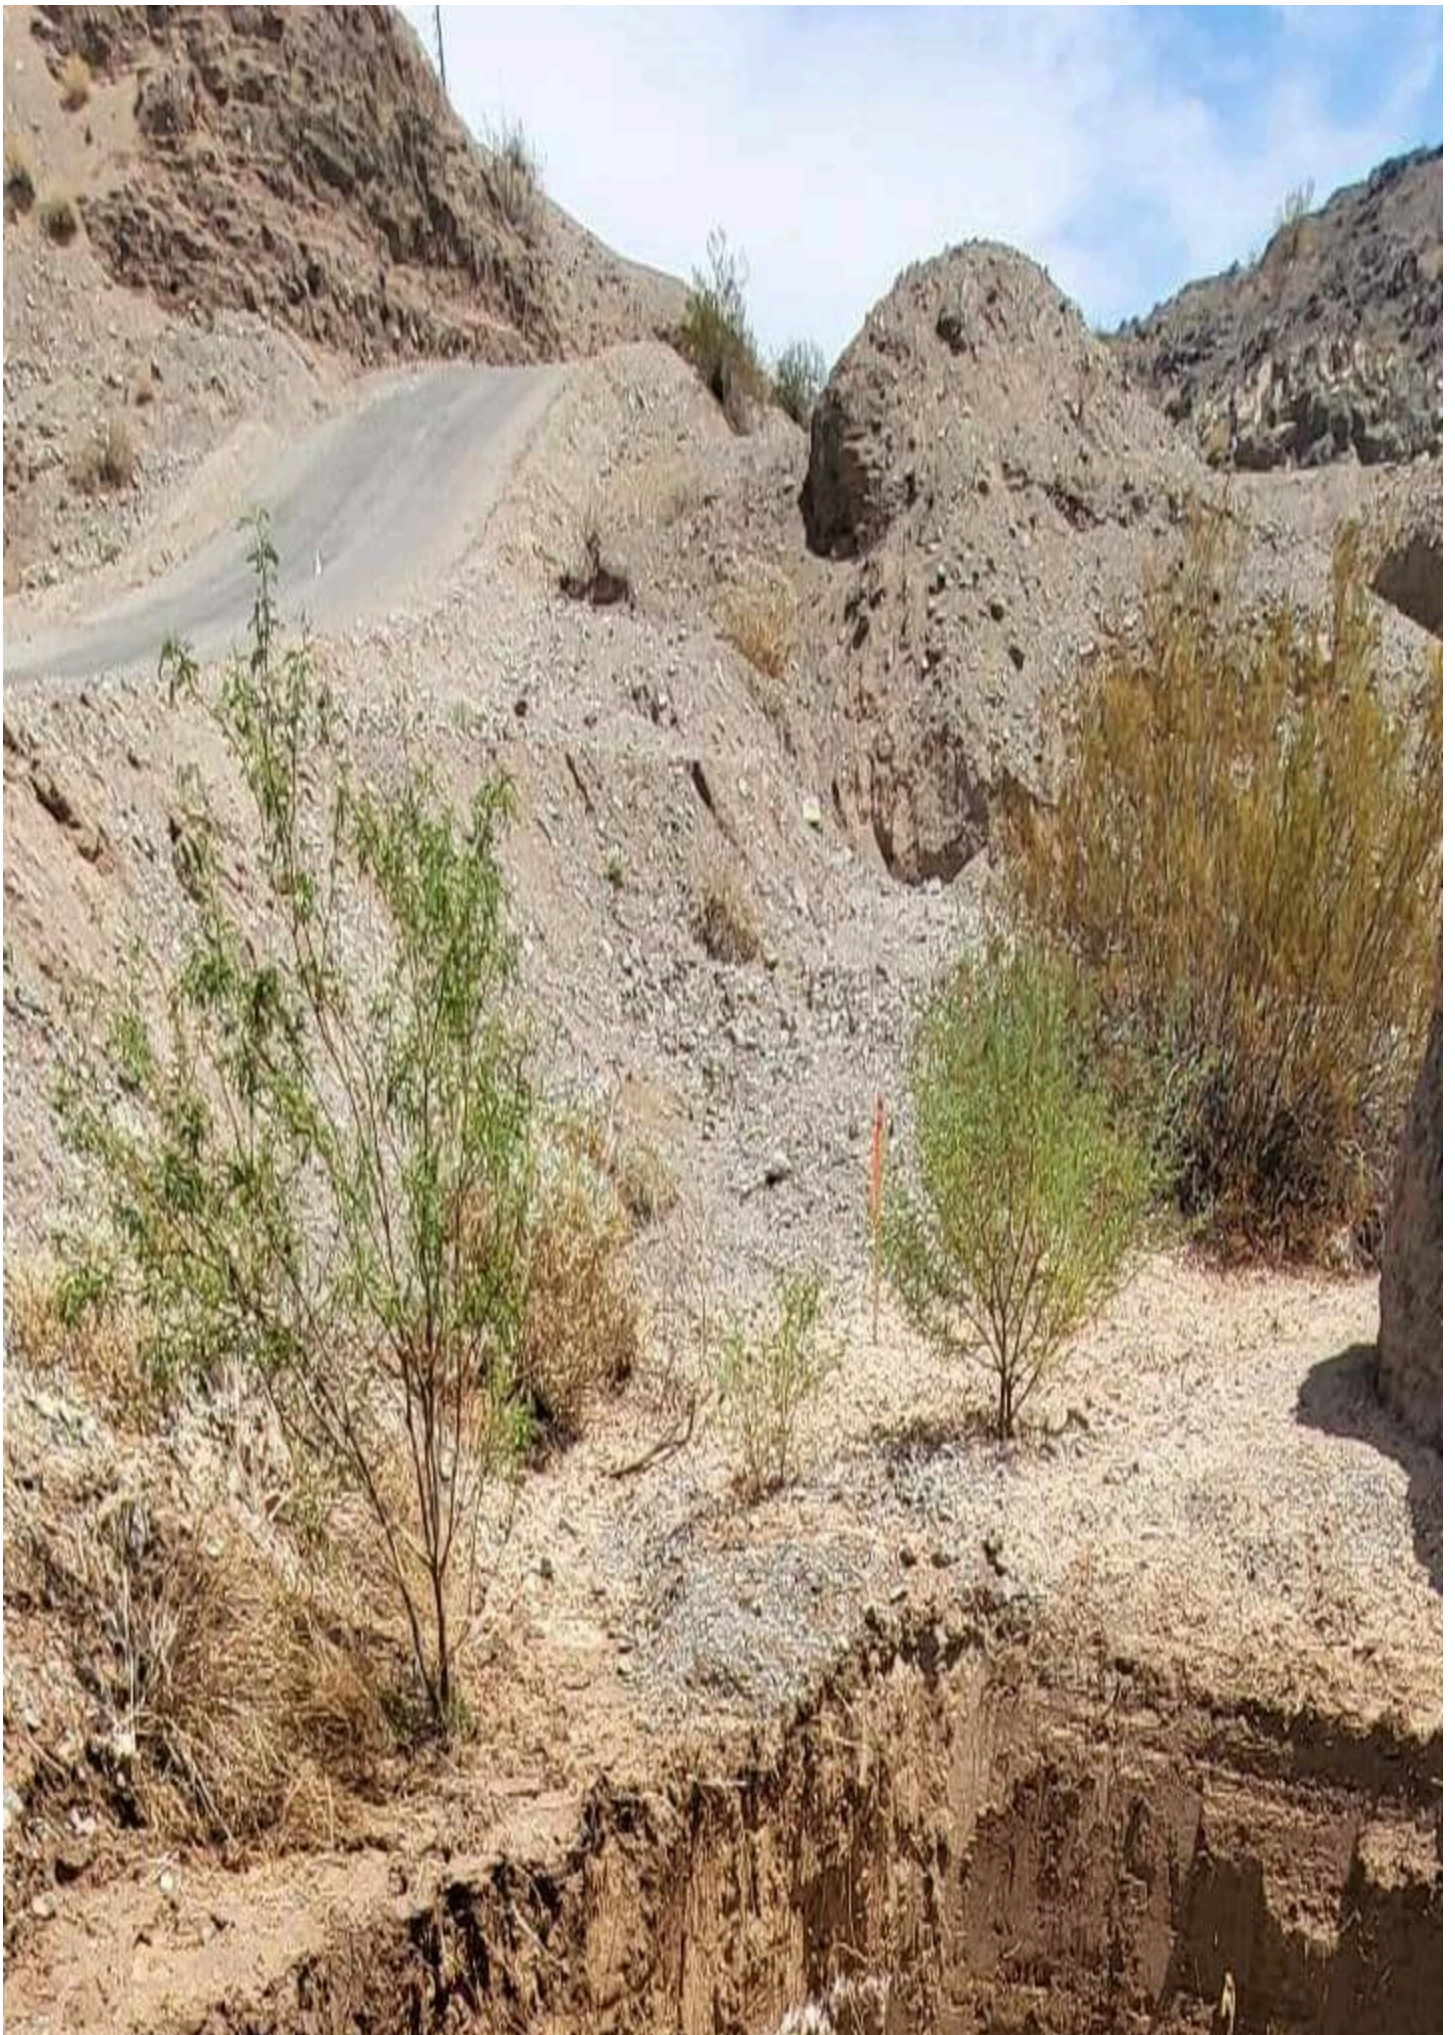
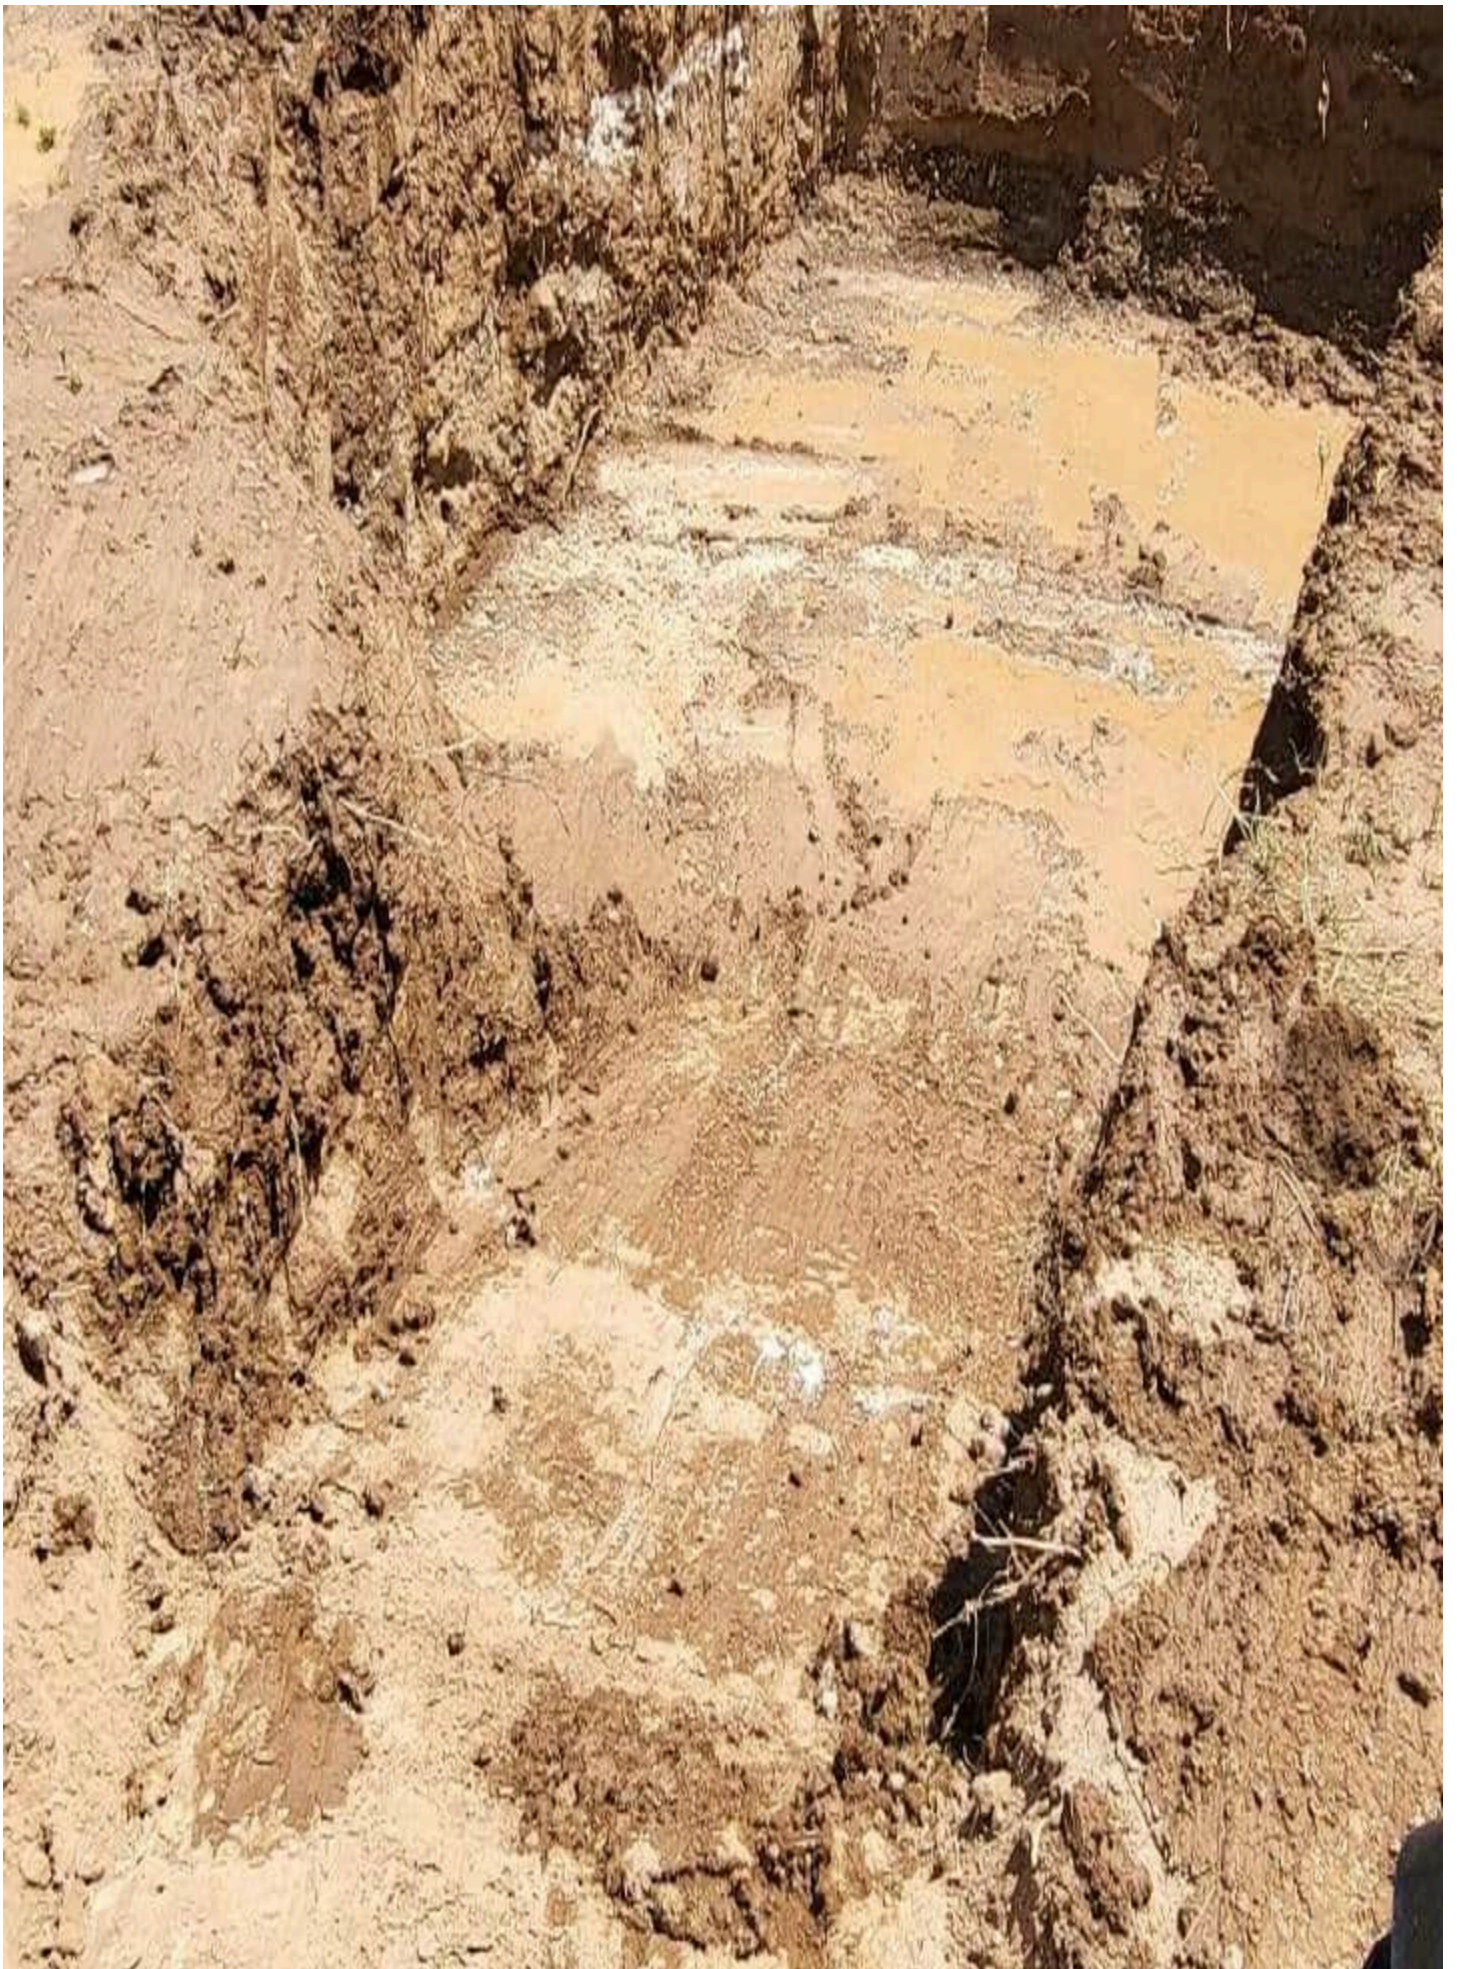
Location of Discolored Materials – A lens of white powder material (about 2-3 inches thick) was observed approximately 2.5 feet bgs. The lens appears on all sides of the excavation. Confirmation soil samples were collected from 3 feet bgs, approximately 6 inches below the white powder lens. A sample of the white powder was also collected (AOC10TAA4-CW5-3).

Sample Results – The results below showed that samples on the western sidewall (AOC10TAA4-CW3-3) and eastern sidewall (AOC10TAA4-CW5-3) at a depth of 3 feet exceed the Remedial Action Goals (RAGs). These sampling locations are shown in the map below.

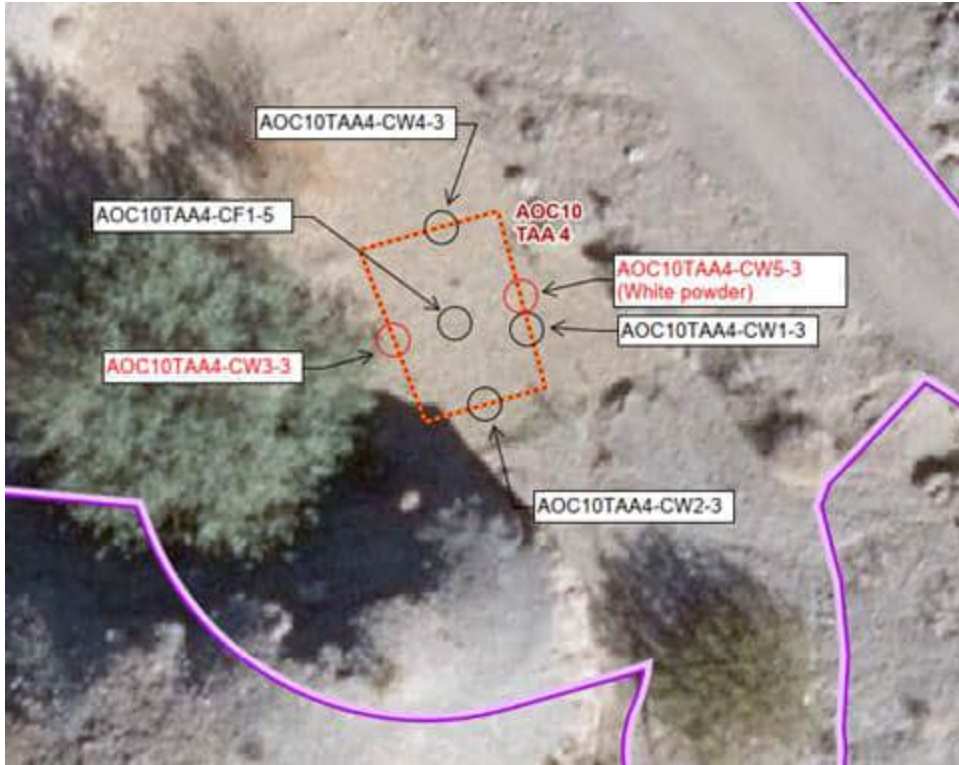
AOC10TAA4-CW5-3 (white powder) = 530 mg/kg Total Chromium, >241 ng/kg Dioxins/Furans (Immunoassay Method)

Next Steps -- PG&E proposes to step out in 1 foot increment laterally (up to the extent of the approved work area) and to 3 feet bgs to remove the white powder lens.
