Soil Non-Time-Critical Removal Action Completion Report

Topock Compressor Station, Needles, California

Final

Pacific Gas and Electric Company

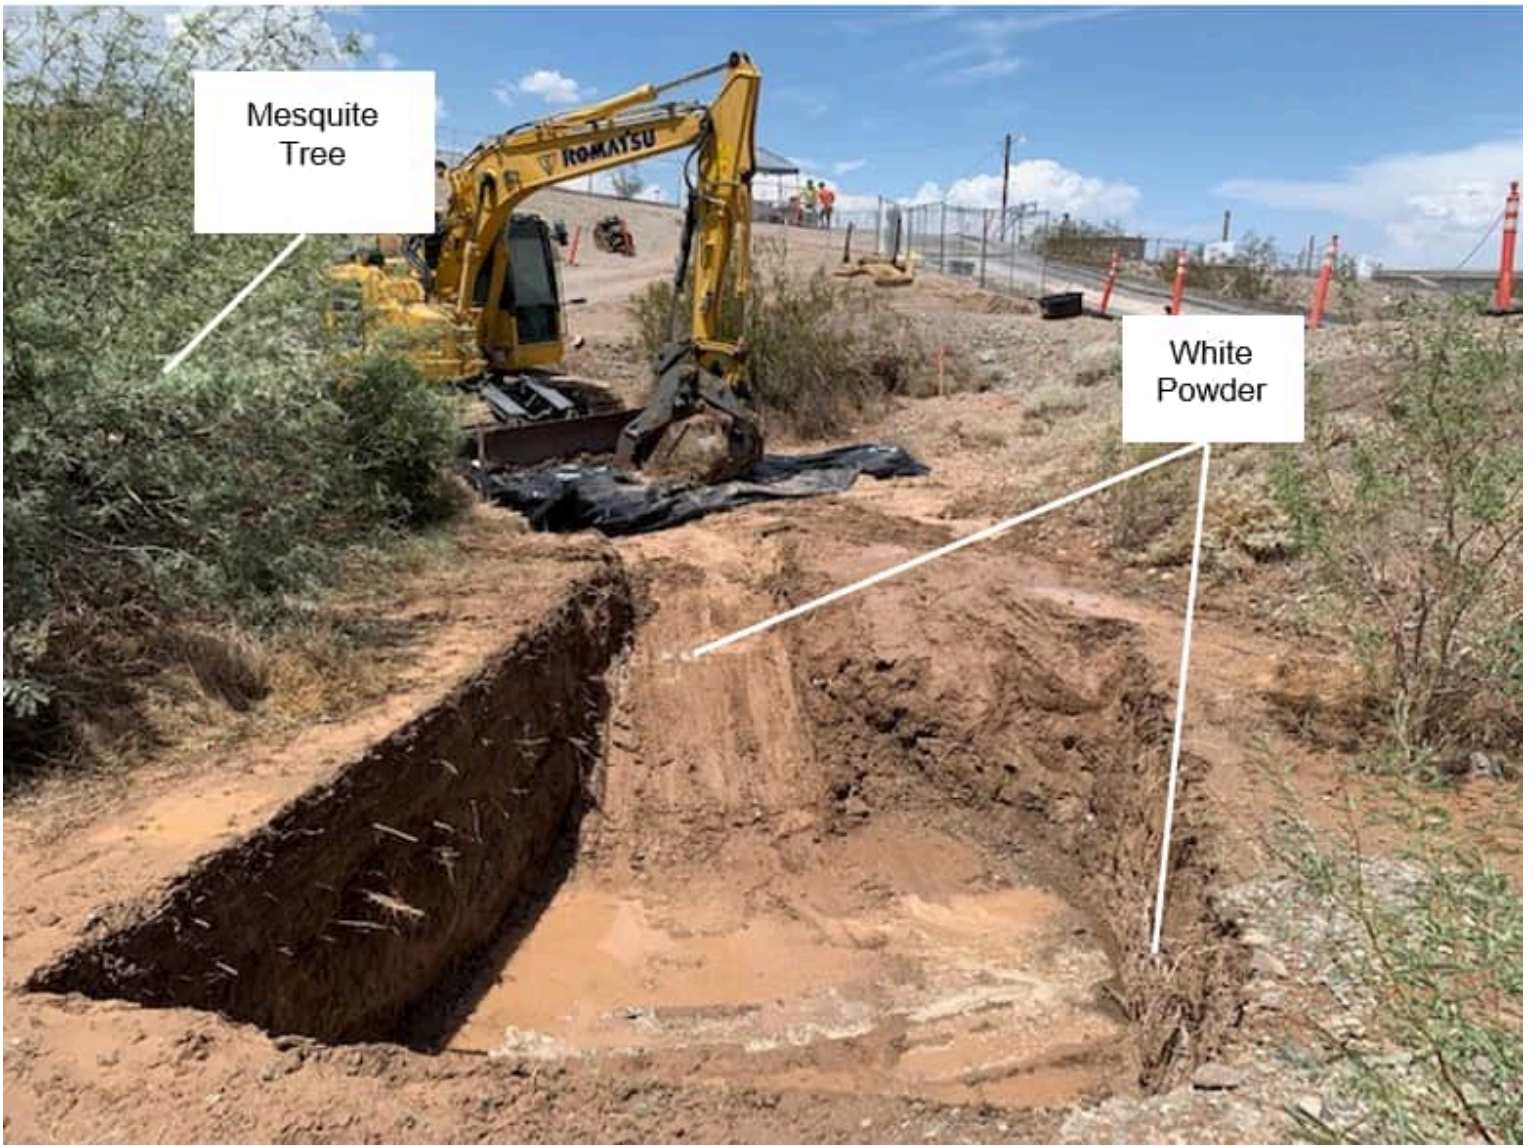
Mesquite
Tree

White
Powder

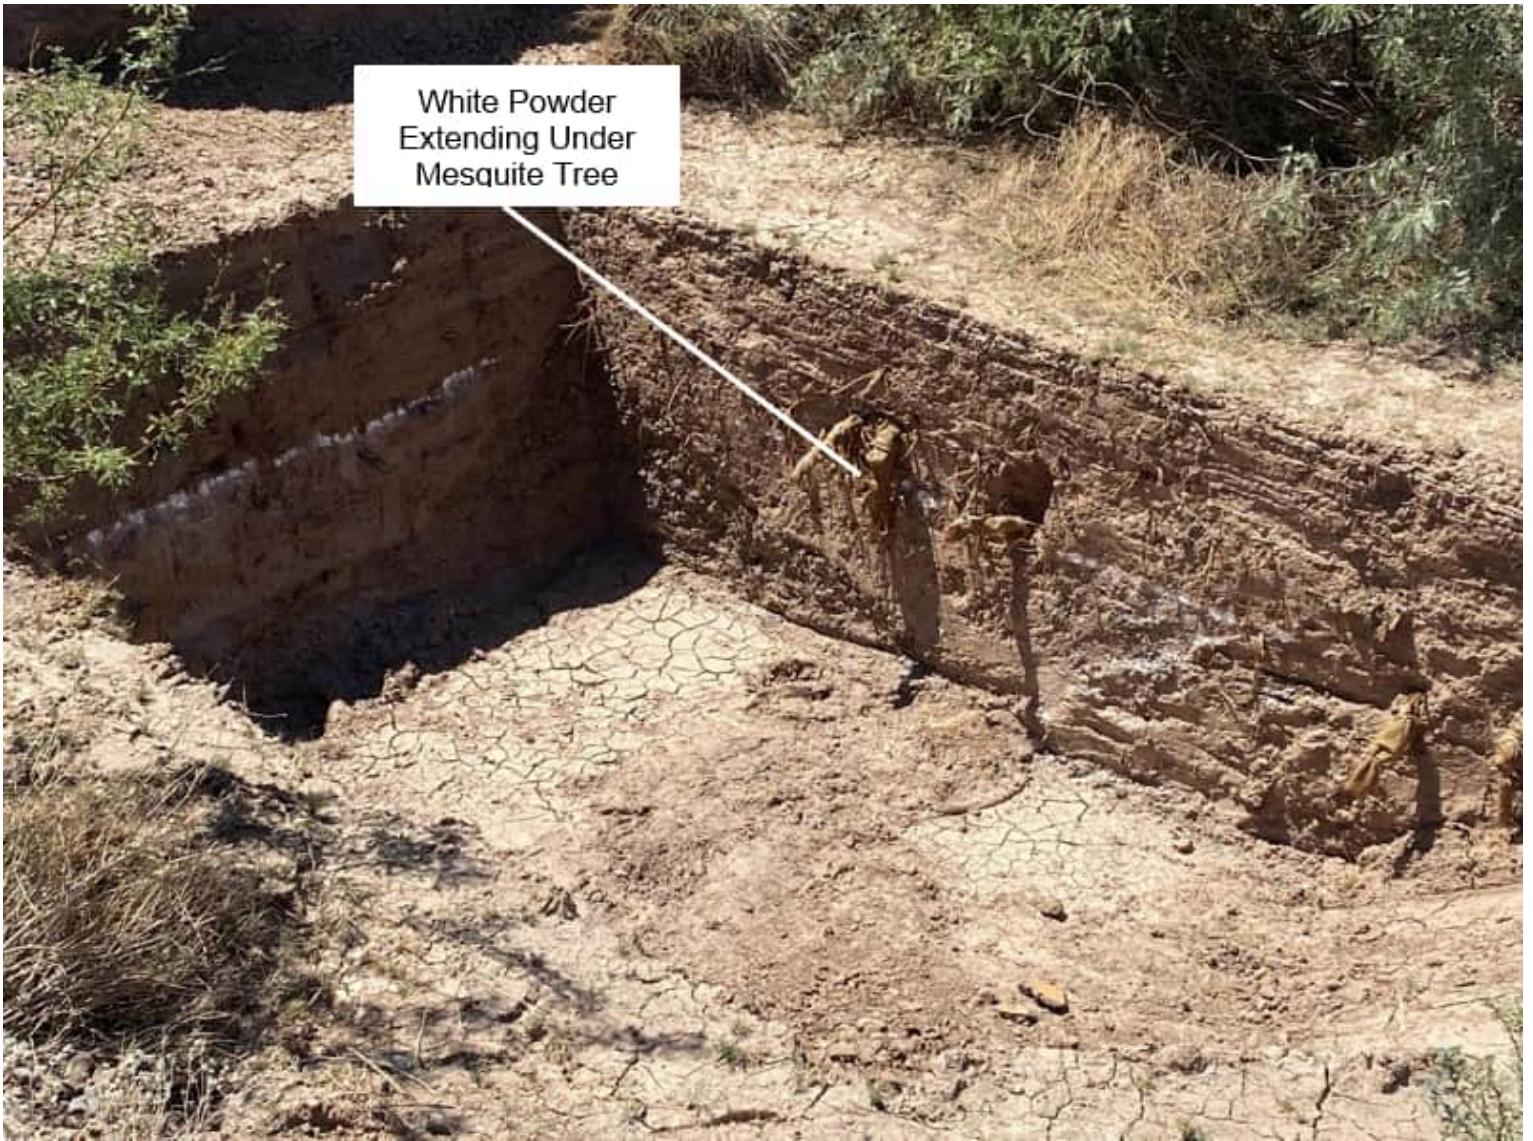
White Powder
Extending Under
Mesquite Tree

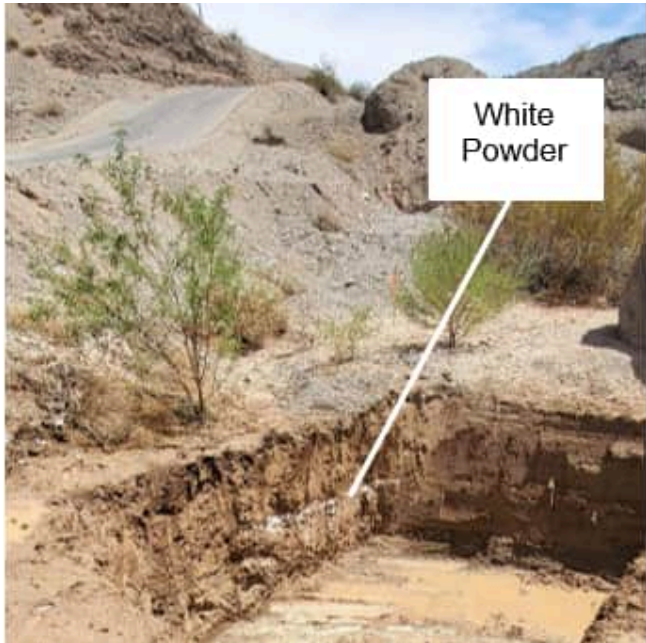
White
Powder

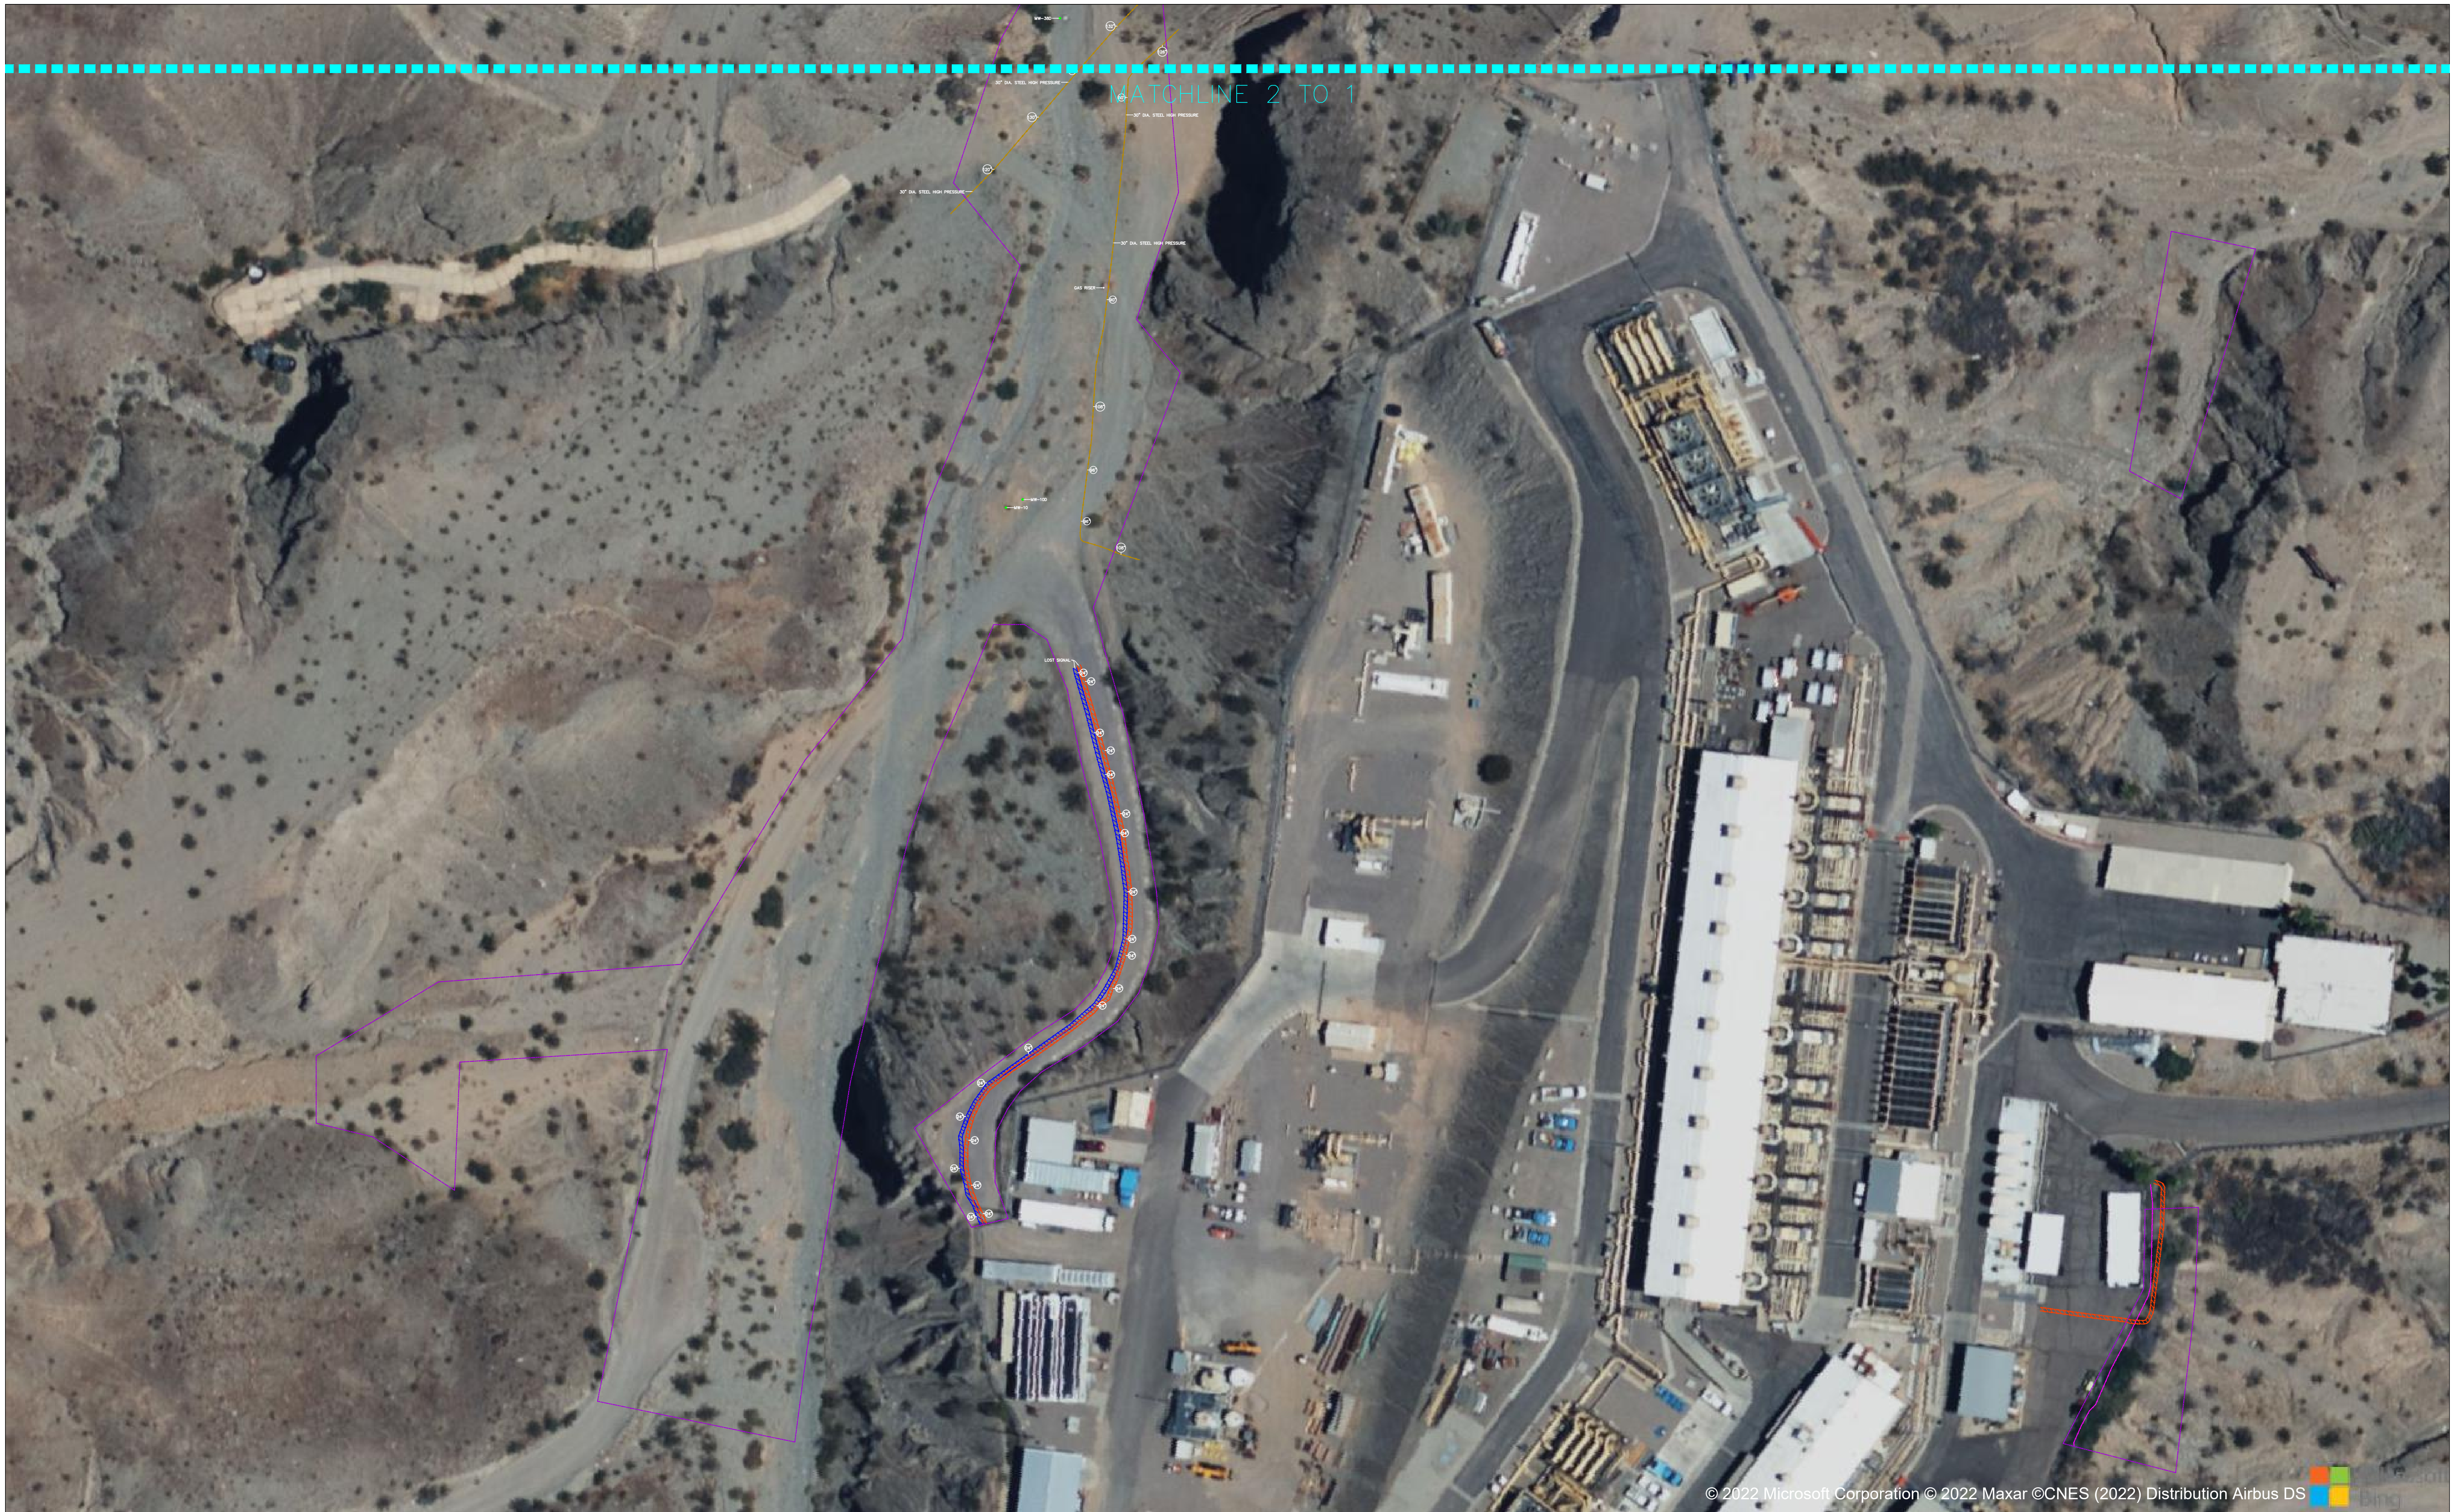
FIGURE 1	
	SITE MAP WITH GEOPHYSICAL INTERPRETATION	
	PG&E TOPOCK SITE	
	NEEDLES, CA	
	PREPARED FOR JACOBS	
Project No.	22284	
Date	Nov. 28, 2022	
Developed by	E. VASQUEZ	
Drawn by	S. ORTEGA	
Approved by	M. RICHES P.G.P.	
File Name	012284\22284-1.dwg

NOTE: All the geophysical methods have limitations dependent on instrumentation used, soil conditions, and local cultural noise and other interference. The interpretation of geophysical conditions presented above comprises a declaration of the geophysicist's professional judgement using methods and a degree of care and skill ordinarily exercised, under similar circumstances, by reputable members of their profession practicing in the same or similar locality. It does not constitute a warranty or guarantee, expressed or implied, nor does it relieve any other party of its responsibility to abide by contract documents, applicable codes, standards, regulations or ordinances. If you require further information about the limitations of the instruments and/or methods used on this project please contact GEOVision Geophysical Services.

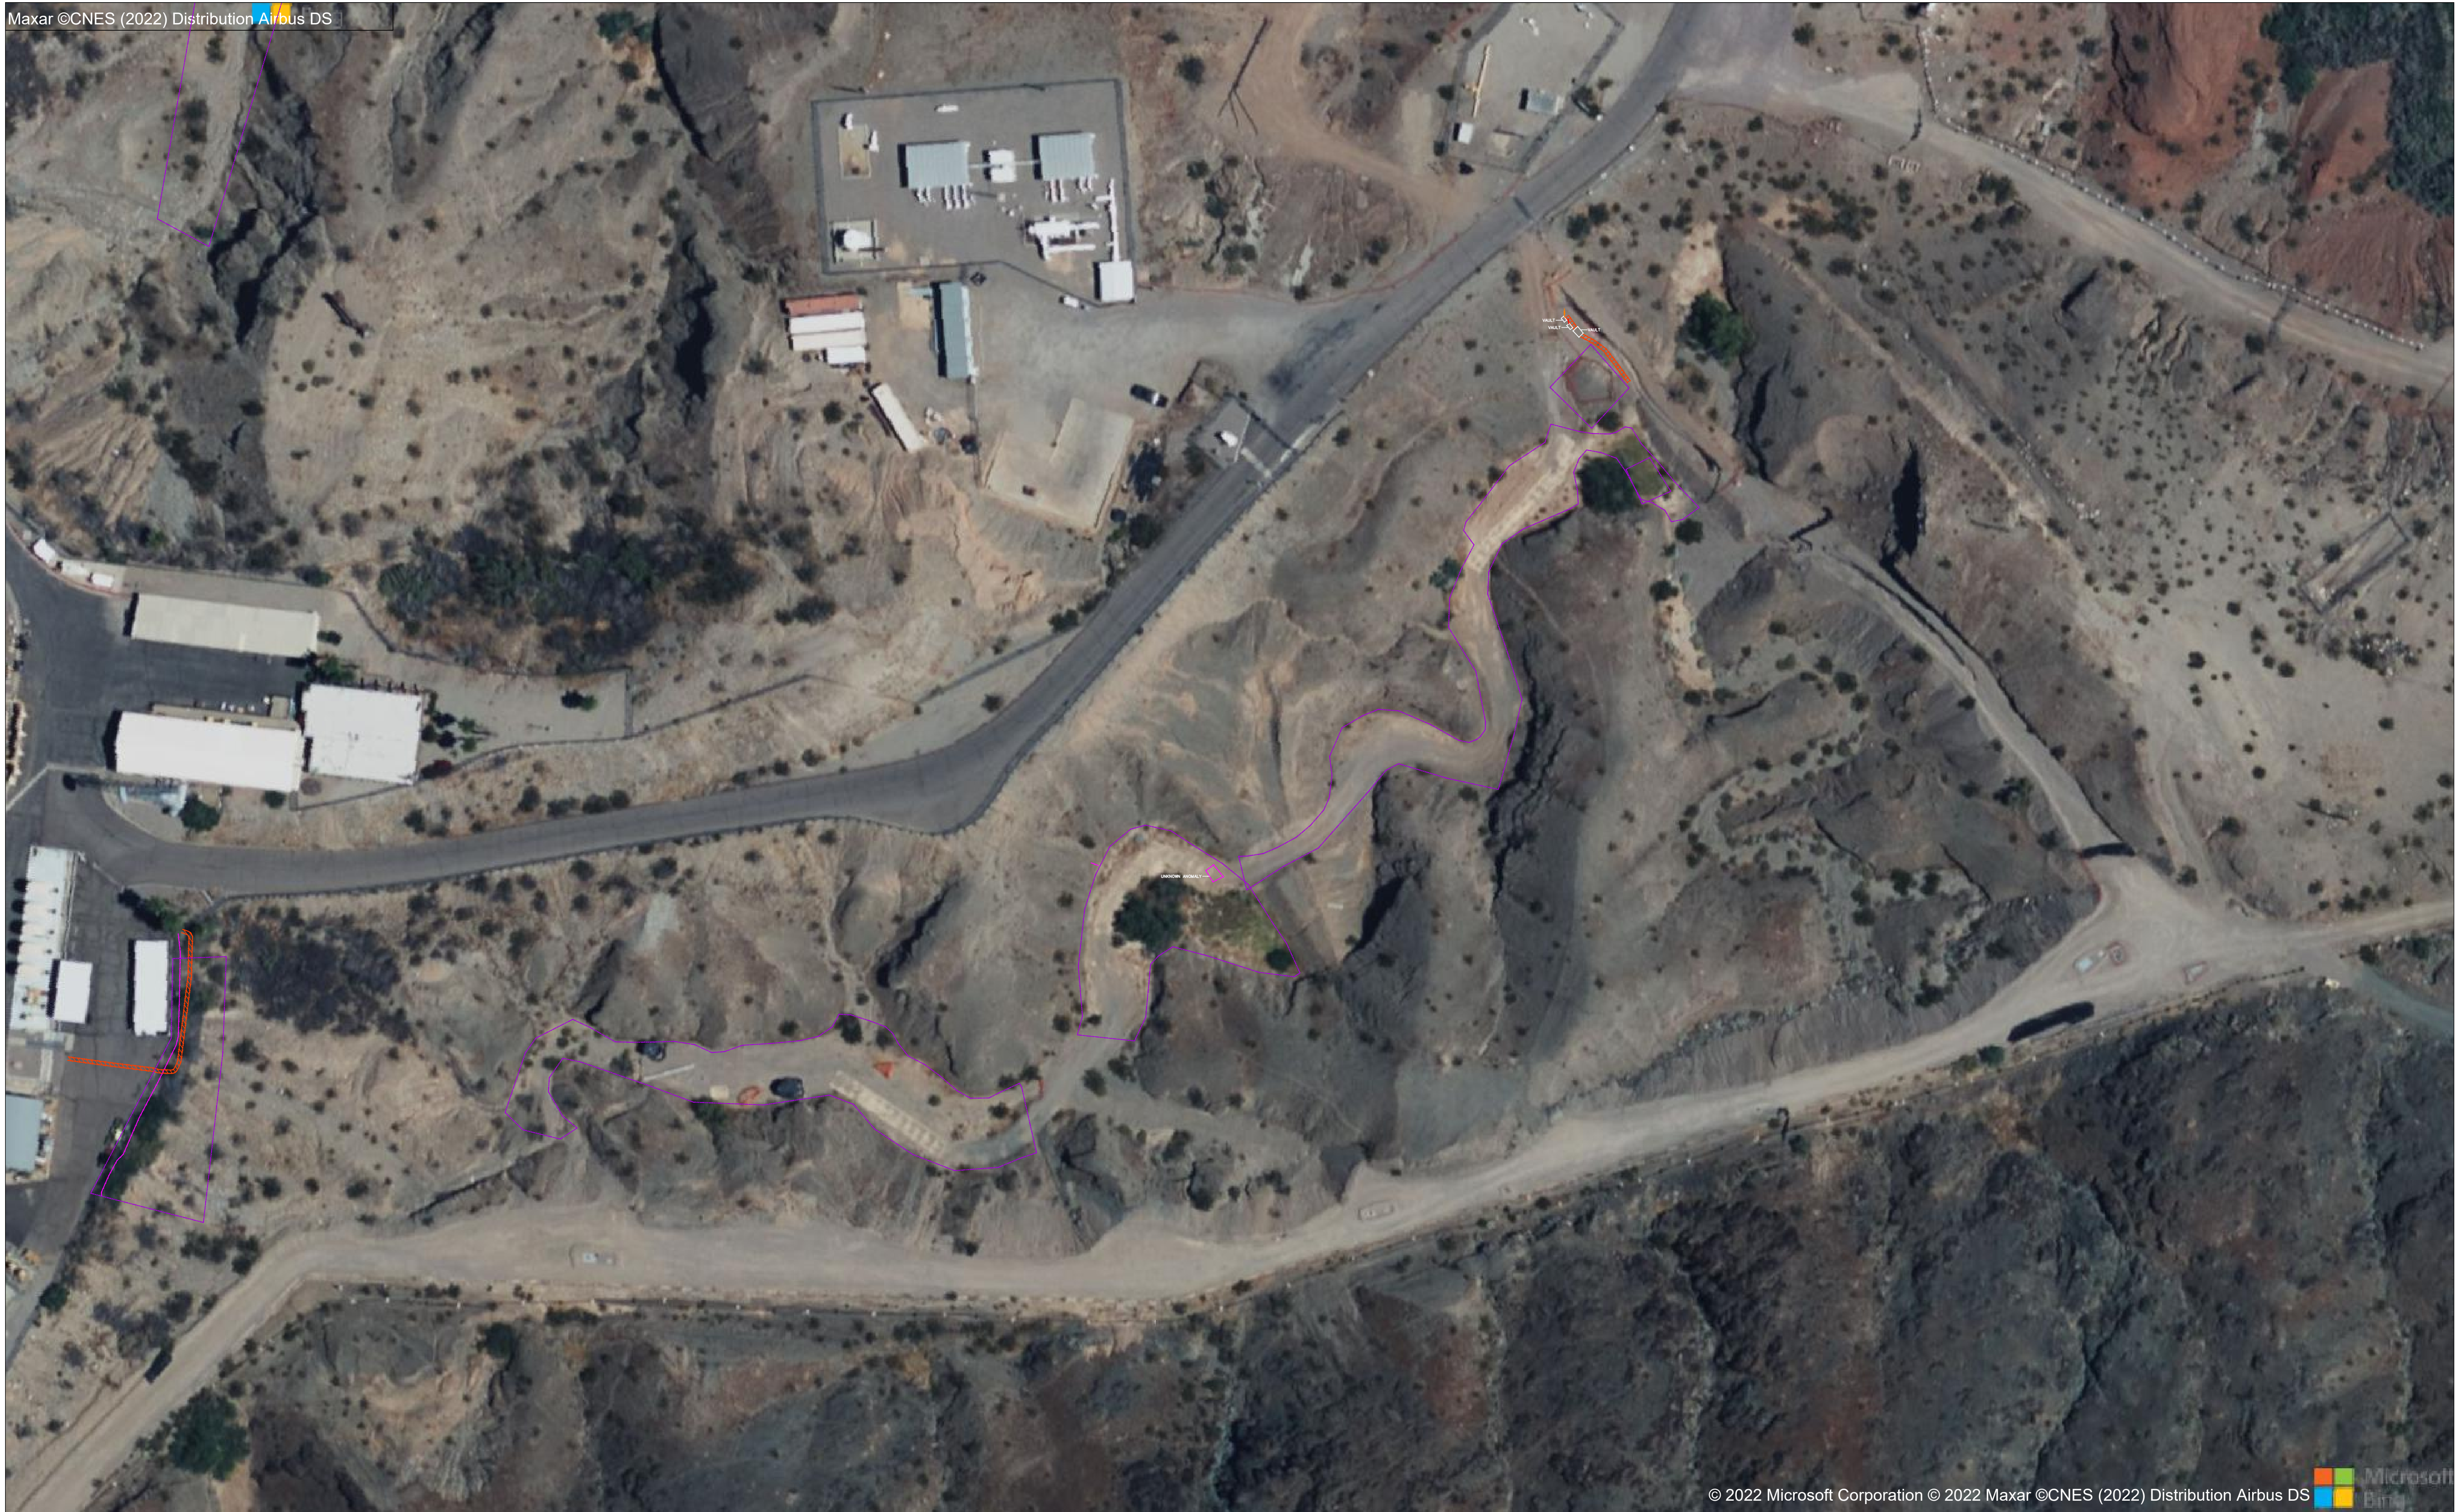
FIGURE 2 SITE MAP WITH GEOPHYSICAL INTERPRETATION
	PG&E TOPOCK SITE NEEDLES, CA
	PREPARED FOR JACOBS
	Project No. 22284 Date Nov 28, 2022 Developed by E. VASQUEZ Drawn by S. ORTEGA Approved by M. RICHES P.G.P. File Name: G:\22284\22284-1.dwg

NOTE: All the geophysical methods have limitations dependent on instrumentation used, soil conditions, and local cultural noise and other interference. The interpretation of geophysical conditions presented above comprises a declaration of the geophysicist's professional judgement using methods and a degree of care and skill ordinarily exercised, under similar circumstances, by reputable members of their profession practicing in the same or similar locality. It does not constitute a warranty or guarantee, expressed or implied, nor does it relieve any other party of its responsibility to abide by contract documents, applicable codes, standards, regulations or ordinances. If you require further information about the limitations of the instruments and/or methods used on this project please contact GEOVision Geophysical Services.

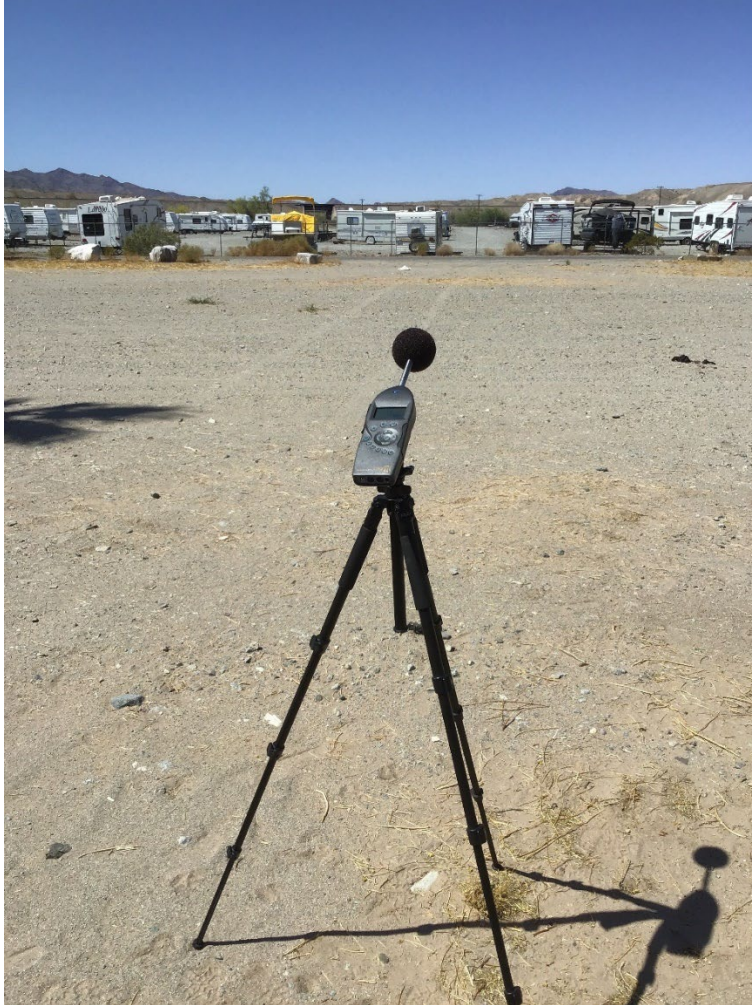
A storage yard for mobile homes, boats, and other recreational equipment) is present between the SPY, CHQ, and the mobile home park, breaking the line of sight, as well as reducing project-generated construction noise levels to inaudible or immeasurable levels. Photograph 2-1 shows the monitoring station.

Photograph 2-1. Noise Monitoring Location West of the Mobile Home Park at Moabi Regional Park, Looking Toward the Soil Processing Yard

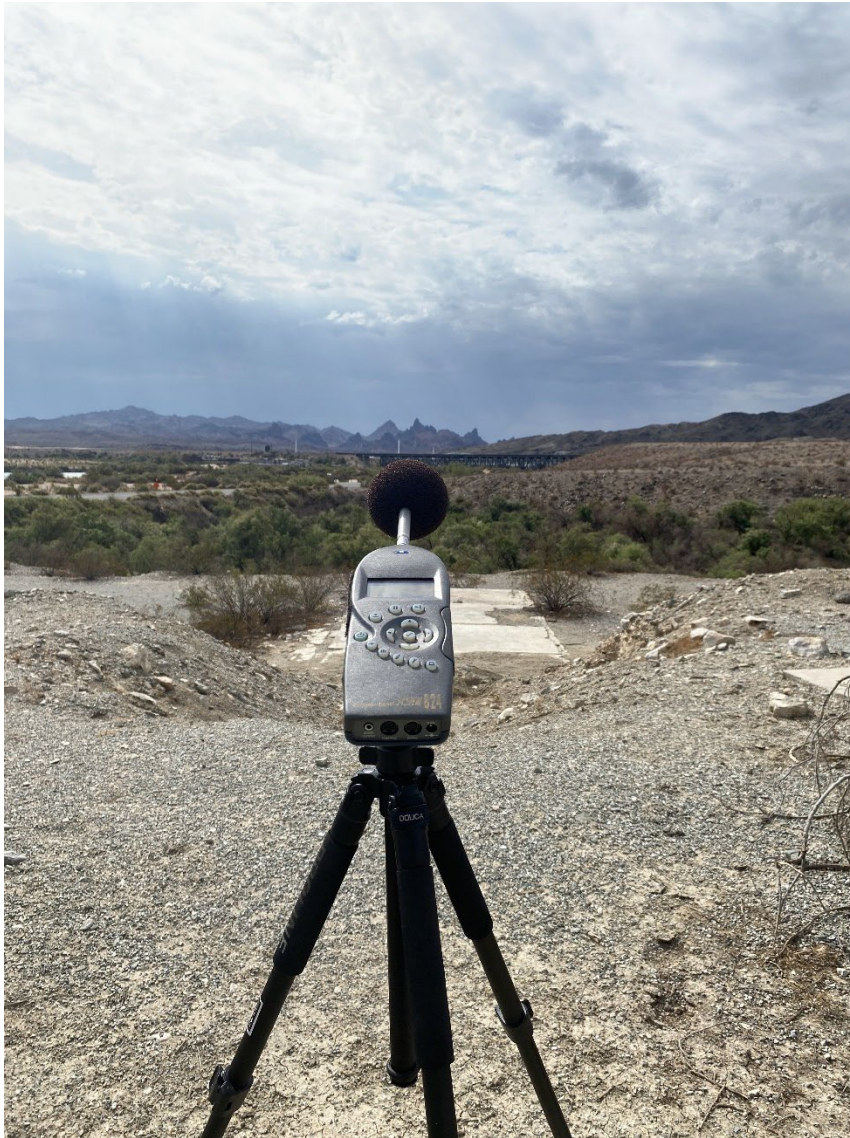
Photographs 2-2A and 2-2B show the monitoring station.

Photograph 2-2A. Noise Monitoring Location Old Restaurant Site, West of National Trails Highway, Looking Northeast Toward MW-20 Bench

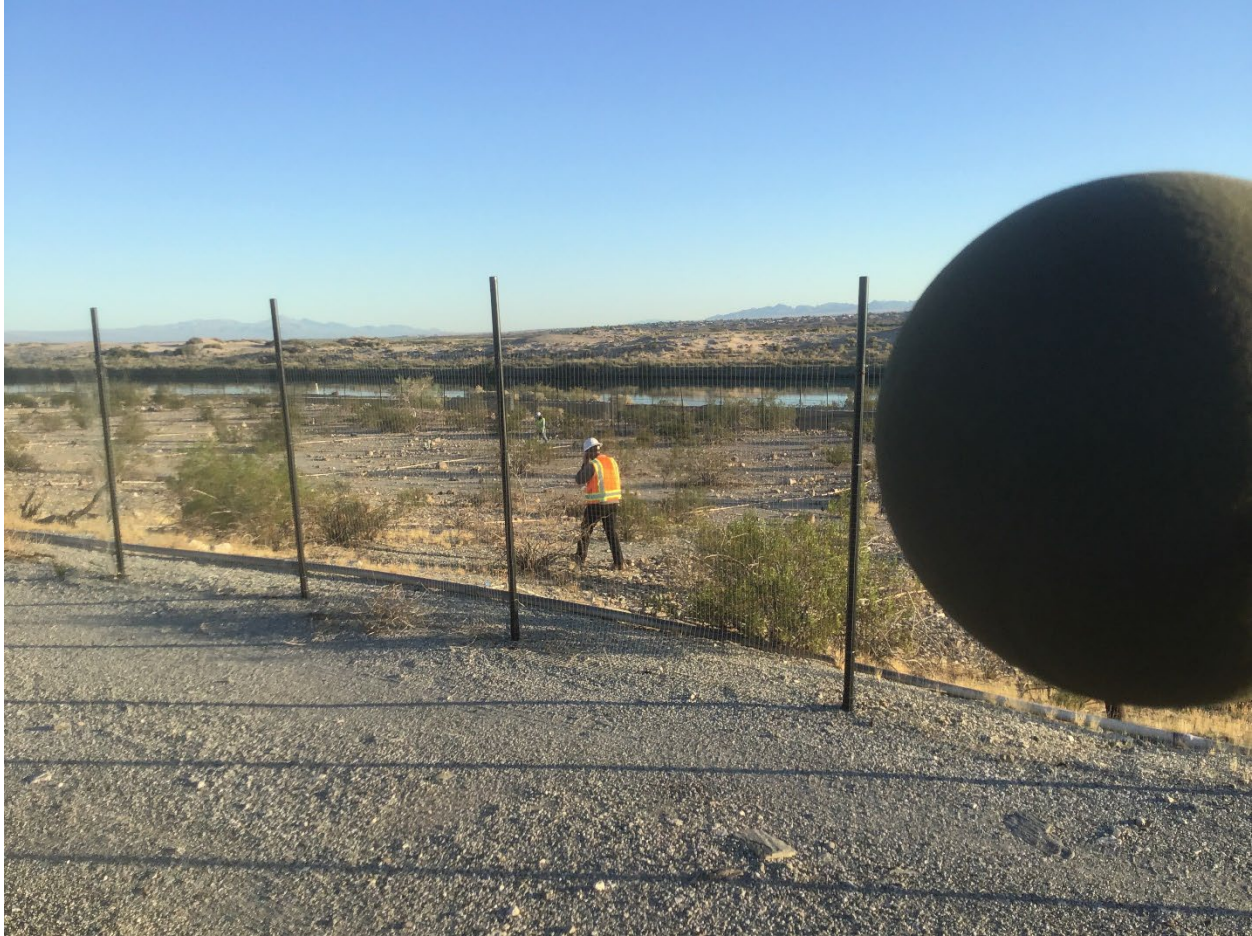
Photograph 2-2B. Noise Monitoring Location Old Restaurant Site, West of National Trails Highway, Looking Southeast Toward UHR-1 Revegetation Area

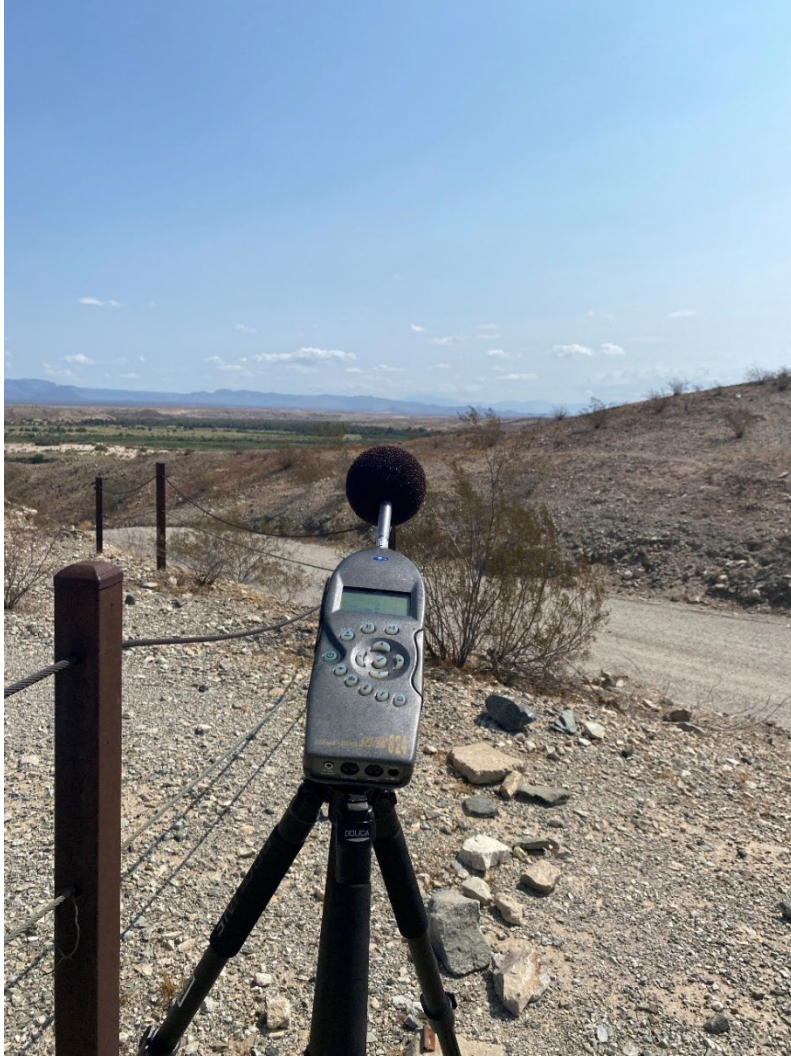
Photograph 2-3A. Noise Monitoring Location in the Upland, off IM-3 Access Road, Near Top of Hill, Looking East Toward MW-20 Bench

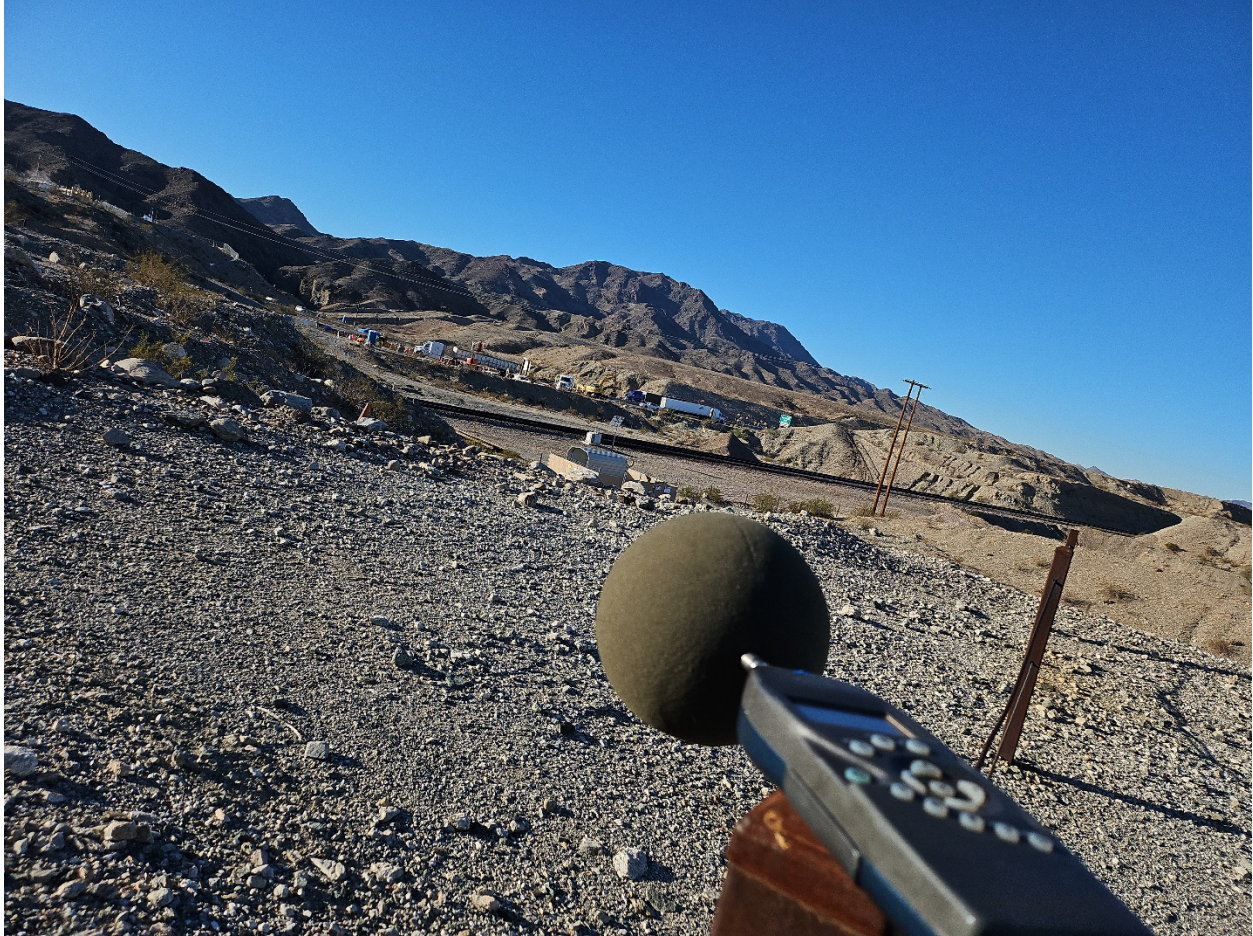
Photograph 2-3B. Alternate Noise Monitoring Location in the Upland, off IM-3 Access Road, Near Top of Hill, Looking West Toward AOC14 during Soil NTCRA

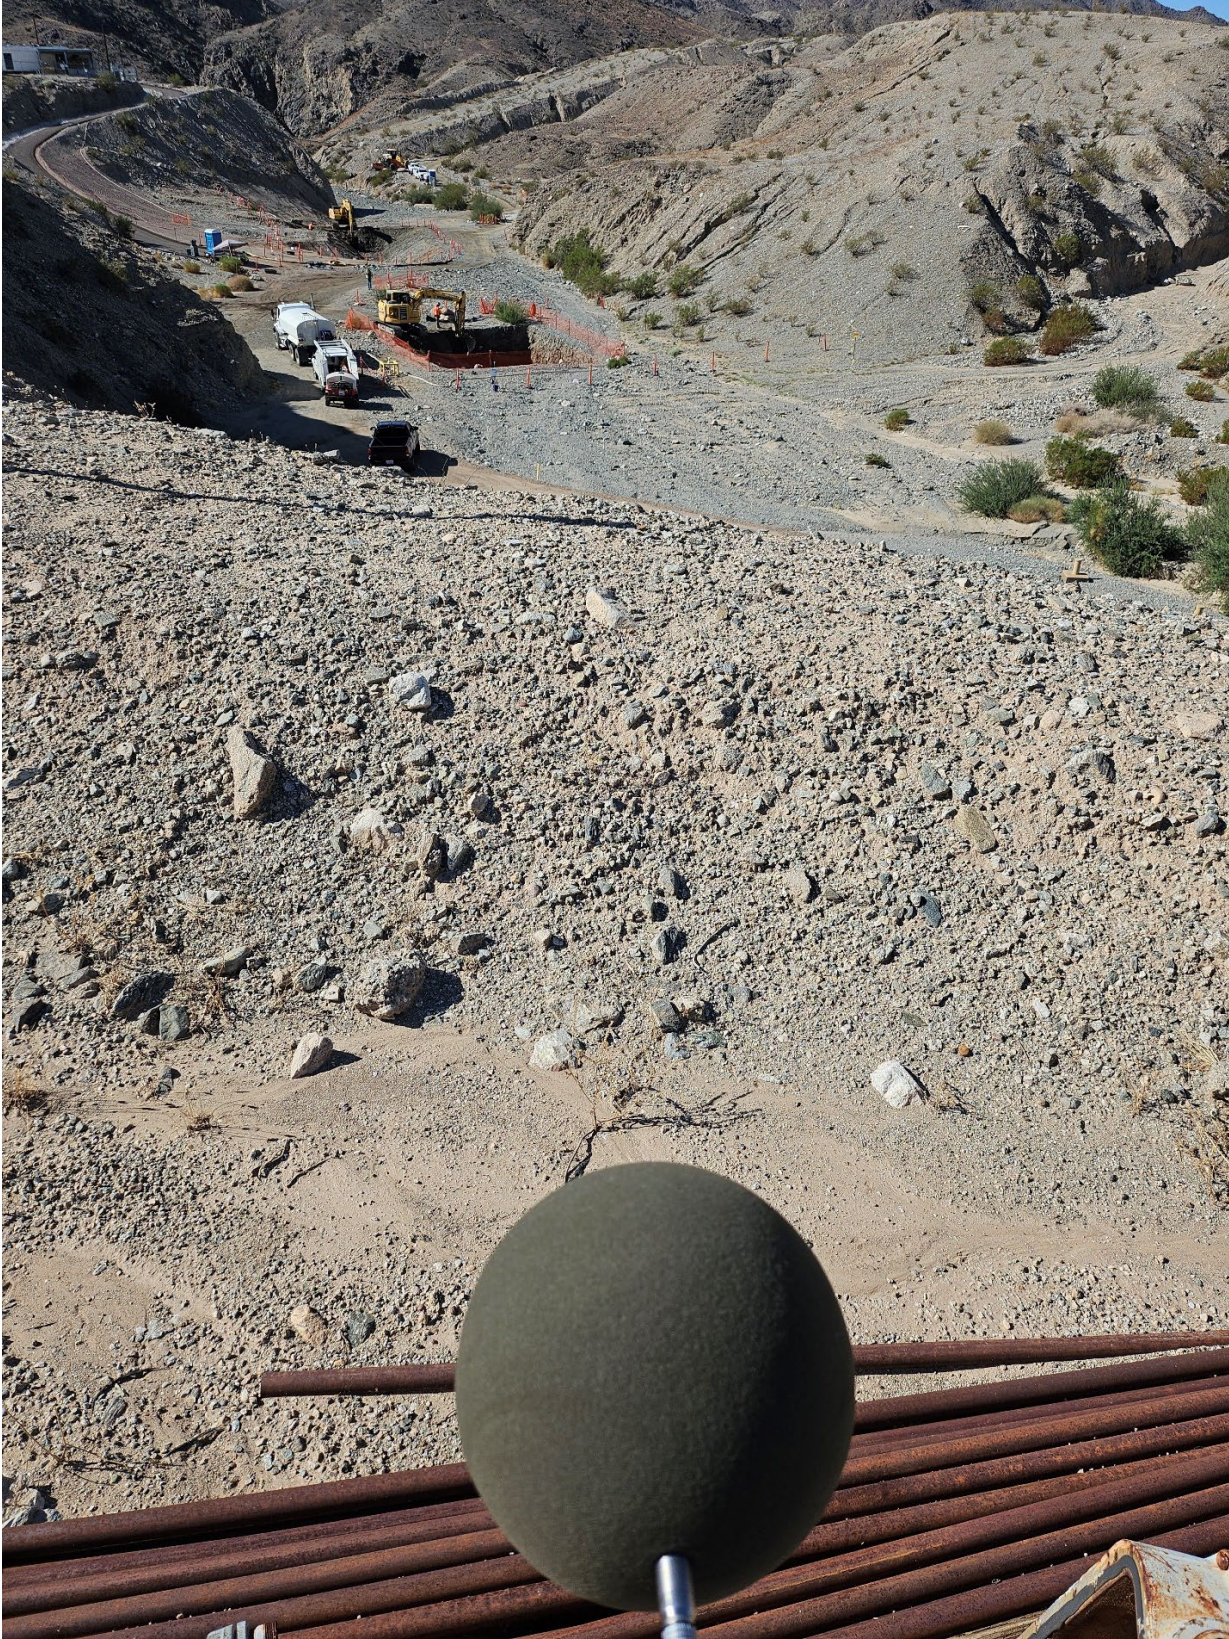
Photograph 2-4. Noise Monitoring Location on a Bluff Below Topock Compressor Station, just South of I-40 and East of Topock Maze, Looking South Toward Bat Cave Wash during Soil NTCRA

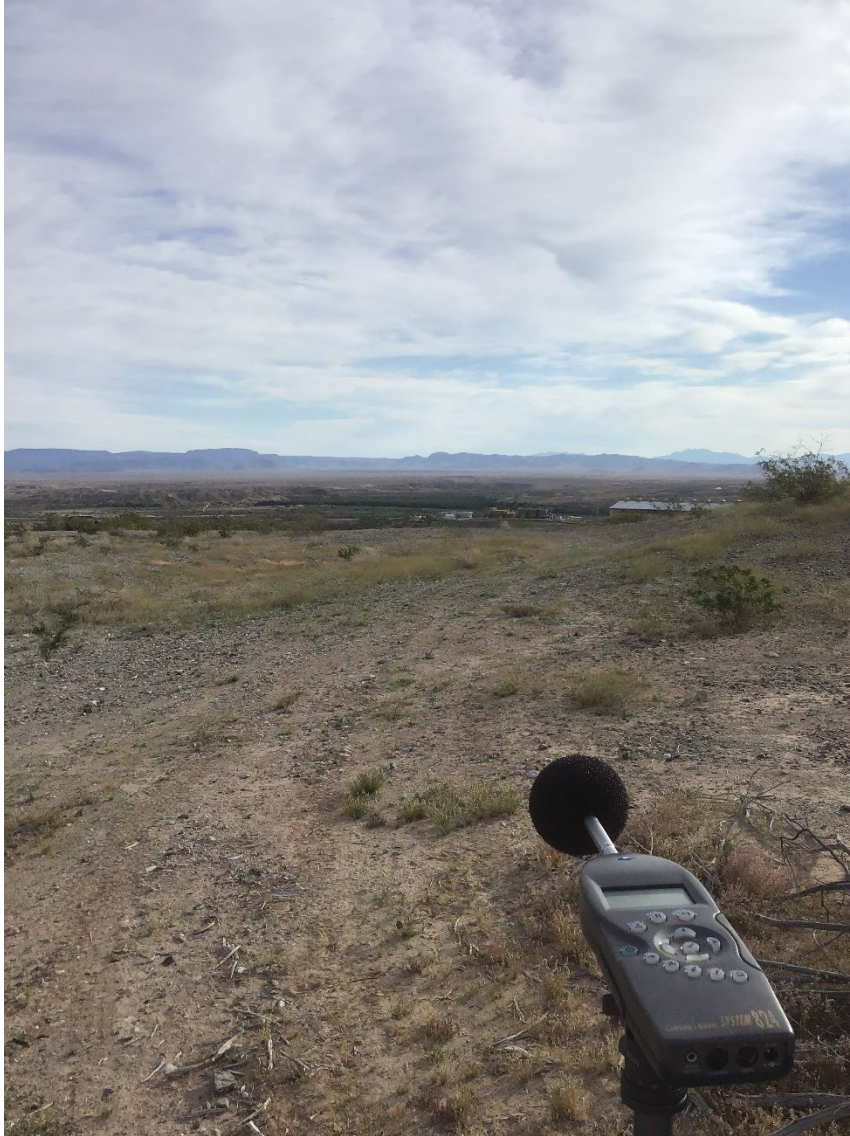
Photograph 2-5A. Noise Monitoring Location West of the Access Road to Bat Cave Wash, on Same Elevation as Topock Maze, Looking North

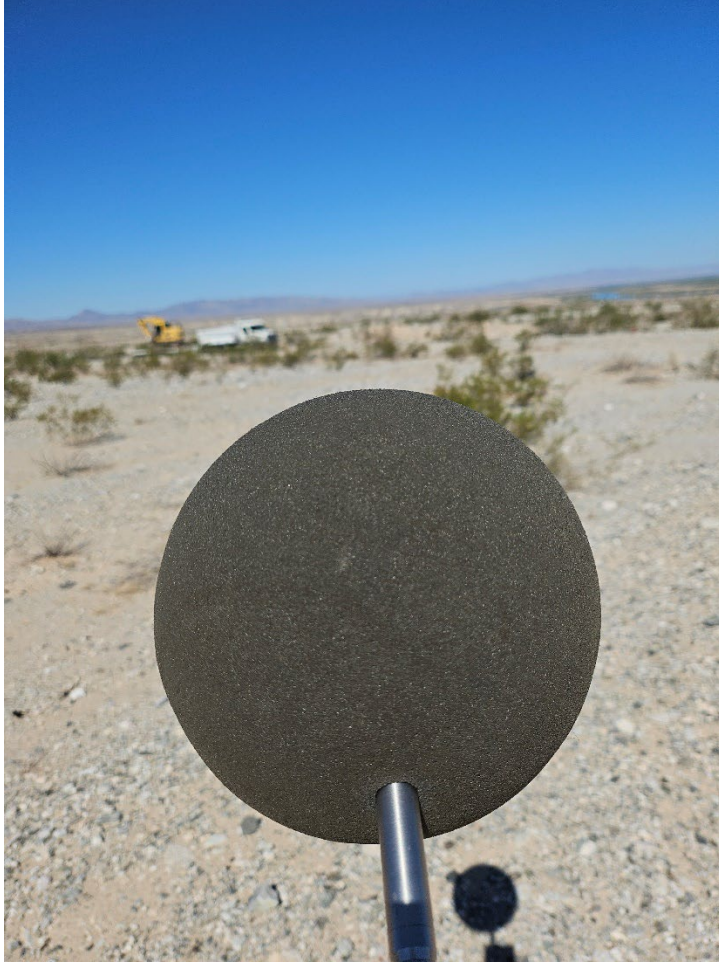
Photograph 2-5B. Noise Monitoring Location West of the Access Road to Bat Cave Wash, on Same Elevation as Topock Maze, Looking Northwest at NTCRA Construction Equipment Traffic

^[a] The maximum sound level of 74 dBA was noted when a large track excavator passed by the noise monitoring location on September 11, 2023. The next section describes the mitigation measures implemented.

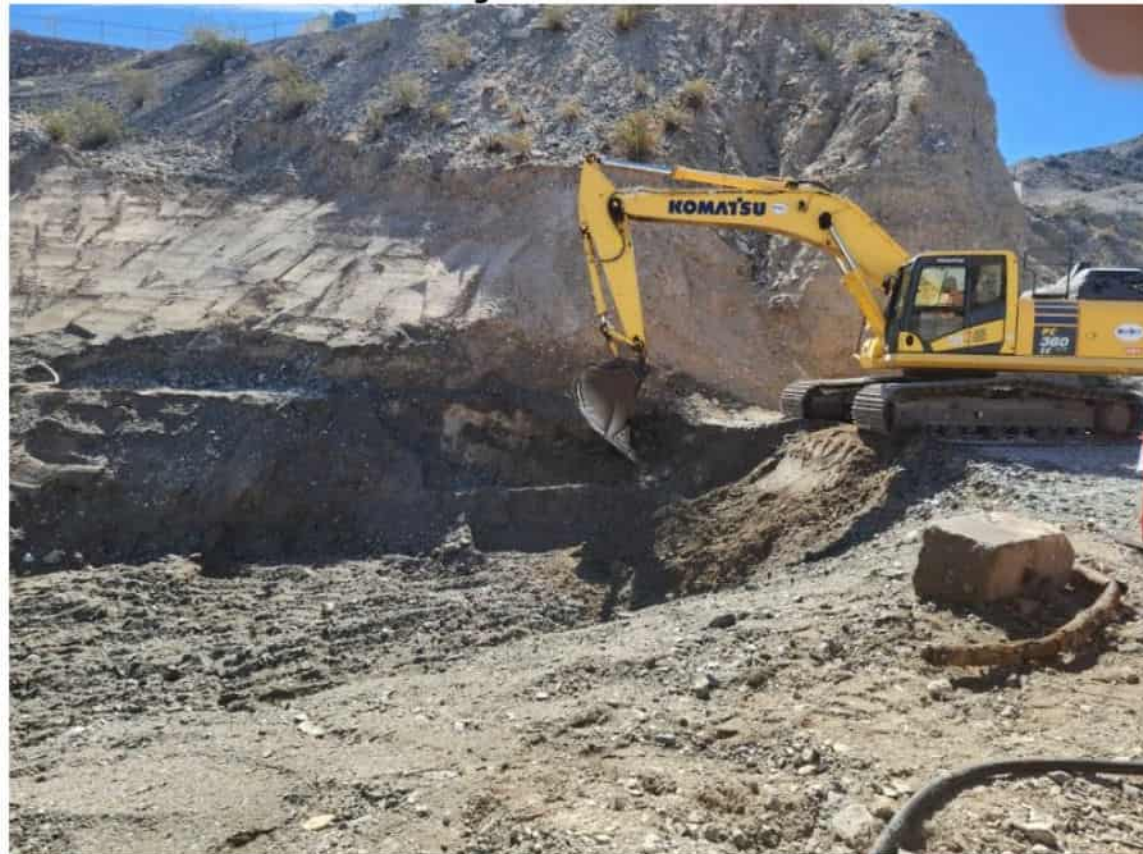
FIGURE I-1
SWMU1 TAA1 Site Photos
 Soil NTCRA Completion Report
 PG&E Topock Compressor Station
 Needles, California

SWMU1 TAA1 Visible white powder lens and greenish gray discolored soil - Facing Southeast

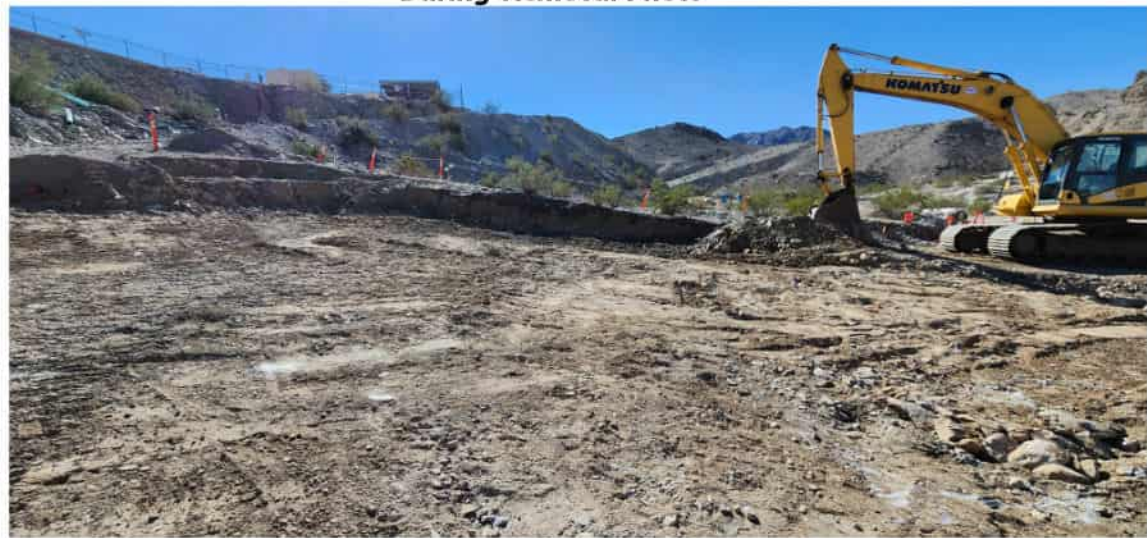
FIGURE I-2
SWMU1 TAA1 Site Photos
 Soil NTCRA Completion Report
 PG&E Topock Compressor Station
 Needles, California

SWMU1 TAA1 Step-out excavations to east of the TAA - Facing Southeast
