Soil Non-Time-Critical Removal Action Completion Report

Topock Compressor Station, Needles, California

Final

Pacific Gas and Electric Company

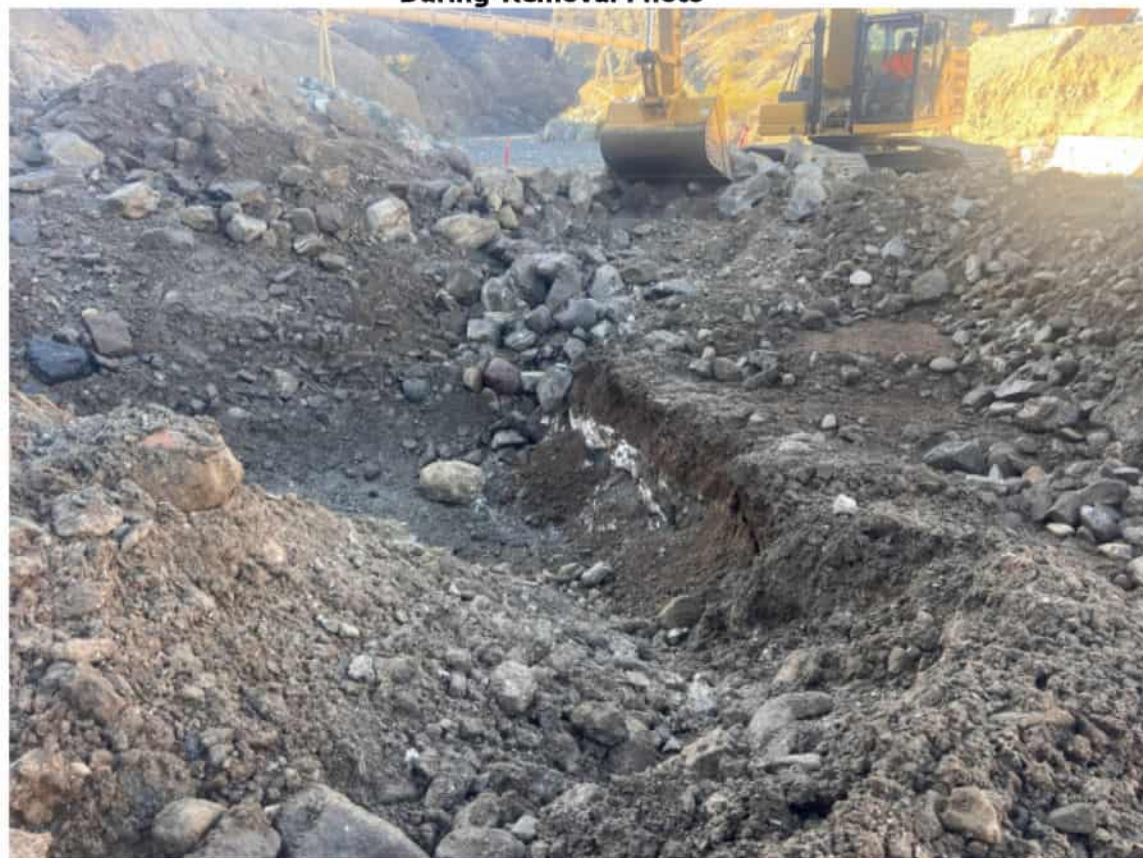
FIGURE I-3
SWMU1 TAA2 Site Photos
 Soil NTCRA Completion Report
 PG&E Topock Compressor Station
 Needles, California

SWMU1 TAA2 Visible white powder lens - Facing South

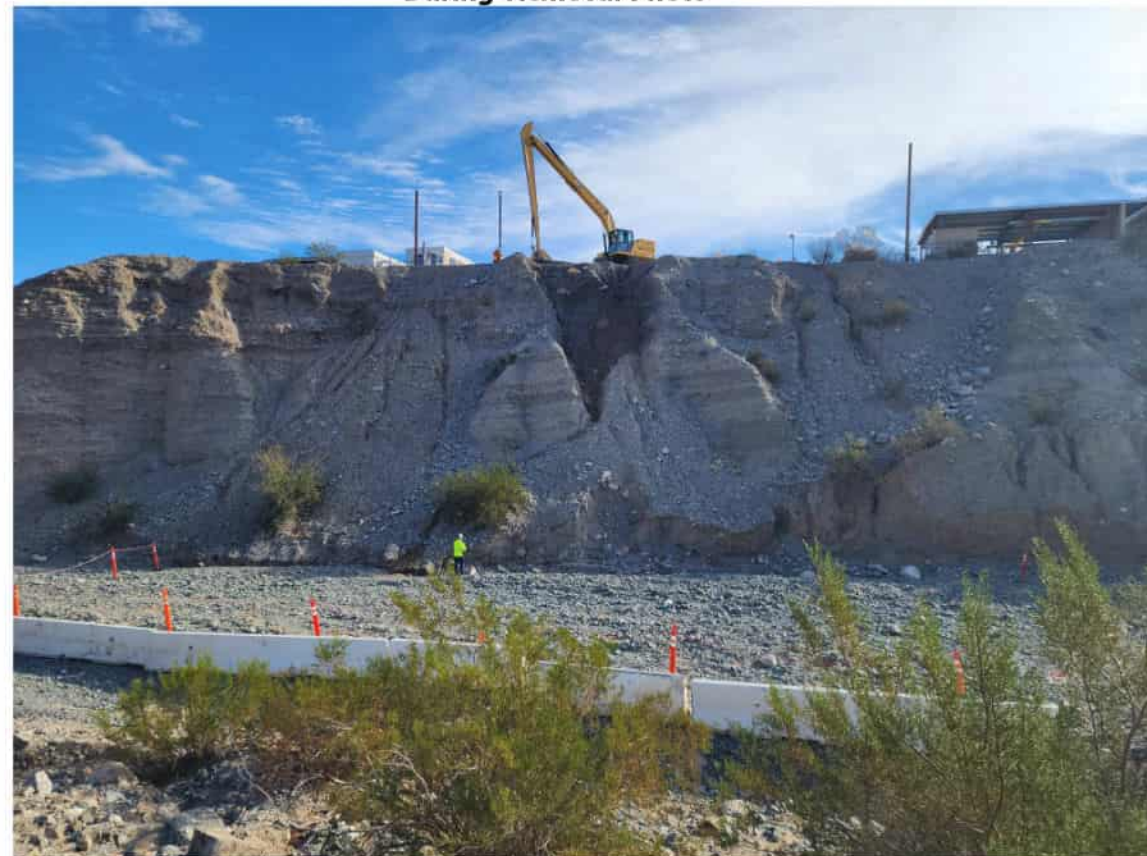
FIGURE I-4
SWMU1 TAA3 Site Photos
 Soil NTCRA Completion Report
 PG&E Topock Compressor Station
 Needles, California

SWMU1 TAA3 Initial excavation from top of slope - Facing East

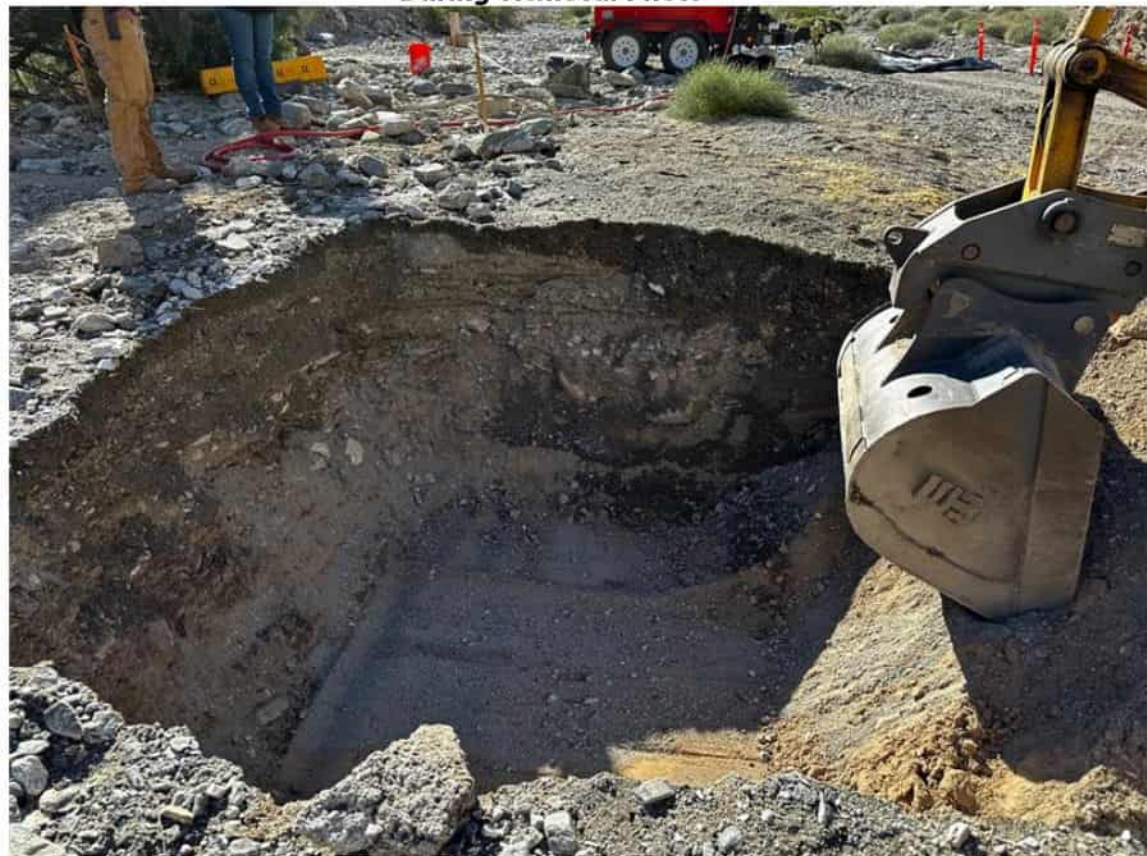
FIGURE I-5
AOC1 TAA1 Site Photos
 Soil NTCRA Completion Report
 PG&E Topock Compressor Station
 Needles, California

AOC1 TAA1 Initial excavation - Facing South

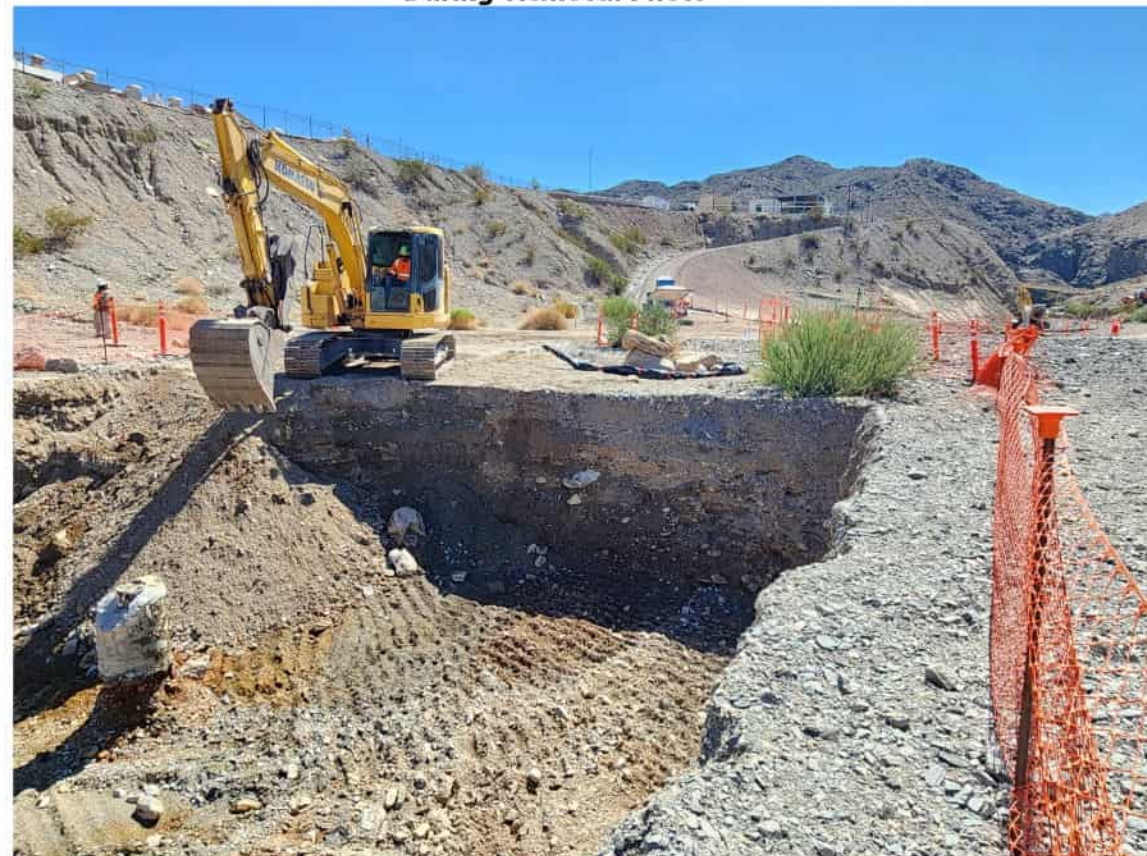
FIGURE I-6
AOC1 TAA2 Site Photos
 Soil NTCRA Completion Report
 PG&E Topock Compressor Station
 Needles, California

AOC1 TAA2 TCS-4 well uncovered and visible brownish orange discolored soil - Facing Southeast

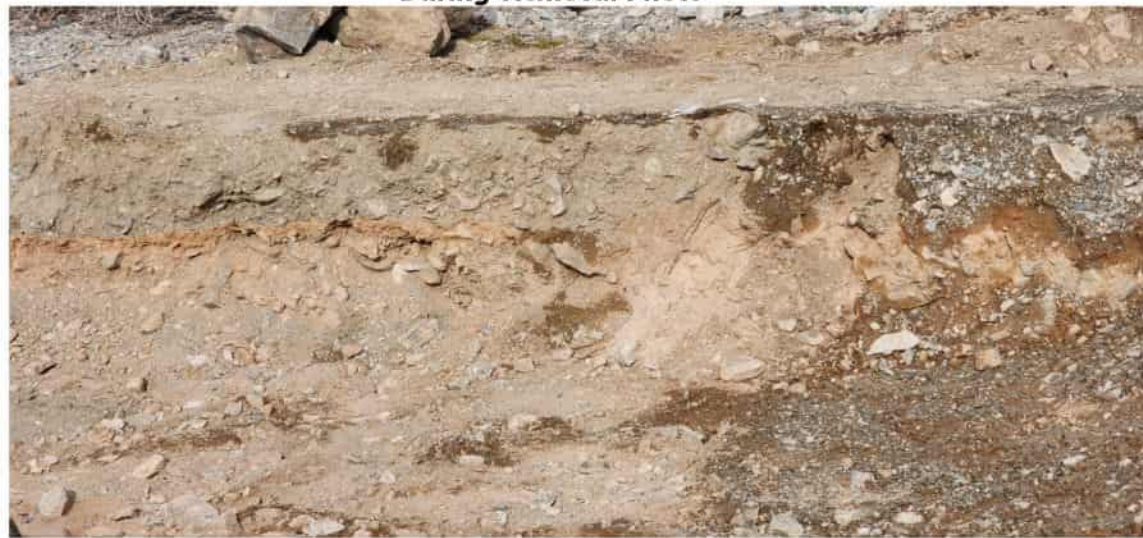
FIGURE I-7
AOC1 TAA3 Site Photos
 Soil NTCRA Completion Report
 PG&E Topock Compressor Station
 Needles, California

AOC1 TAA3 Visible greenish gray discolored soil - Facing Northeast

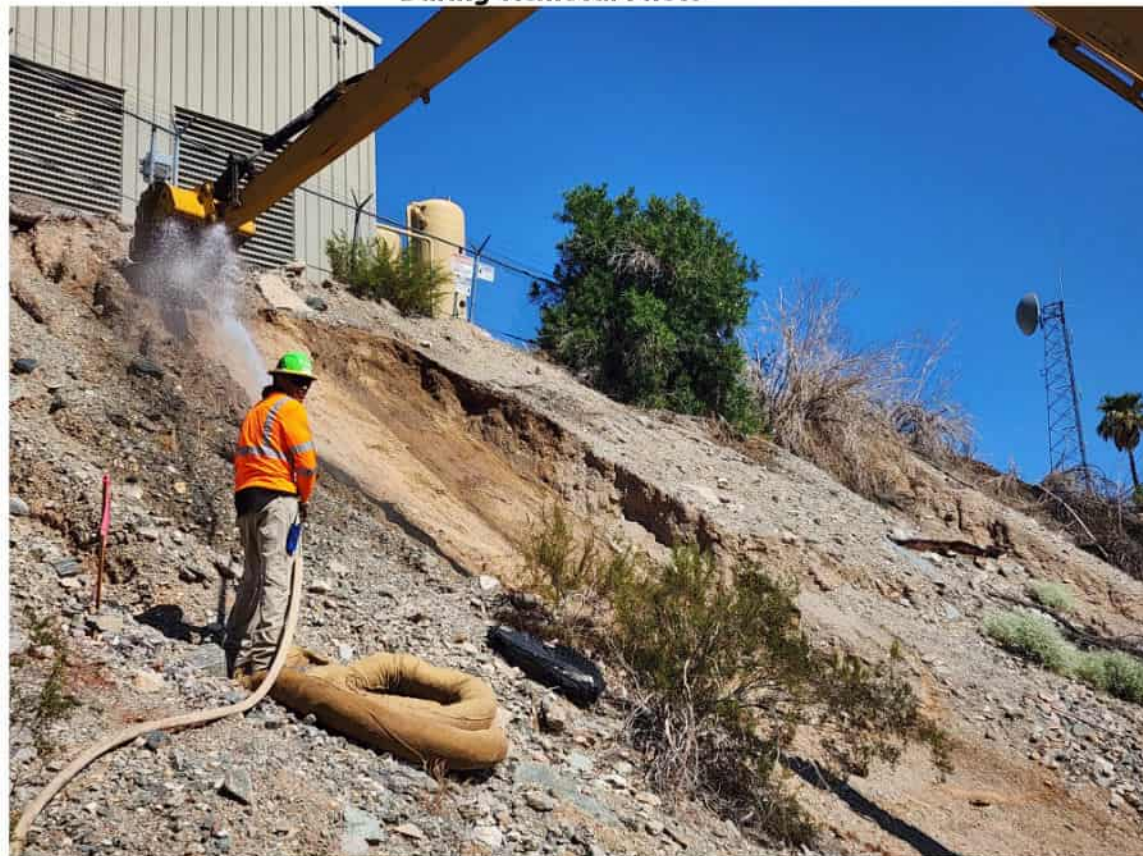
AOC9 TAA1 Initial excavation and debris removal - Facing North

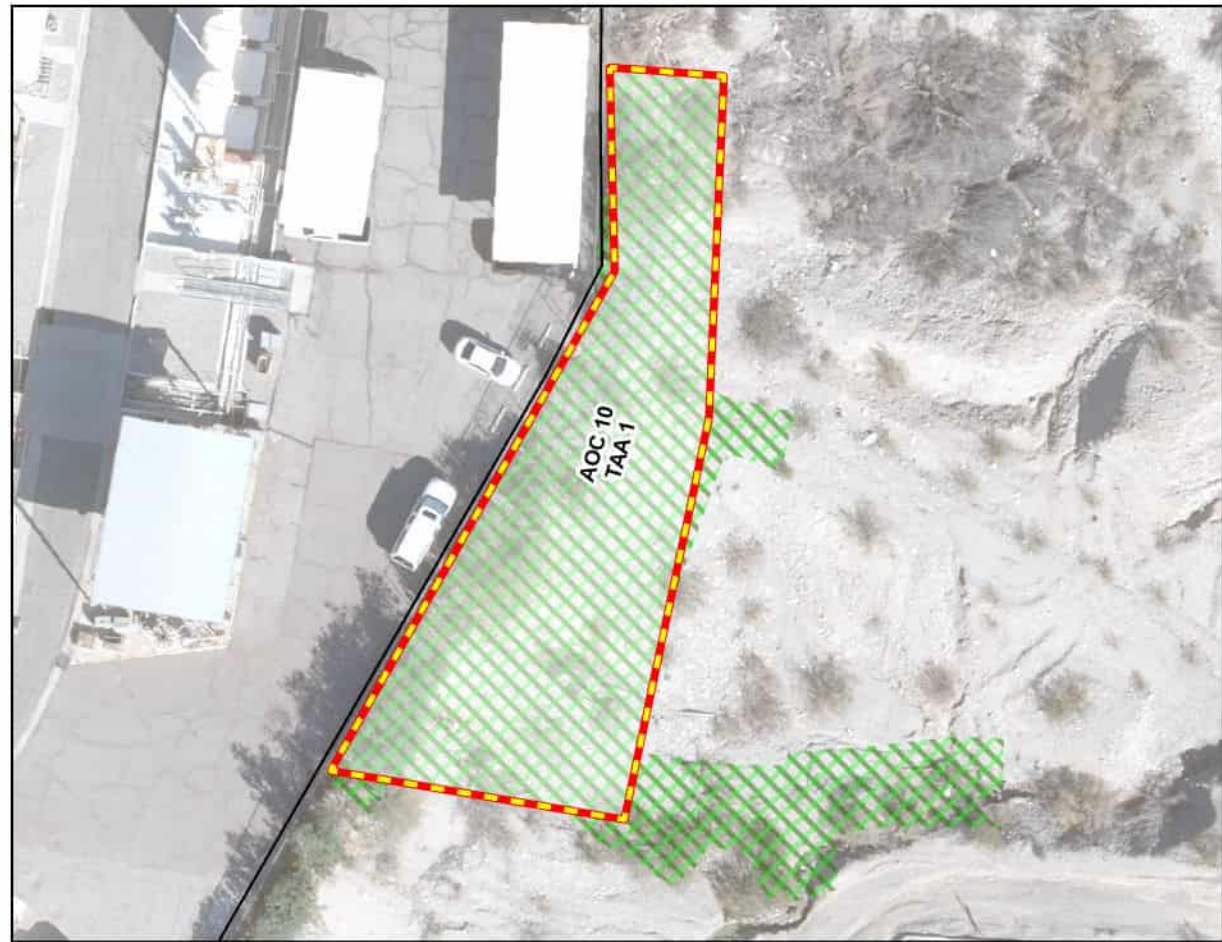
During-Removal Photo

AOC10 TAA1 Visible white powder and rust discolored soil - Facing West

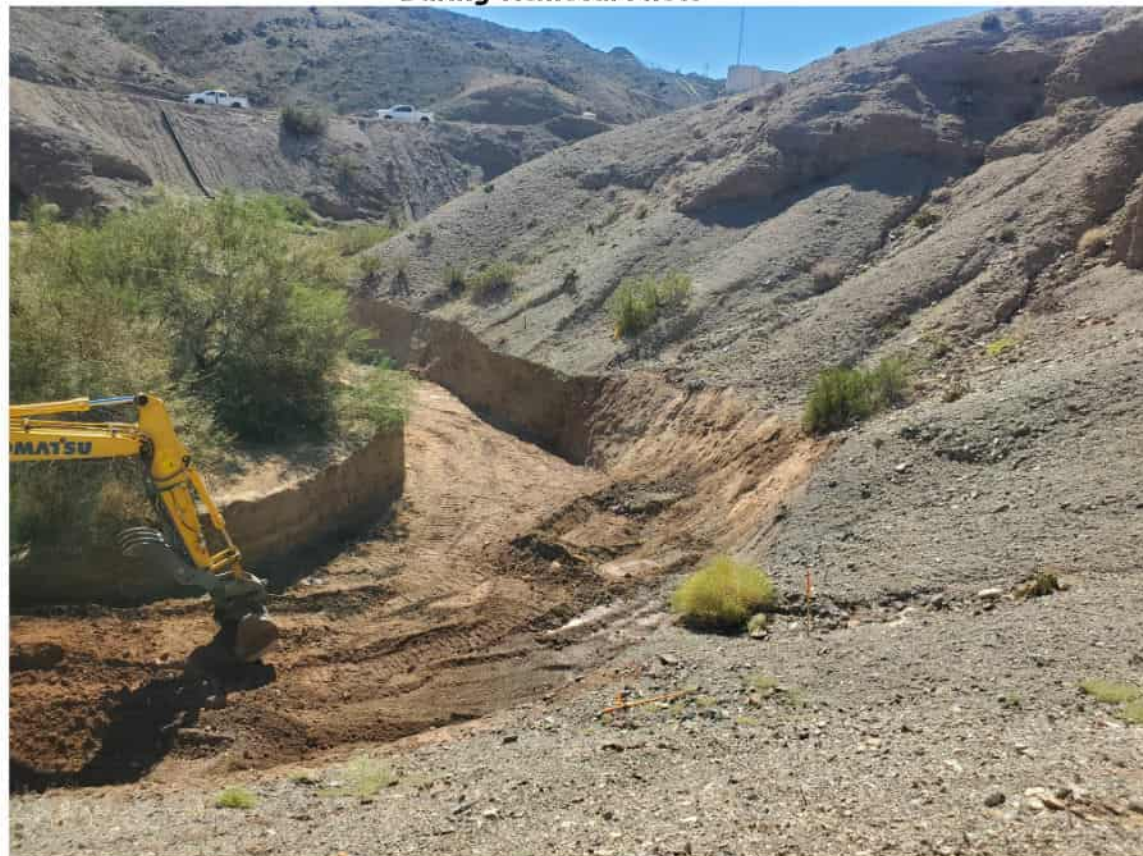
During-Removal Photo

AOC10 TAA2 Initial excavation around mesquite trees - Facing South

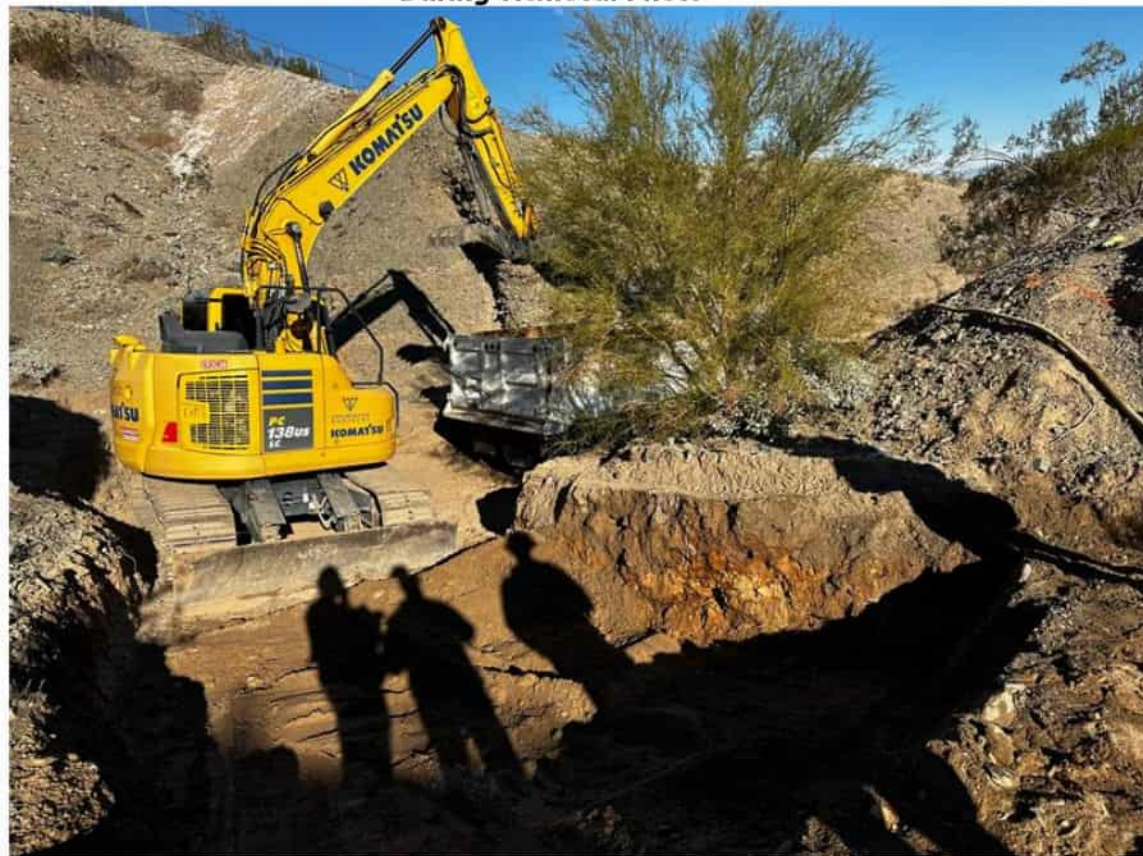
AOC10 TAA2 West end of excavation. Rust discoloration under Palo Verde tree - Facing Northeast

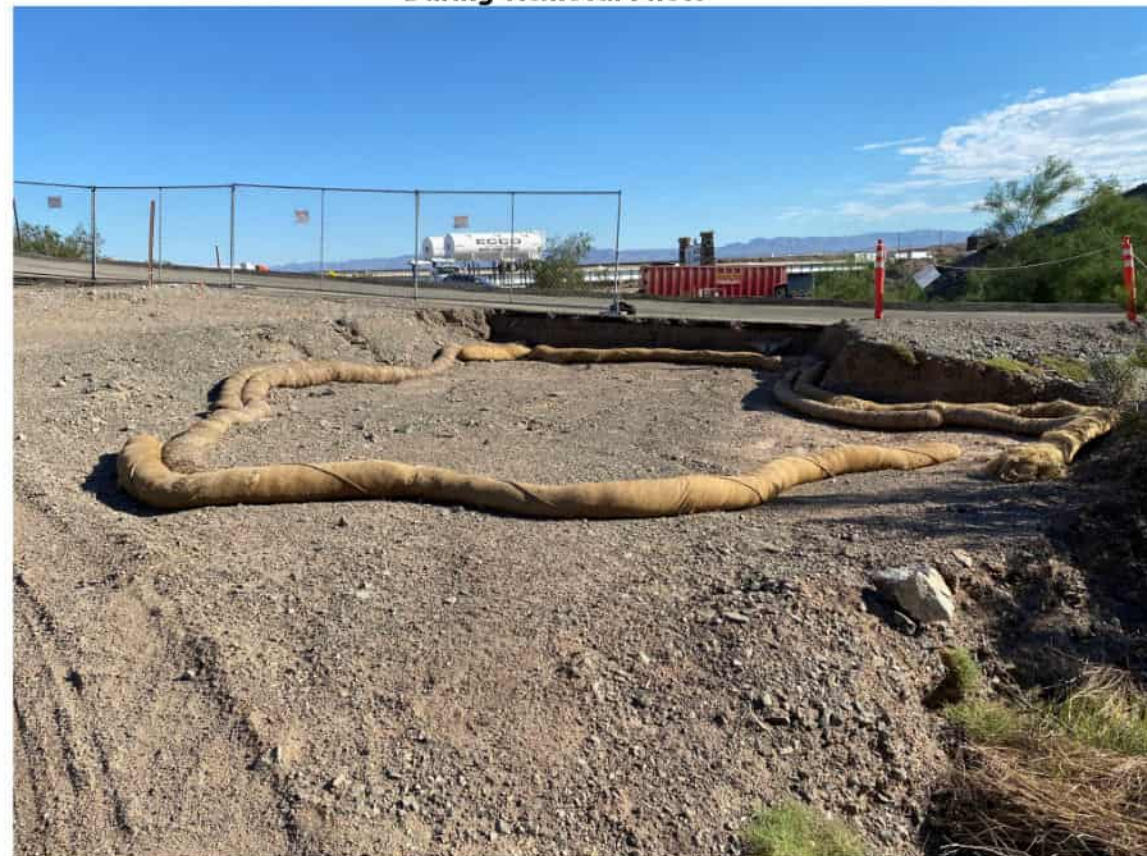
AOC10 TAA3 Initial excavation - Facing North

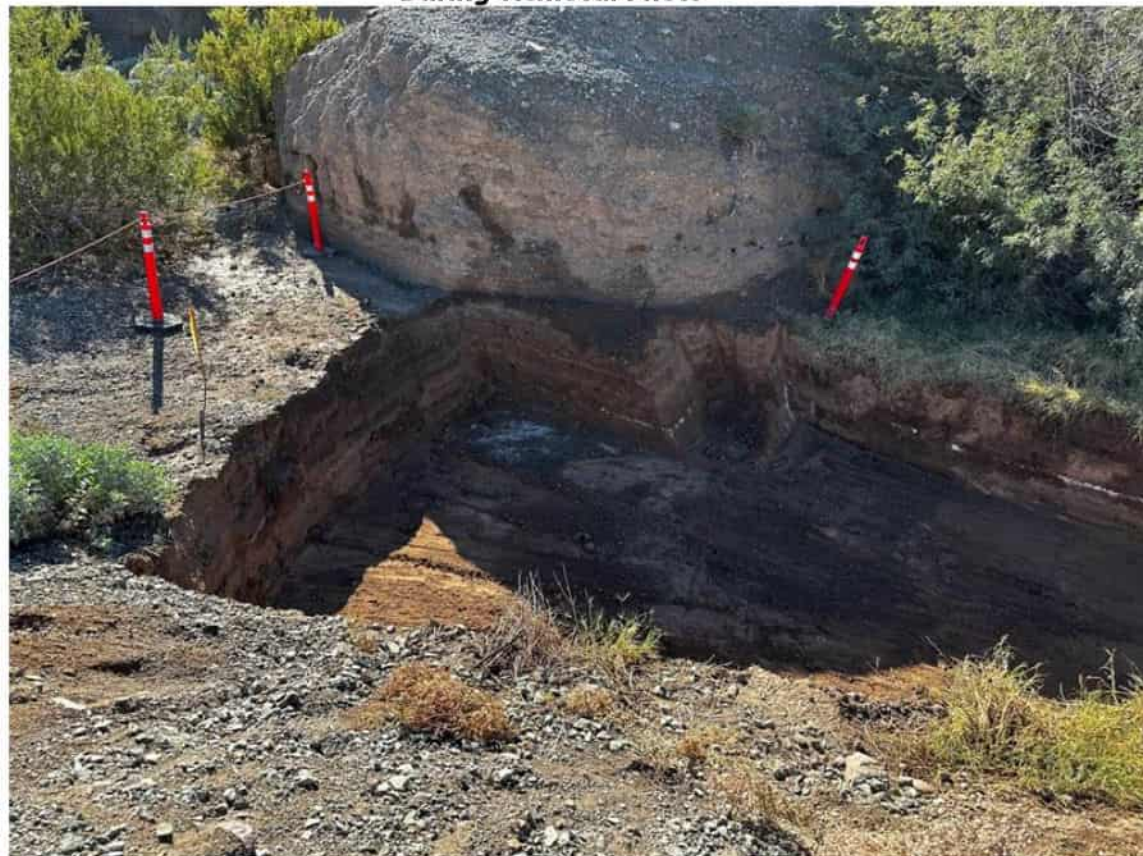
During-Removal Photo

AOC10 TAA4 Initial excavation and visible white powder lens - Facing Southwest

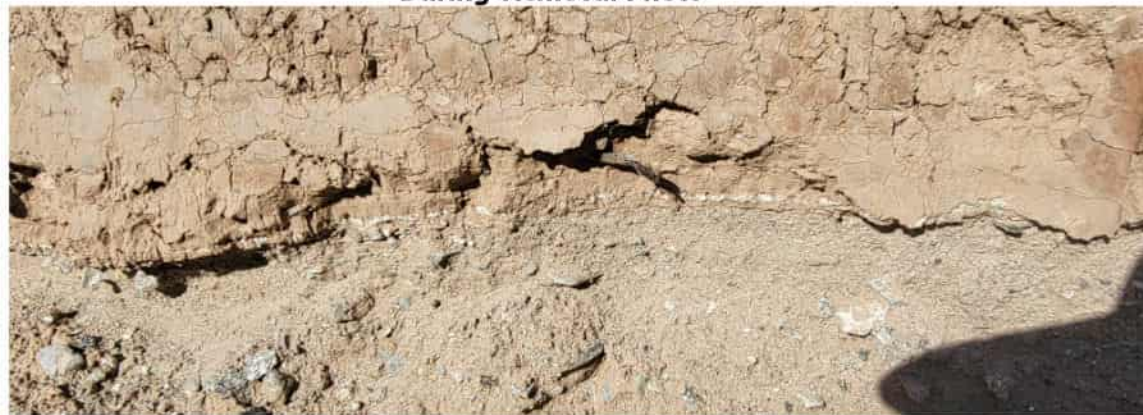
During-Removal Photo

AOC11 TAA1 Visible white powder lens - Facing Southwest

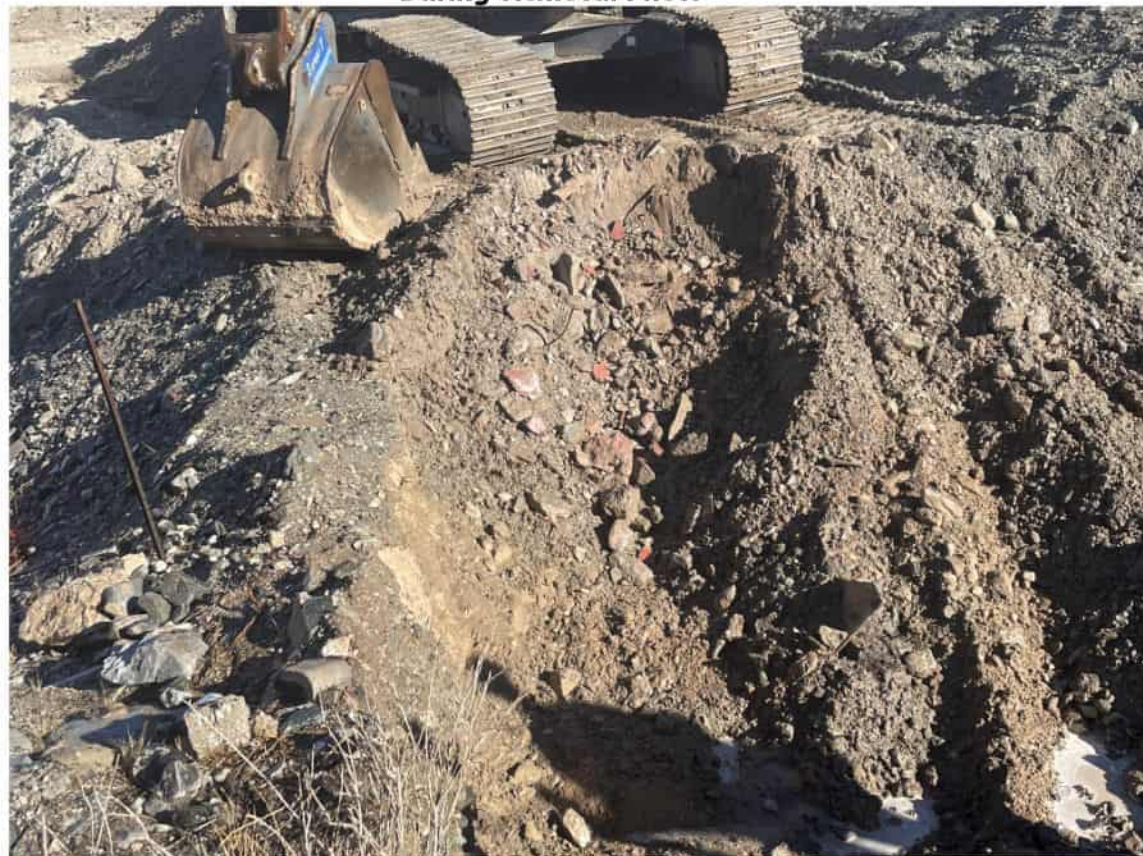
During-Removal Photo

AOC14 TAA1 Visible debris with potential ACM - Facing North

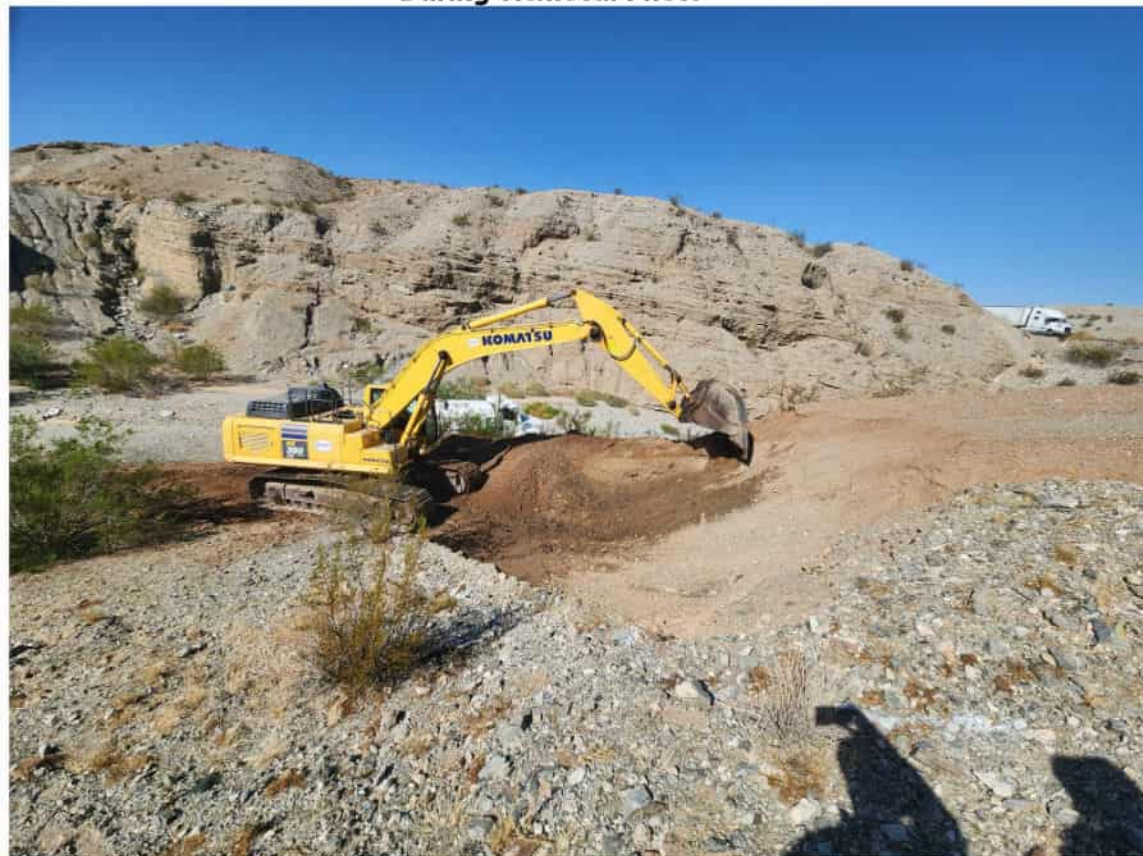
During-Removal Photo

AOC27 TAA1 Initial excavation - Facing West
