Pacific Gas and Electric Company

Topock Revegetation Year 2 Mitigation Monitoring Report

January 2025

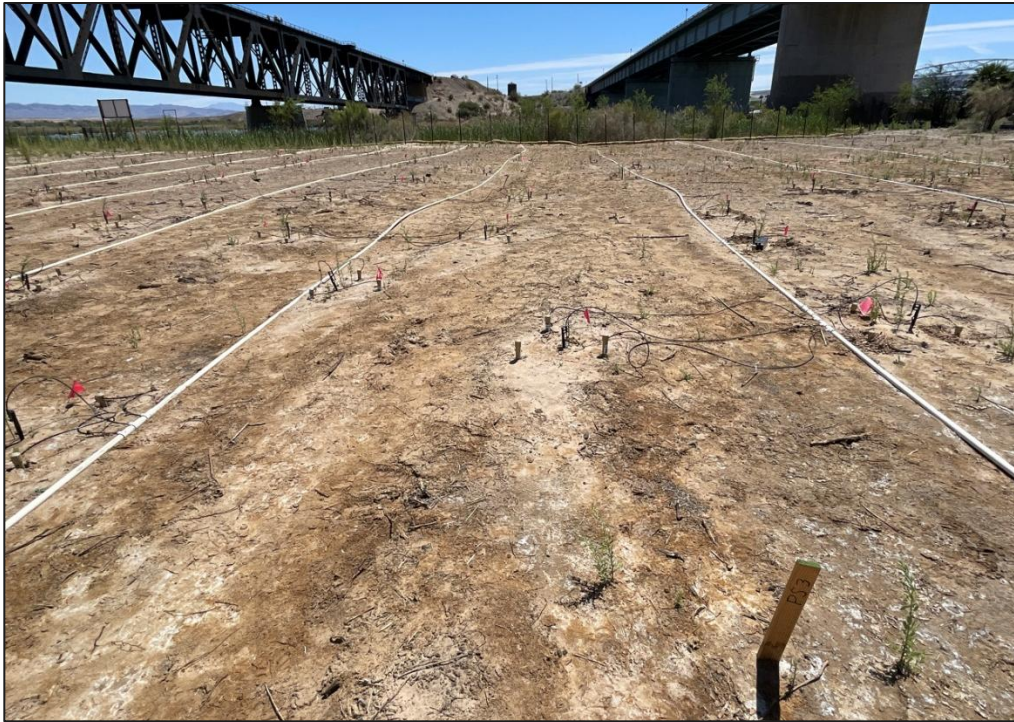
Photostation-003

Located in the center of Area 1 between the I-40 bridge and the railroad bridge

The greatest cover by mitigation plants in Area 1 occurs between the I-40 bridge and the railroad bridge: blue palo verde (25% cover), honey mesquite (7% cover), and screwbean mesquite (20% cover). This portion of Area 1 also supports large stands of arrowweed (25% cover). Volunteer mesquite mitigation plants tower over blue palo verde in this area, with some individuals reaching up to 14 feet tall and 11 feet wide.

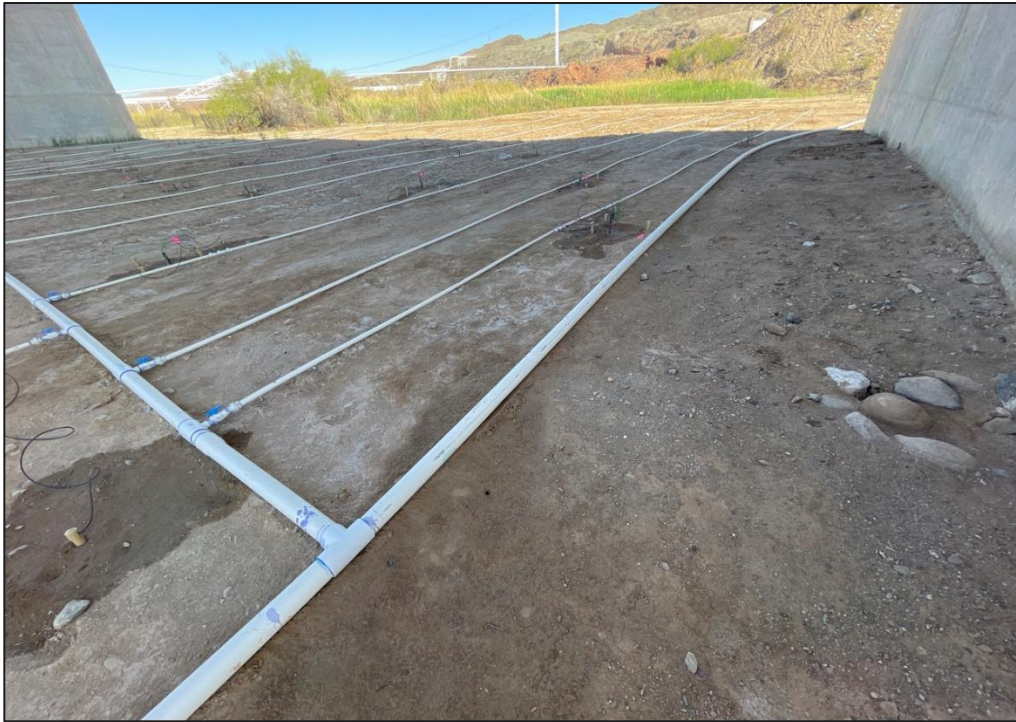
Photostation-004

Located in Area 2 in the northwest corner under the I-40 bridge

Area 2, like Area 1, was planted with blue palo verde and supports volunteer recruit mitigation plants of honey mesquite and screwbean mesquite. Cover in this section of Area 1 is dominated by blue palo verde (13% cover) with honey mesquite (3% cover) and screwbean mesquite (5% cover) mitigation plants. Arrowweed (10% cover) is scattered throughout this portion of Area 2.

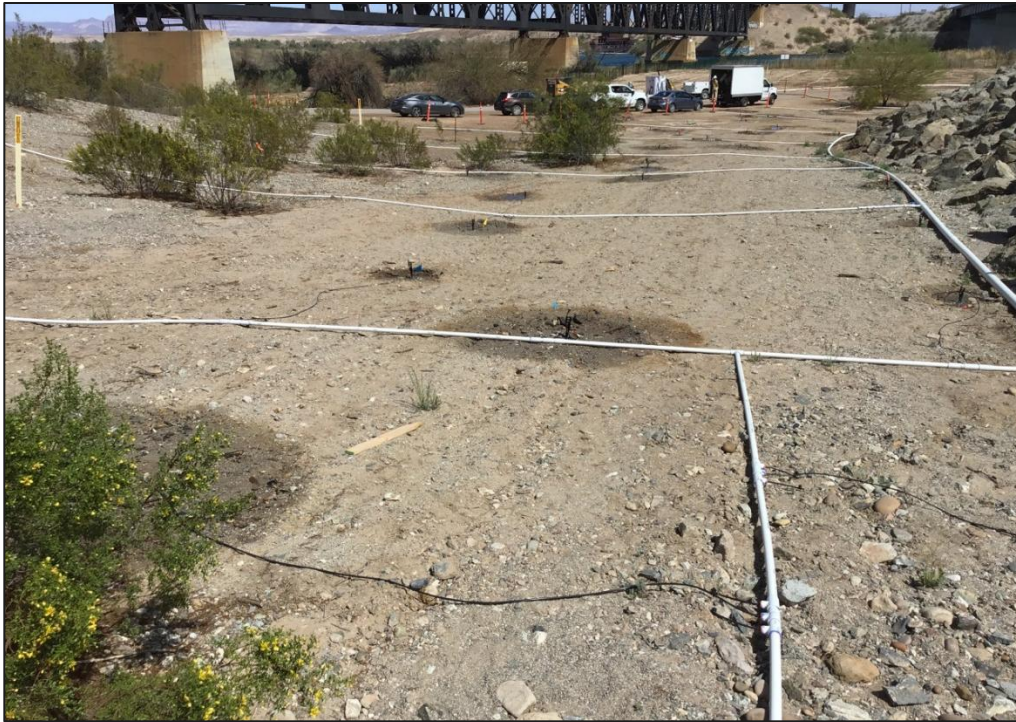
Photostation-009

Located in Area 5 along the southern perimeter

Area 5 supports mitigation plantings of blue palo verde (2% cover), desert smoke tree (4% cover), and catclaw acacia (1% cover), as well as honey mesquite and screwbean mesquite mitigation plants originating from volunteer recruits (10% cover, including a large existing honey mesquite tree that occurs in this area, not shown in photo). Area 5 also supports mature naturally-occurring shrubs, including cheesebush, sweetbush, and creosote bush. Like Area 3, Area 5 experiences elevated water flow during heavy rain events.
