Topock Project Executive Abstract

Soil RCRA Facility Investigation/Remedial Investigation, Riparian and Sensitive Habitat Impact Evaluation, Topock Compressor Station, California

PREPARED FOR:	Virginia Strohl/PG&E
PREPARED BY:	Steve Long/CH2M and Brandy McWain/Transcon
COPIES:	Marjorie Eisert/CH2M
DATE:	May 26, 2017

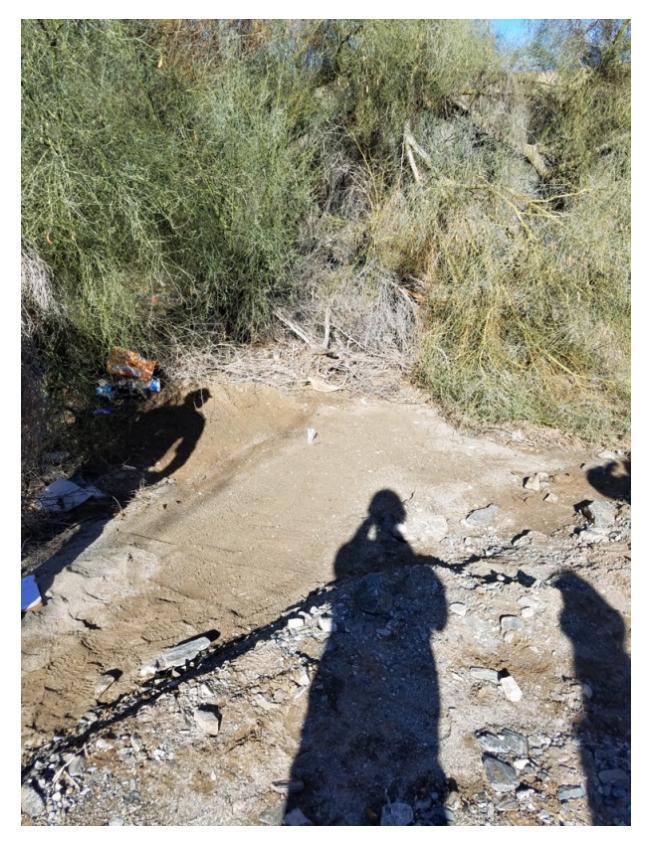
Photo 1. Example of AOC 1 hand sample site in Bat Cave Wash

Hand Samples at Two Locations (see Photos 1, 2, and 3). All hand sampling work was conducted with soil augers or shovels and occurred in previously disturbed or non-vegetated habitats. No native, perennial vegetation was trimmed or removed for these activities at any locations. For these reasons, no impacts to riparian or floodplain habitat occurred within Bat Cave Wash during hand sampling.

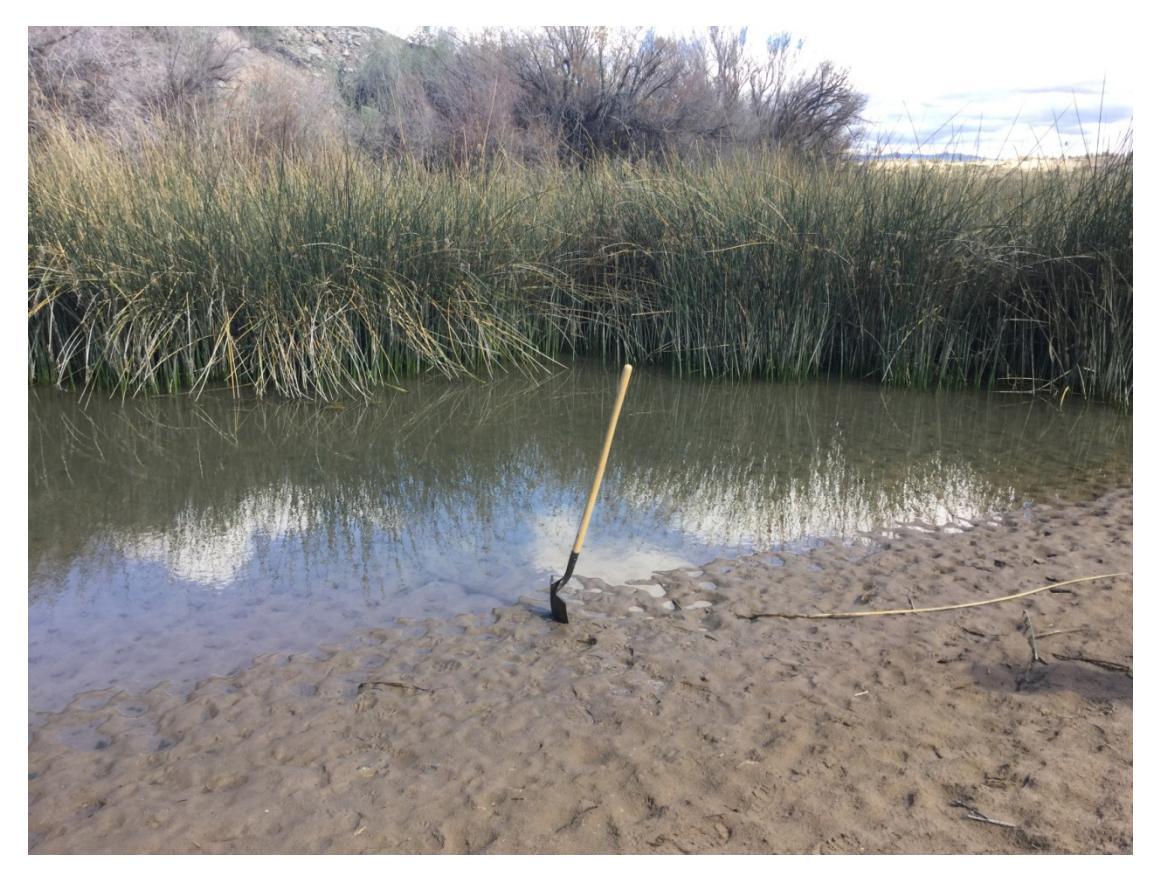
Photo 2. Hand sample site at AOC 1-32 near the mouth of Bat Cave Wash before sampling

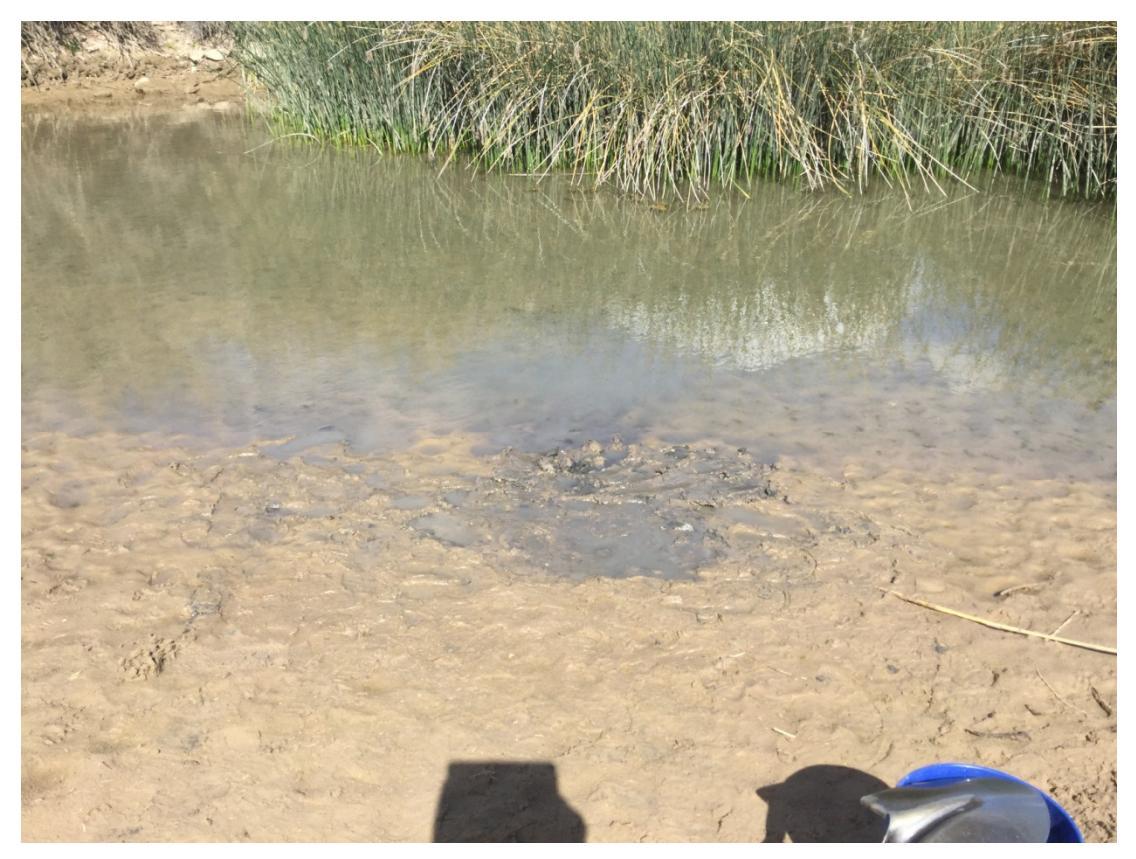
Photo 3. Hand sample site at AOC 1-32 near the mouth of Bat Cave Wash after sampling

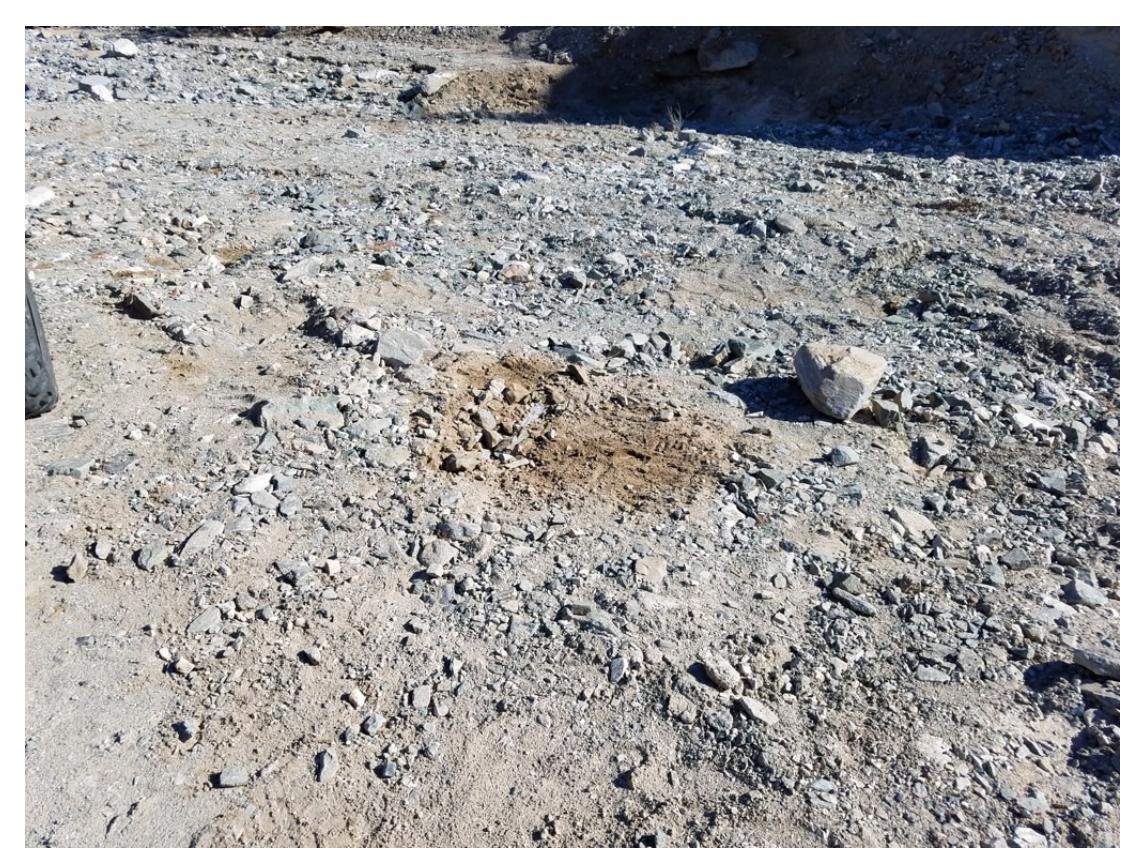
Photo 4. Example of AOC 1 bore sample site in Bat Cave Wash after completion

Drill Sites (Borehole samples) at 35 Locations (see Photo 4). All borehole sample sites occurred within previously disturbed access routes in Bat Cave Wash. As part of the work within Bat Cave Wash, six bore samples were taken in the wash on the western edge of AOC 4. The trimming of one palo verde located in Bat Cave Wash was required, about half way between IM3 and the tamarisk thicket at the mouth of Bat Cave Wash, to clear the access route to sample AOC 1-7. In order to reduce the amount of trimming

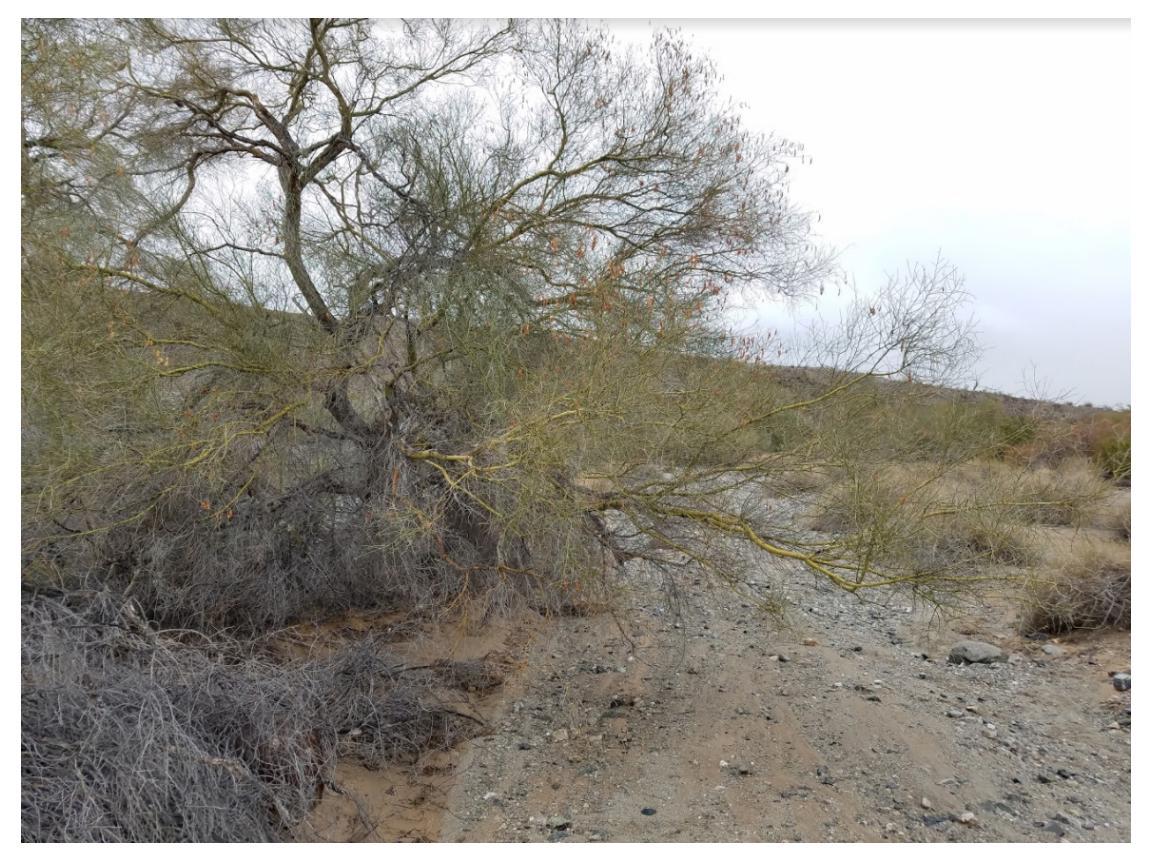
Photo 5. Before palo verde was trimmed for access to AOC 1-7 drill site

required, the branches of the palo verde were pulled back and tied off at the base of the tree so that the overall trimming needed was less than 1 percent of the overall crown of the tree (see Photos 5 and 6). No other native, perennial vegetation was trimmed or removed at any other locations for any activities conducted in the jurisdictional features of Bat Cave Wash. For these reasons, no impacts to riparian or floodplain habitat occurred within Bat Cave Wash during drilling activities.

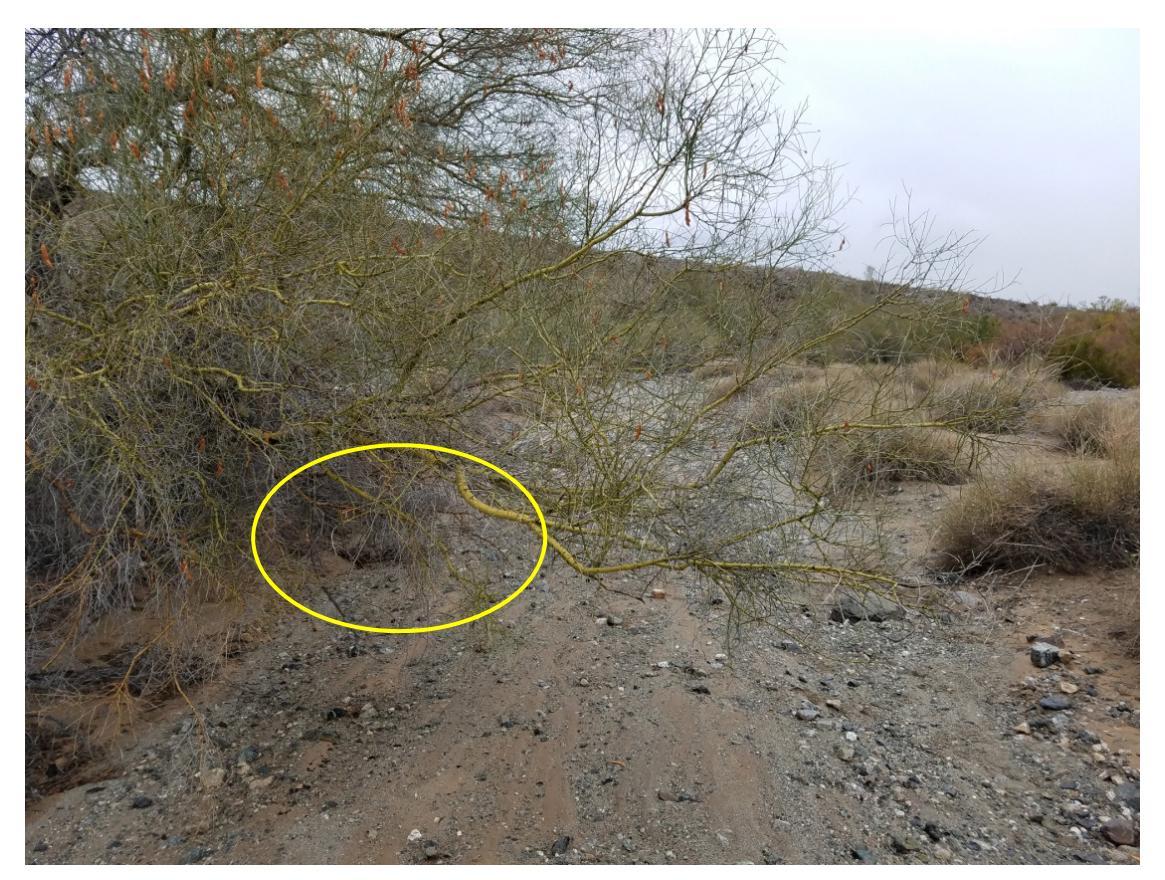
Photo 6. After trimming the palo verde for access to AOC 1-7 drill site

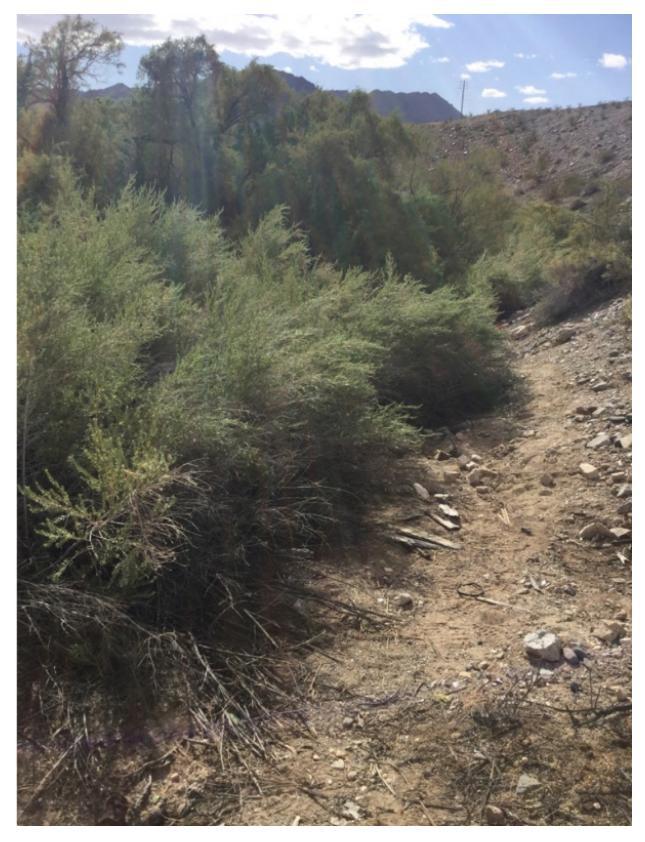
Photo 7. Before arrow weed was trimmed for access to the mouth of Bat Cave Wash drill sites

There was some pruning of arrow weed within the jurisdictional waters of Bat Cave Wash to access a drill location along the right (southeast) side of Bat Cave Wash. Arrow weed was pruned to approximately 1 to 1.5 feet above the ground surface to allow re-sprouting. By avoiding complete removal of the arrow weed plants or roots, this pruning did not result in a permanent disturbance or loss of riparian habitat (see Photos 7 and 8). For these reasons, the limited vegetation clearing described here did not qualify as a riparian habitat loss associated with borehole sampling.

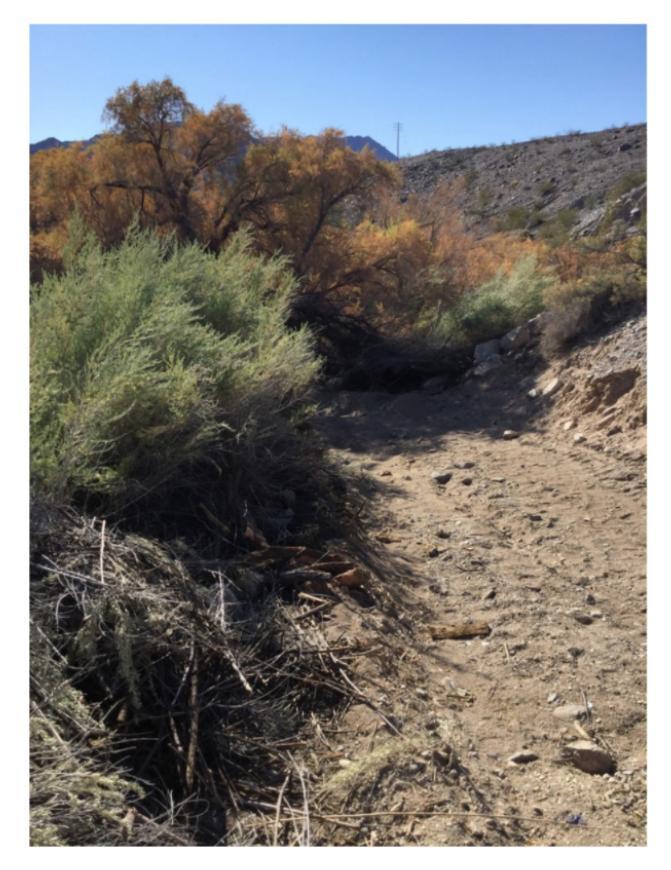
Photo 8. Trimming of arrow weed for access to the drill sites within the tamarisk in Bat Cave Wash

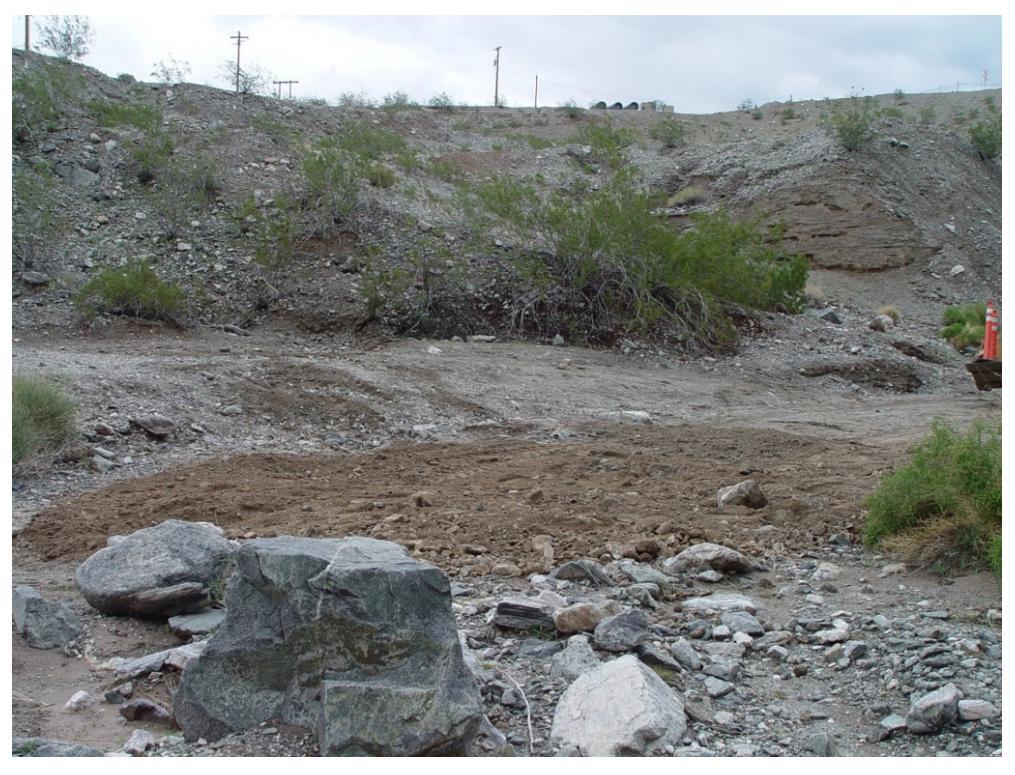
Photo 9. Example of AOC 1 excavation sample site within Bat Cave Wash after backfill

Trenching at Three Locations (see Photo 9). Soil samples were collected from three 4-foot-wide trenches within Bat Cave Wash that ranged in length from approximately 12 to 15 feet long and were all about 10 feet deep. All trenches within Bat Cave Wash were located within the previously disturbed access routes and no native, perennial vegetation was trimmed or removed for these activities at any locations. For these reasons, no impacts to riparian habitat or floodplain occurred within Bat Cave Wash during trenching.

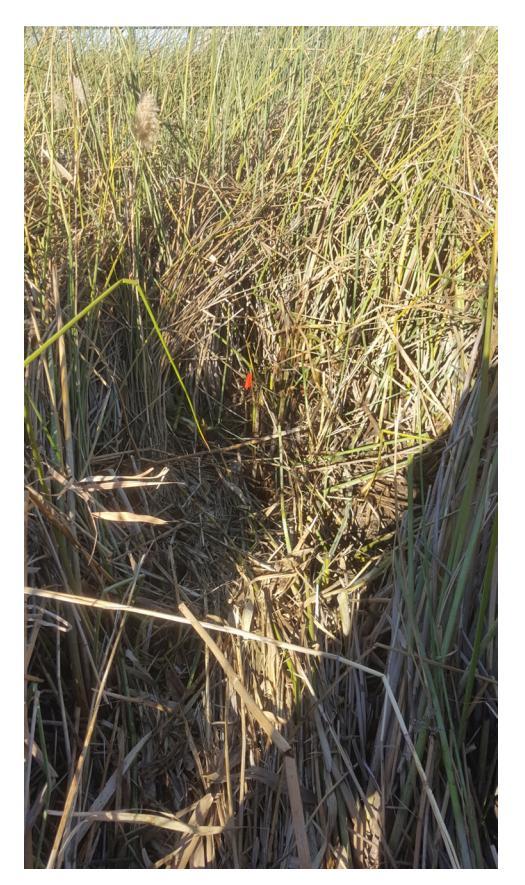
Photo 10. East Ravine Pore Water sample site 8 after clearance

The pore water samples were collected at 10 locations (see Photo 10) within the adjacent, emergent wetland vegetation that occurs within the 100-year floodplain of the Colorado River, and are discussed below as they relate to jurisdictional wetland and floodplain habitat impacts.

Pore water samples were collected along the edge of the Colorado River near East Ravine. Limited clearing of the tules (*Schoenoplectus californicus*) at ten separate locations that were accessed on foot. Pore water samples of the sediment were collected using a narrow, hollow rod with a sampling head and tube to within the pore water sample. This sampling rod was pounded into the ground using hand tools. To gain access to the river sediment for these pore water samples, an area of approximately 5 by 5 feet was created by pushing over the tules rather than cutting them. Only the tules that were in the immediate location around the sample hole were cut to permit access to the pore water sample location. No more than 10 tules stems at each sample location were cut just above ground level with the root balls left intact. All pre-clearing activities were conducted under the supervision of the qualified biologist and, by leaving the tules roots intact, these activities did not result in wetland or floodplain habitat loss or permanent disturbance.

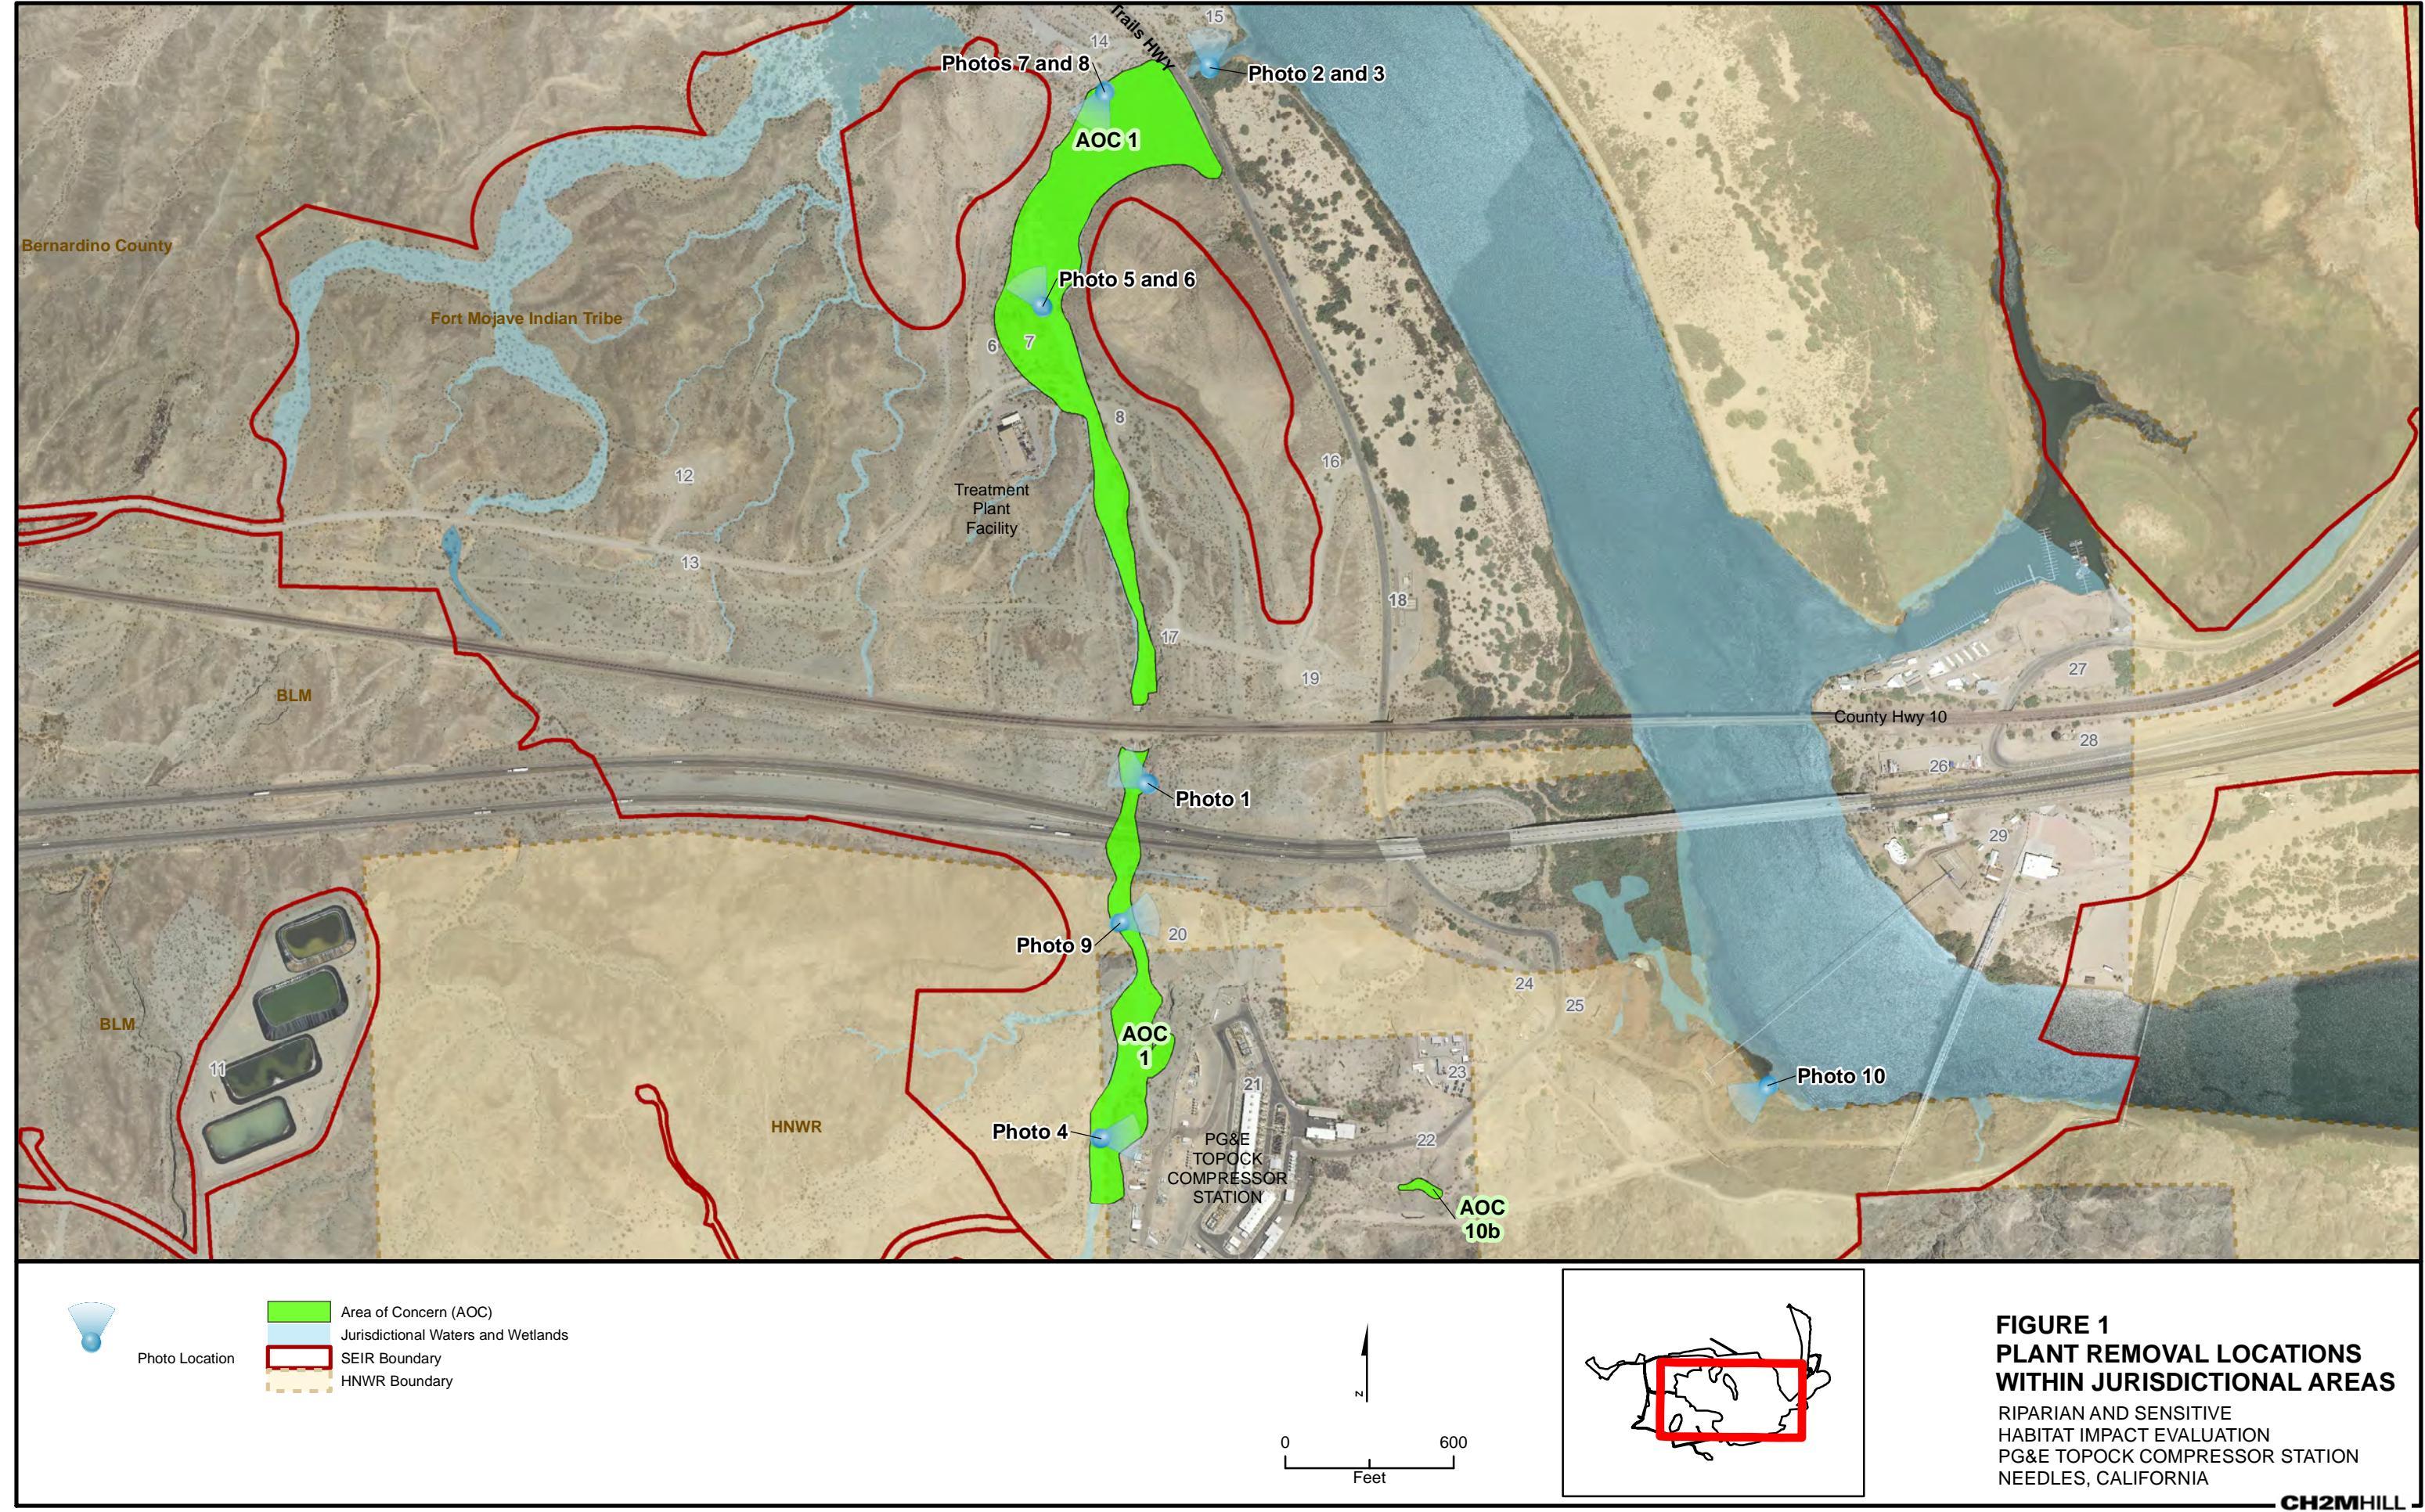
All disturbance was categorized under either riparian, floodplain habitat, WOUS or wetland impacts. Impacts were assessed based on the habitat type. If the site was previously disturbed, then additional impacts to these sites from soil investigation activities were not considered as additional disturbance. The assessment of upland habitat impacts is not included as part of this memorandum. The locations where some vegetation removal was required within jurisdictional areas is described in the following section and are shown on Figure 1.
