Subject: April 2022 Monthly Progress Report for the Final Groundwater Remedy Construction and Startup, PG&E Topock Compressor Station, Needles, California
(Document ID: TPK_Monthly_Progress_Rpt_April_2022_20220510)

April 2022
Monthly Progress Report for the
Final Groundwater Remedy Construction and Startup

PG&E Topock Compressor Station
Needles, California

Document ID: TPK_Monthly_Progress_Rpt_April_20220510

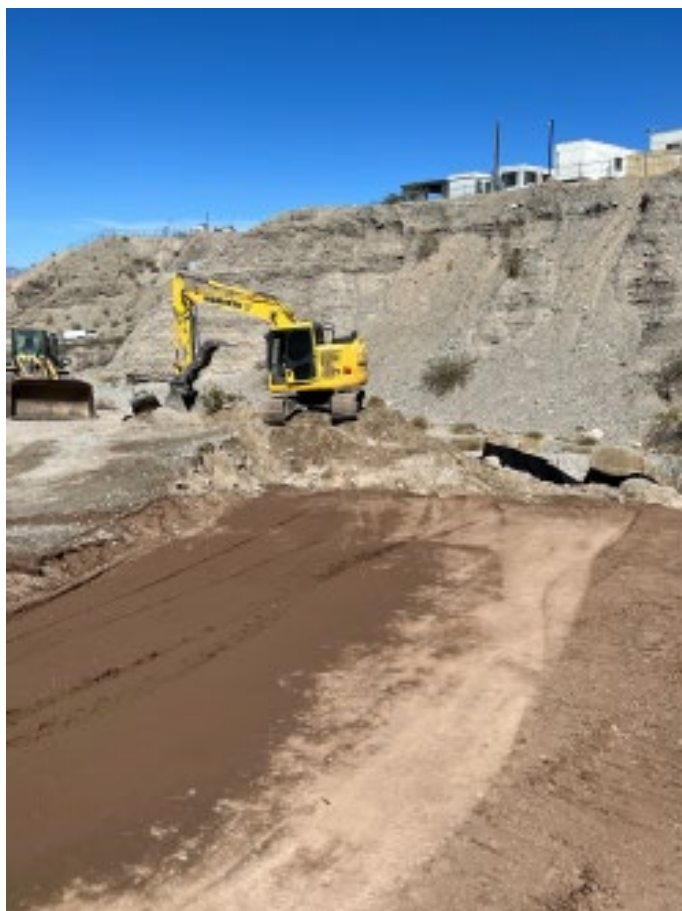
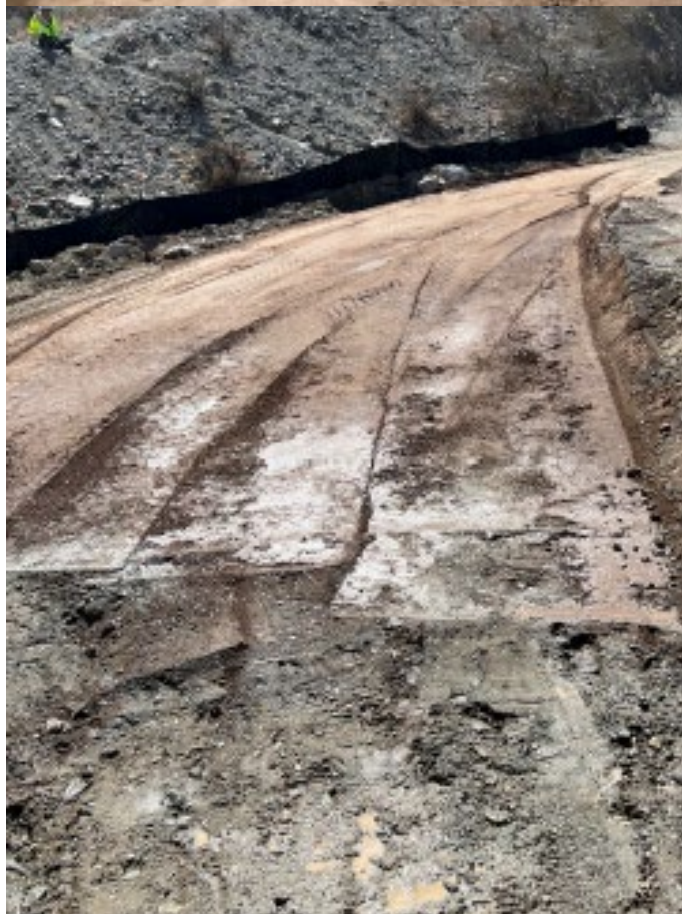
**Pictures of site
preparation at FW-2
drilling location**

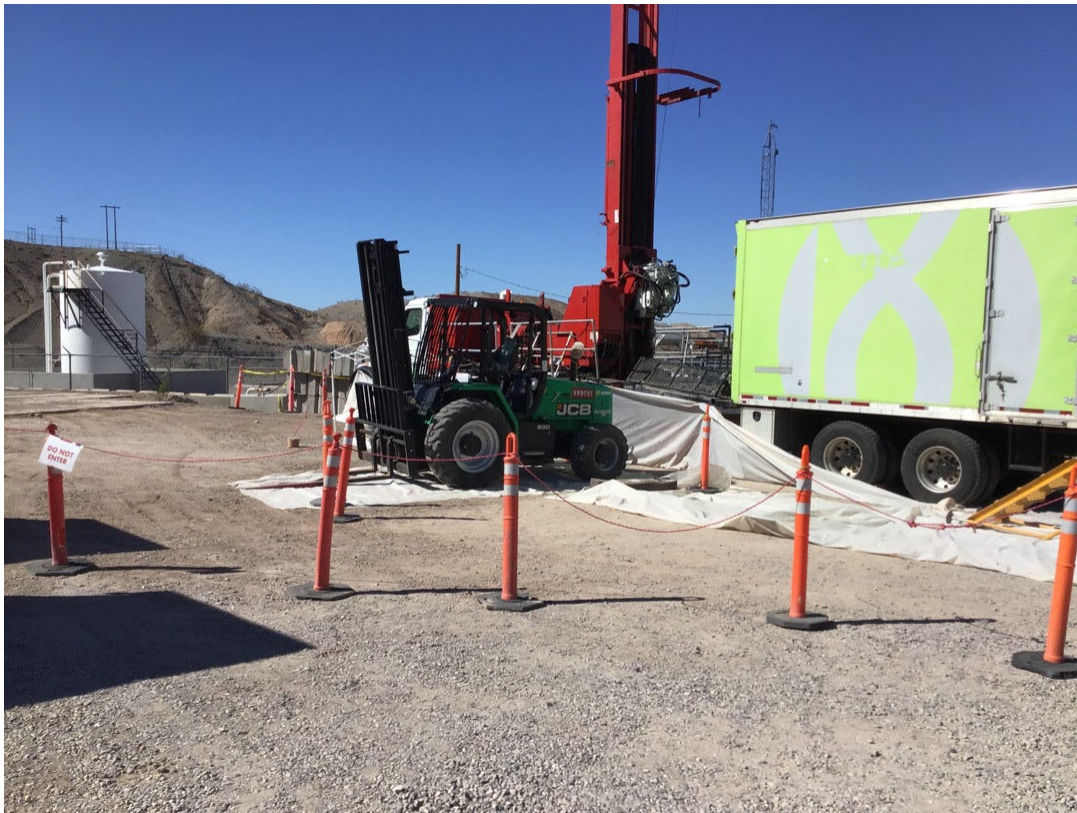
Photo showing
drill rig at the
Transwestern
Bench

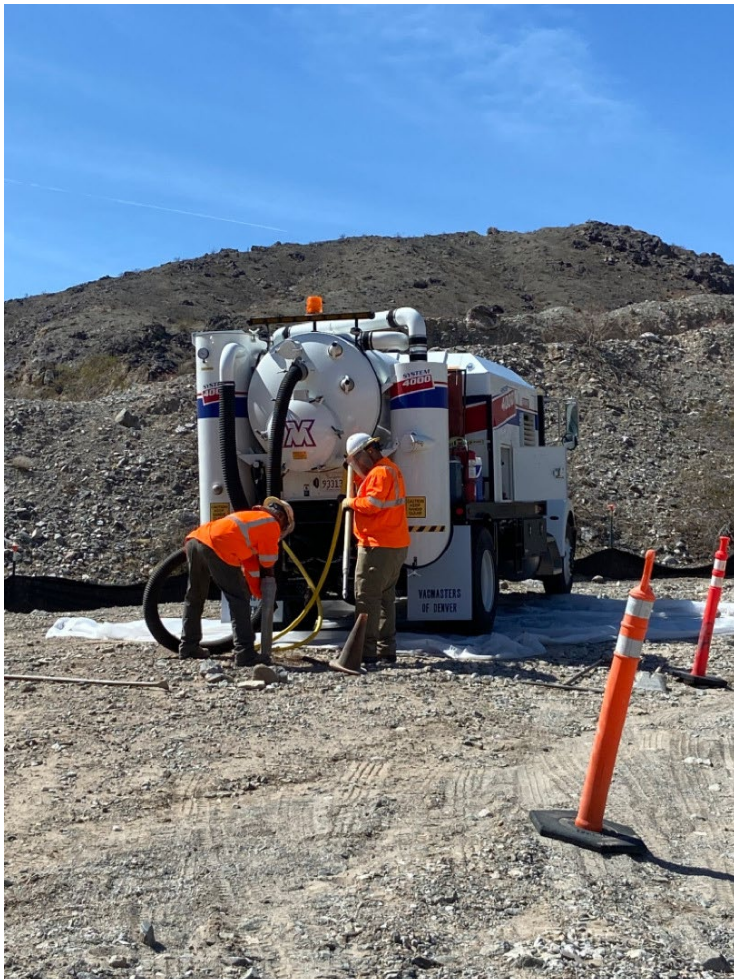
Photo showing
potholing at FW-2
drilling location

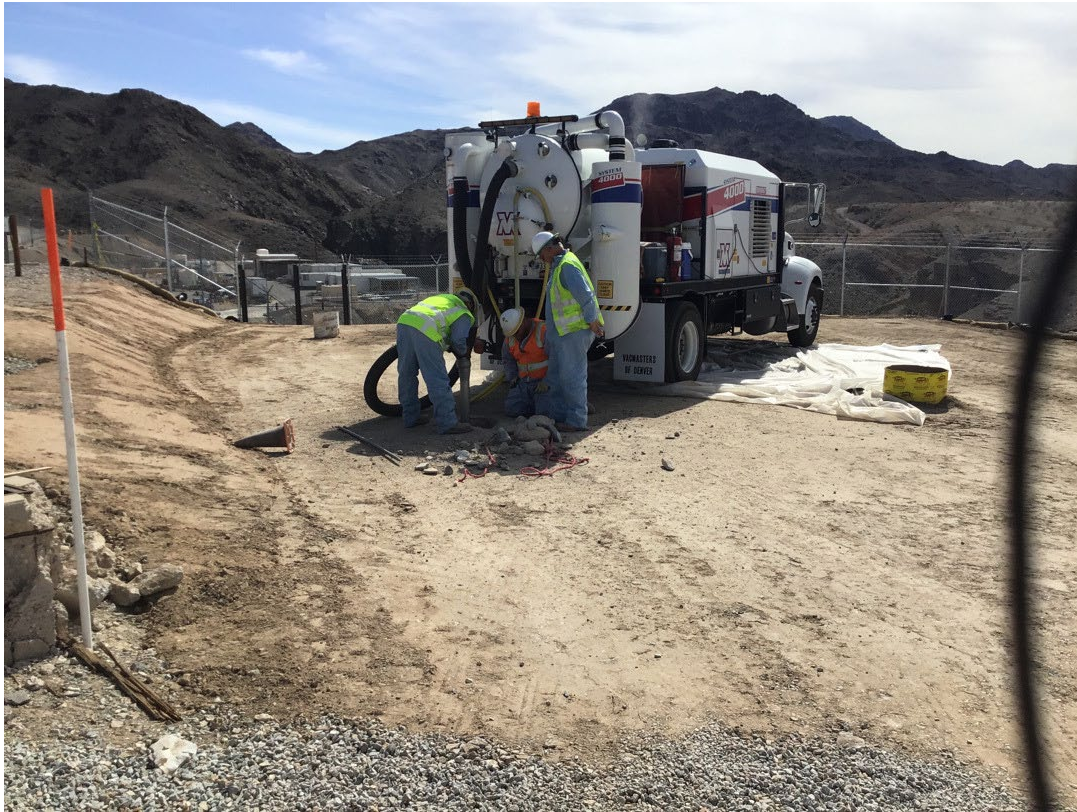
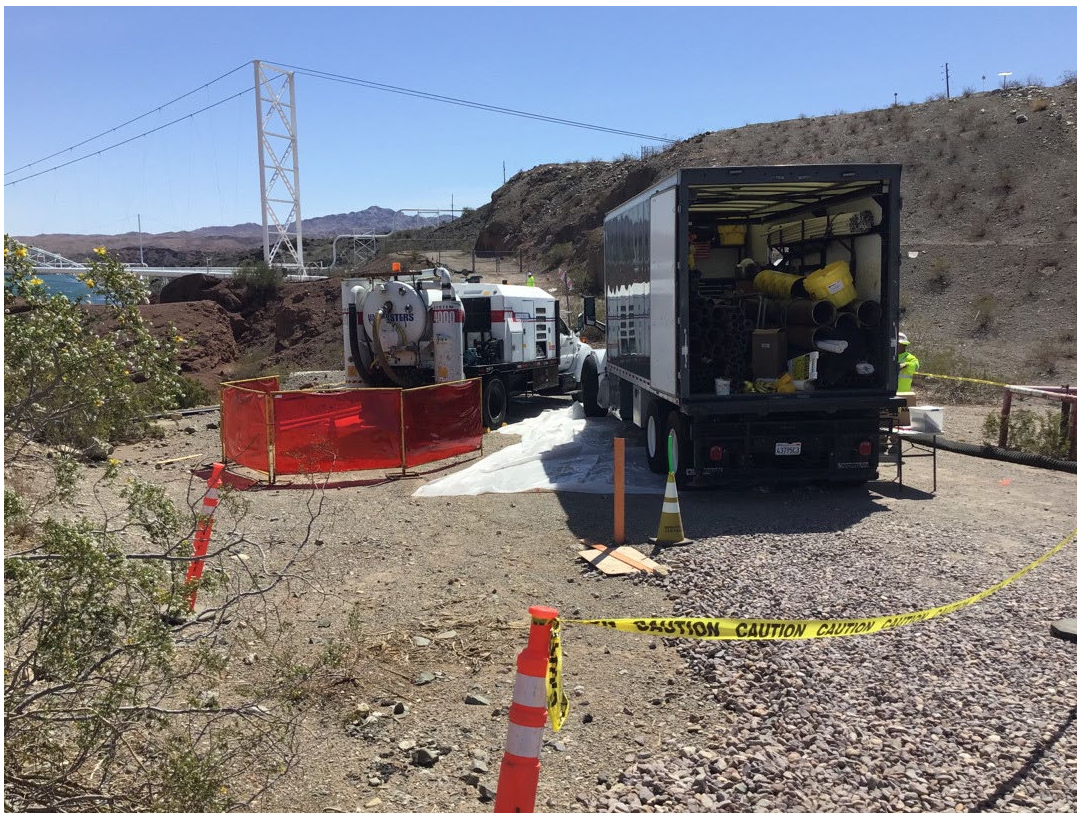
Photos showing potholing at TCS-1 and ER-1 drilling locations.
