Subject: December 2023 Monthly Progress Report for the Final Groundwater Remedy Construction and Startup, PG&E Topock Compressor Station, Needles, California
(Document ID: TPK_Monthly_Progress_Rpt_January_2024_20240110)

December 2023
Monthly Progress Report for the
Final Groundwater Remedy Construction and Startup

PG&E Topock Compressor Station
Needles, California

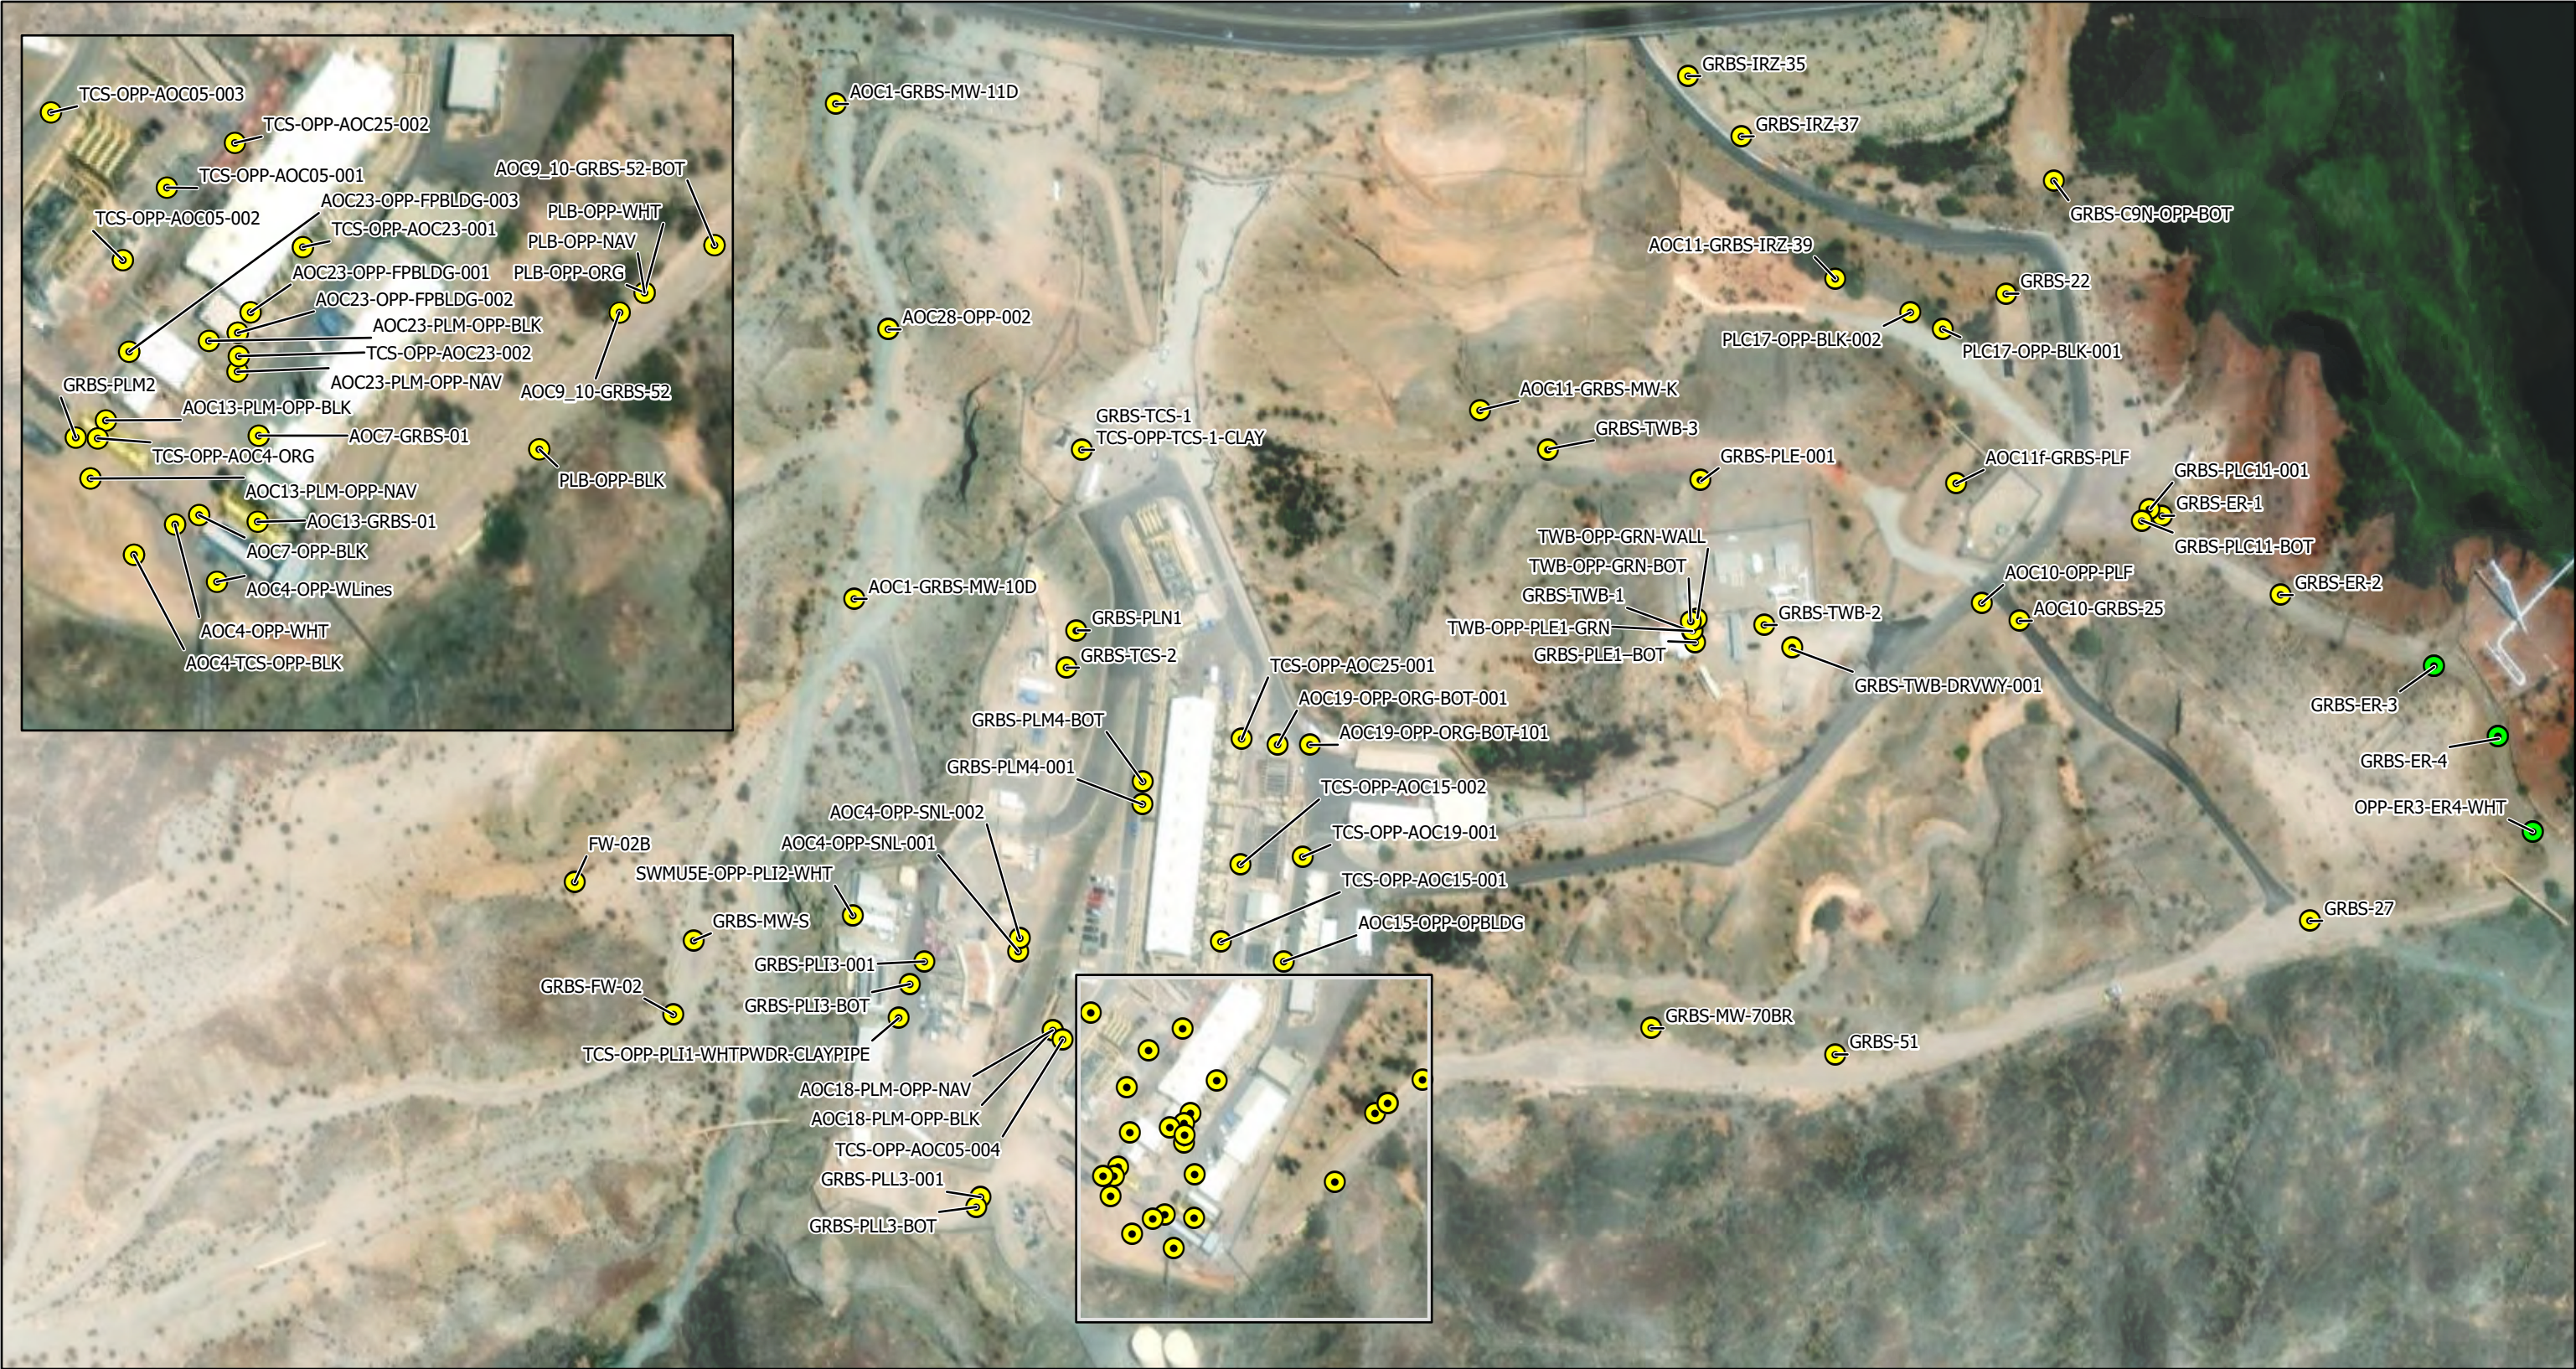
Baseline Opportunistic Soil Sampling Locations
Monthly Progress Report
Groundwater Remedy Construction
PG&E Topock Compressor Station,
Needles, California

- Legend
- Soil Sample Collected March 2023
 - Soil Sample Location
