Subject: July 2022 Monthly Progress Report for the Final Groundwater Remedy Construction and Startup, PG&E Topock Compressor Station, Needles, California
(Document ID: TPK_Monthly_Progress_Rpt_July_2022_20220810)

July 2022
Monthly Progress Report for the
Final Groundwater Remedy Construction and Startup

PG&E Topock Compressor Station
Needles, California

Document ID: TPK_Monthly_Progress_Rpt_July_20220810

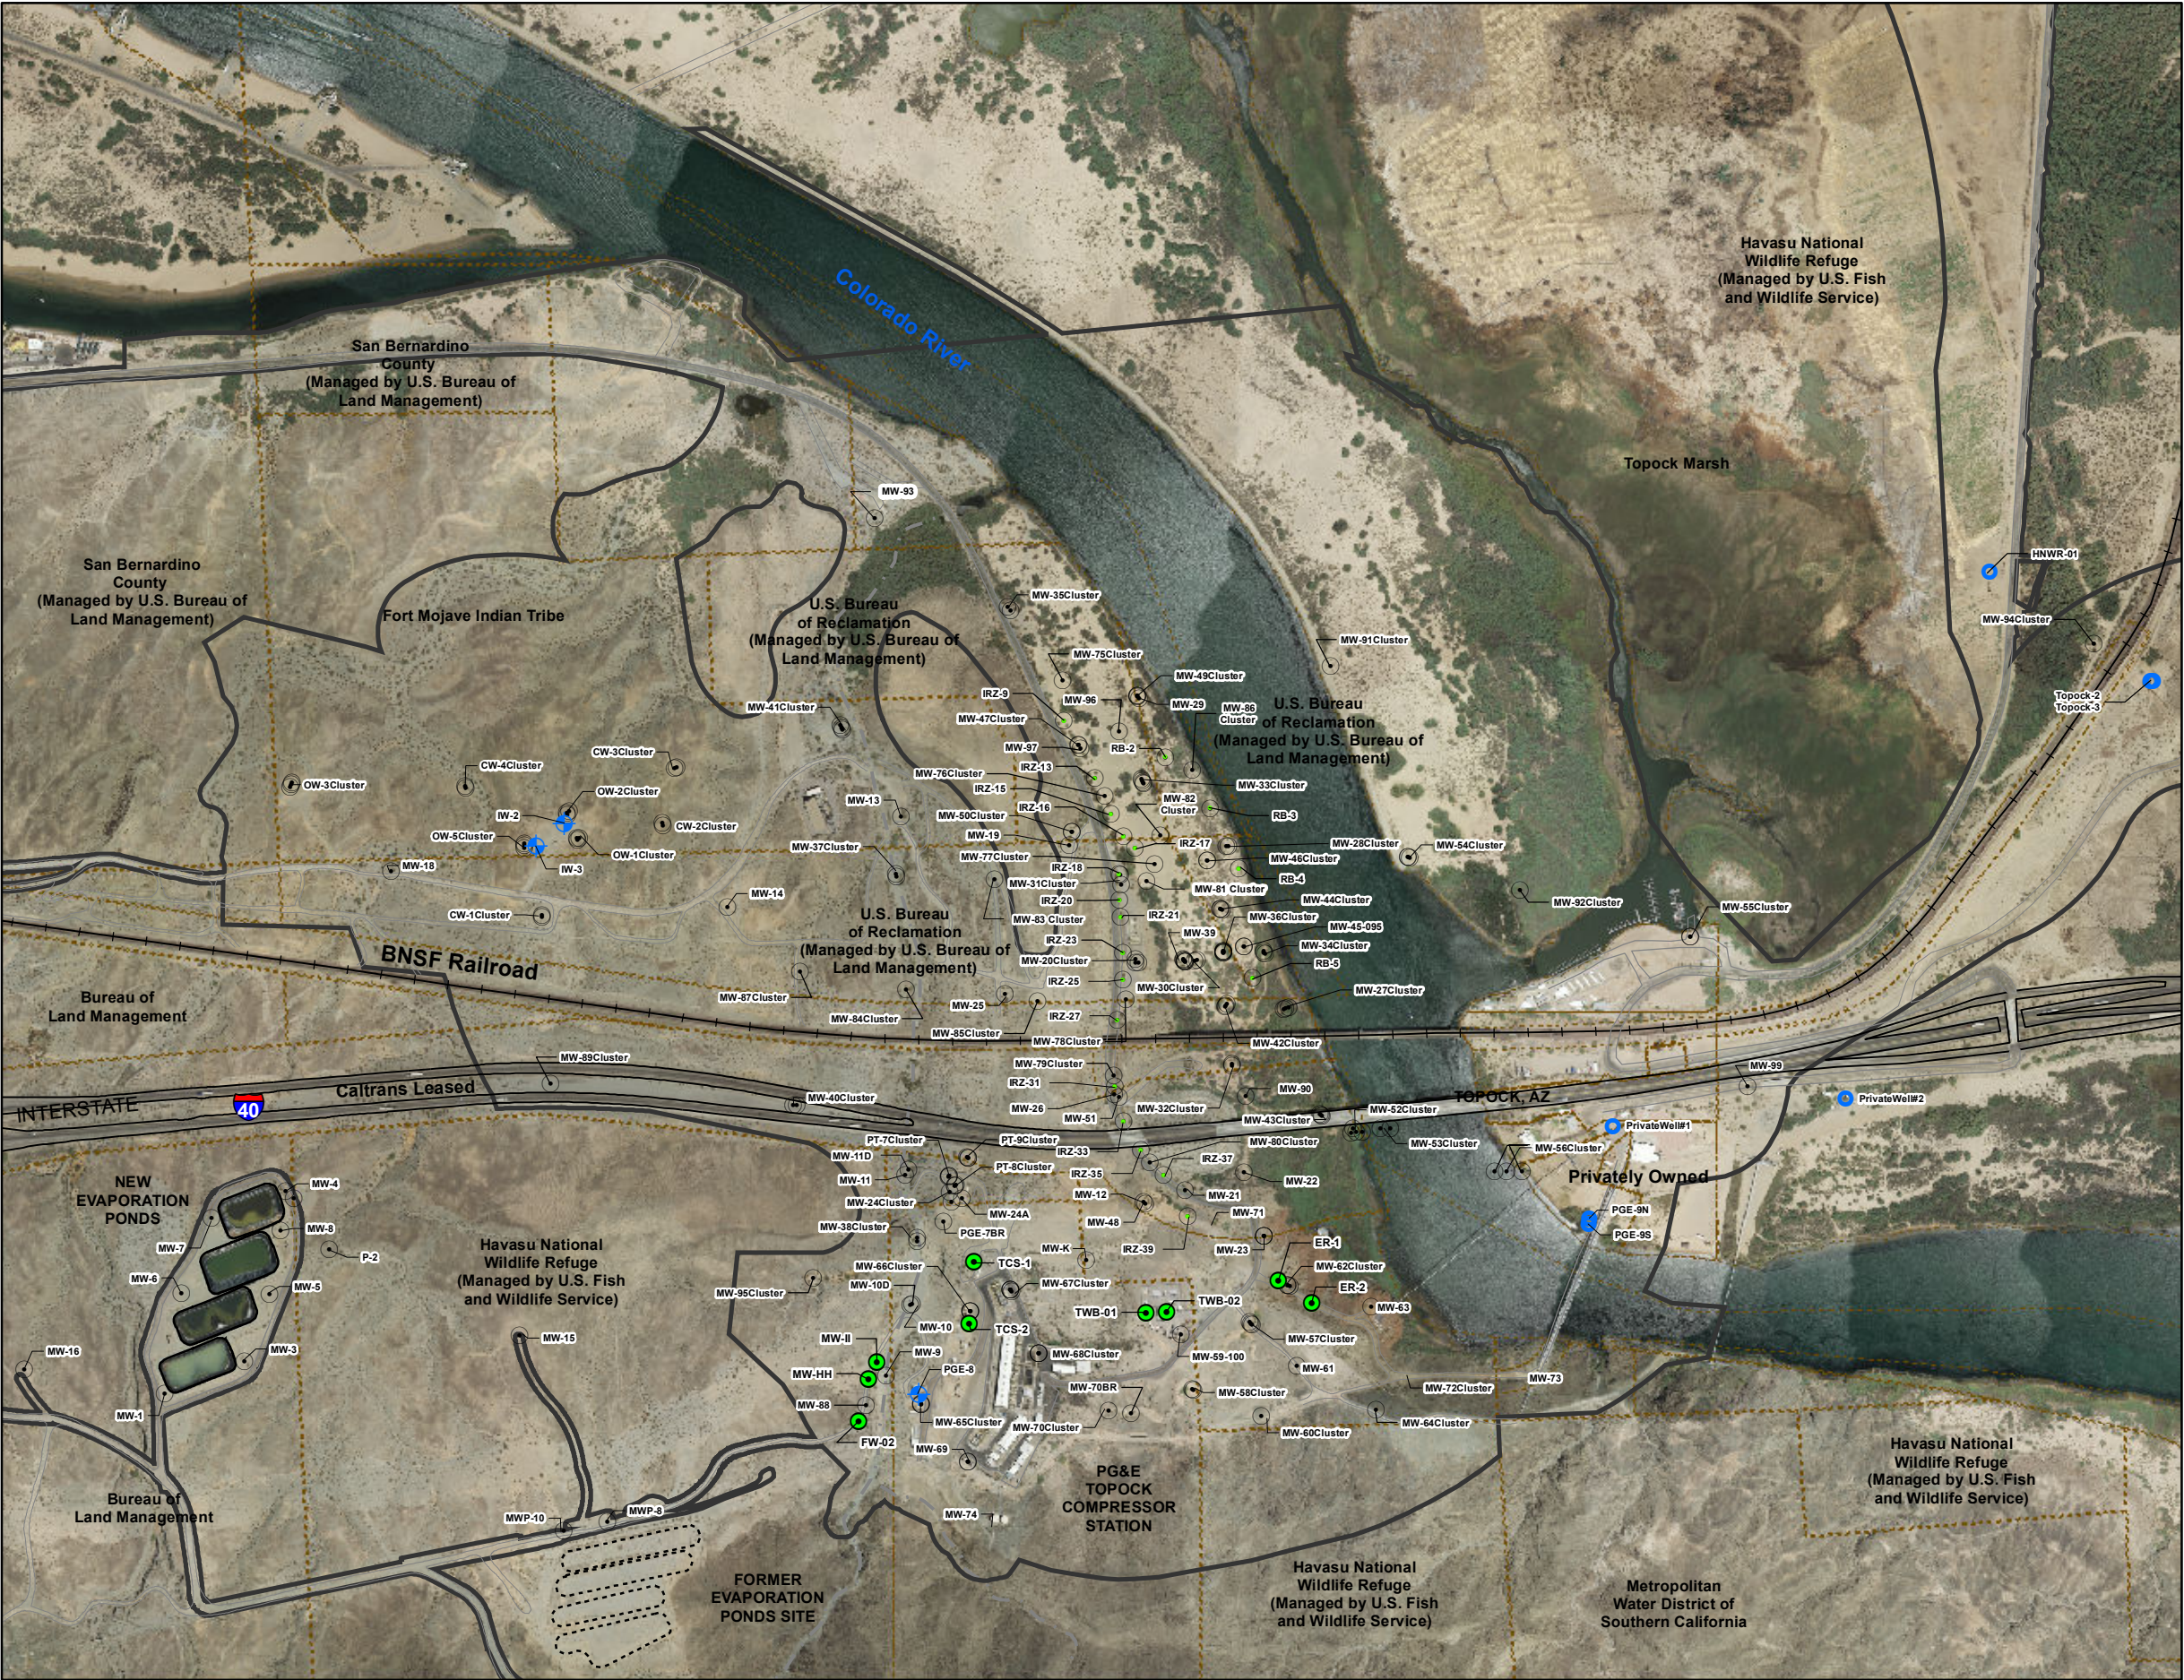
- LEGEND
- Project Area
 - Phase 2A Well (Approximate Location, Drilling program in progress)
 - Injection Well
 - Groundwater Monitoring Well
 - Water Supply Well
 - Remediation Well

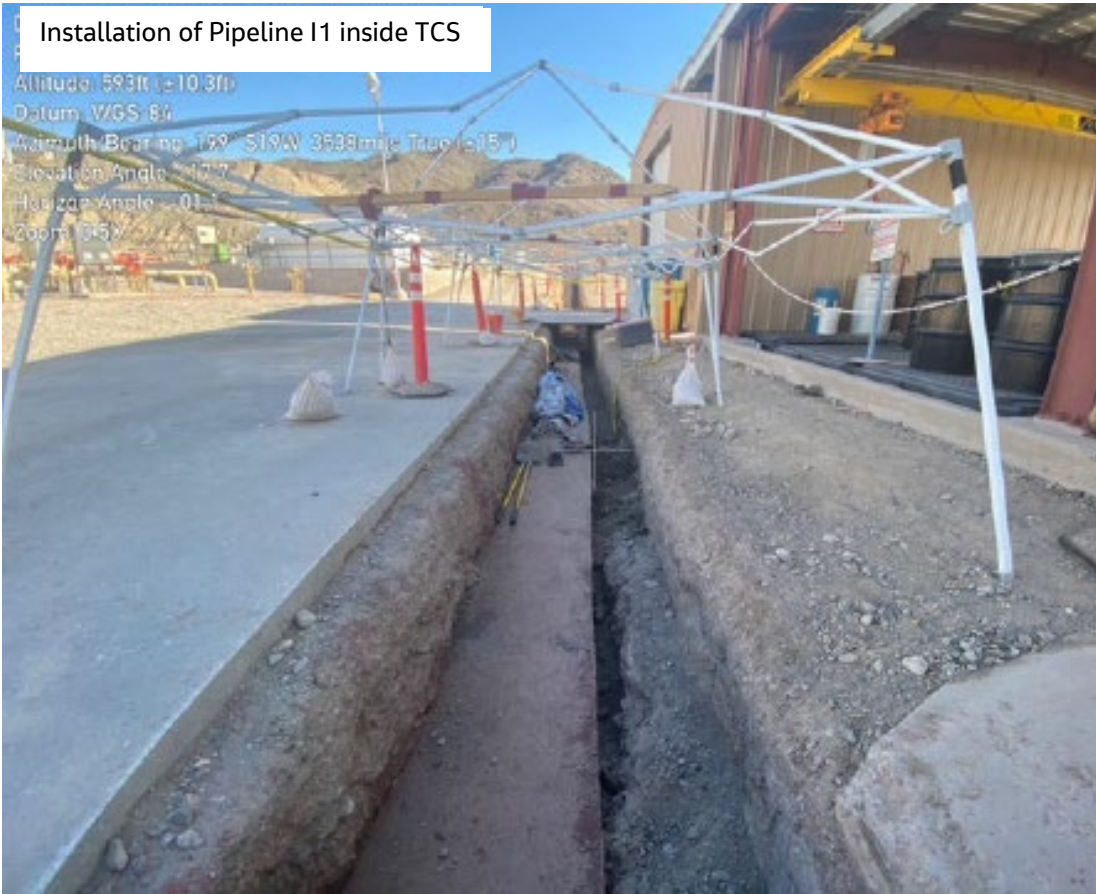
Installation of Pipeline I1 inside TCS

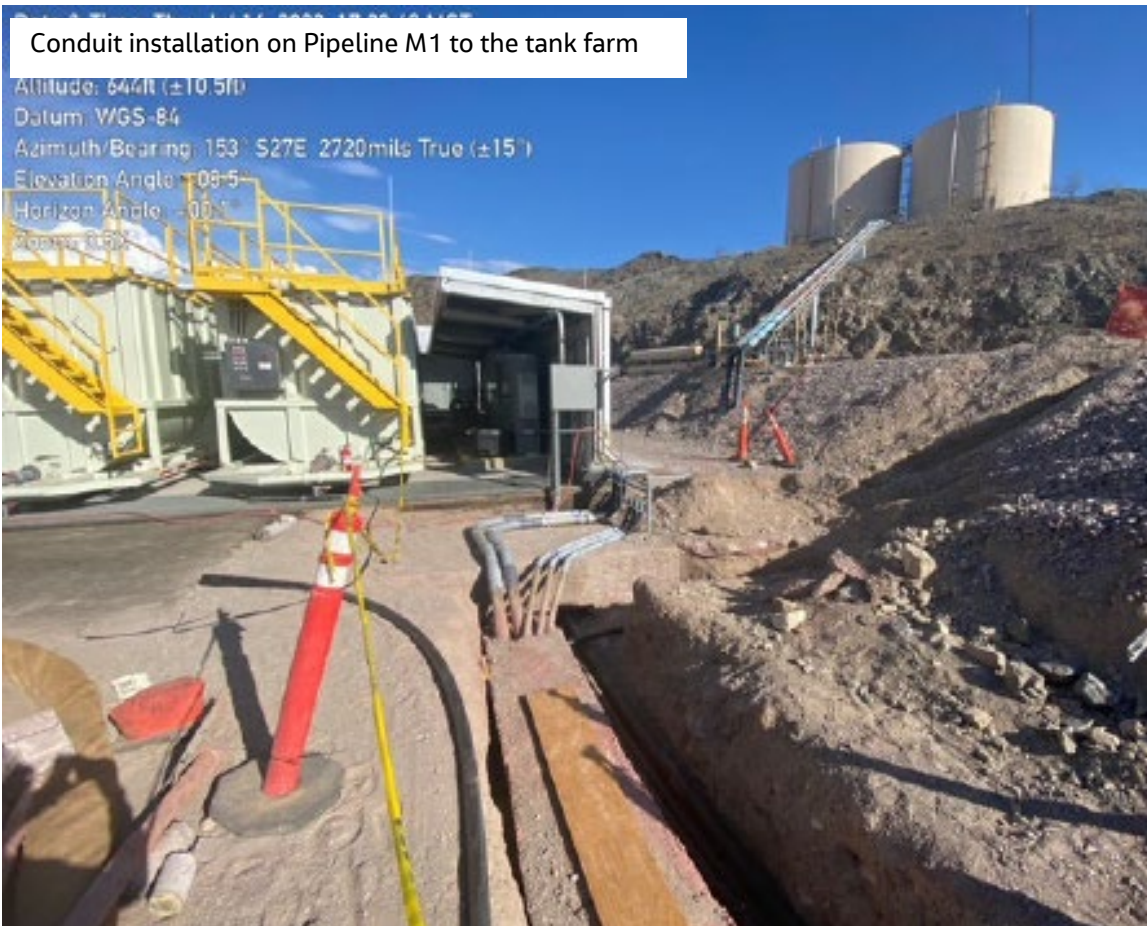
Conduit installation on Pipeline M1 to the tank farm
