Subject: July 2023 Monthly Progress Report for the Final Groundwater Remedy Construction and Startup, PG&E Topock Compressor Station, Needles, California
(Document ID: TPK_Monthly_Progress_Rpt_July_2023_20230810)

July 2023
Monthly Progress Report for the
Final Groundwater Remedy Construction and Startup

PG&E Topock Compressor Station
Needles, California

Document ID: TPK_Monthly_Progress_Rpt_July_20230810

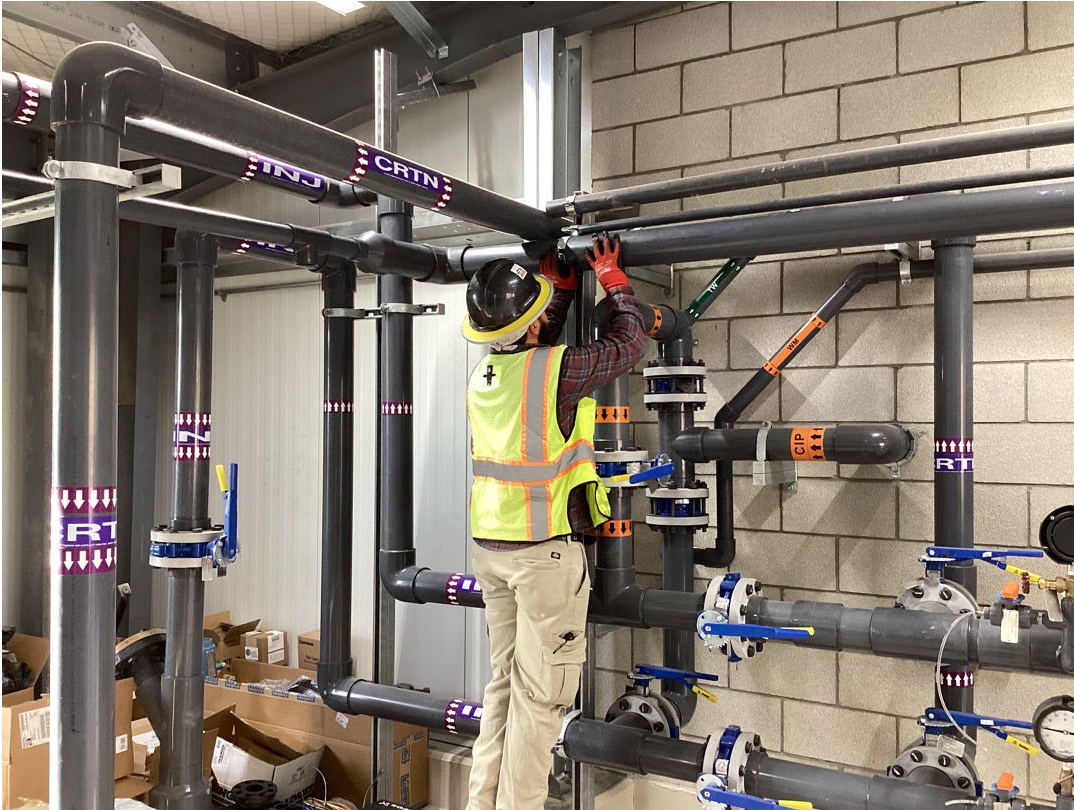
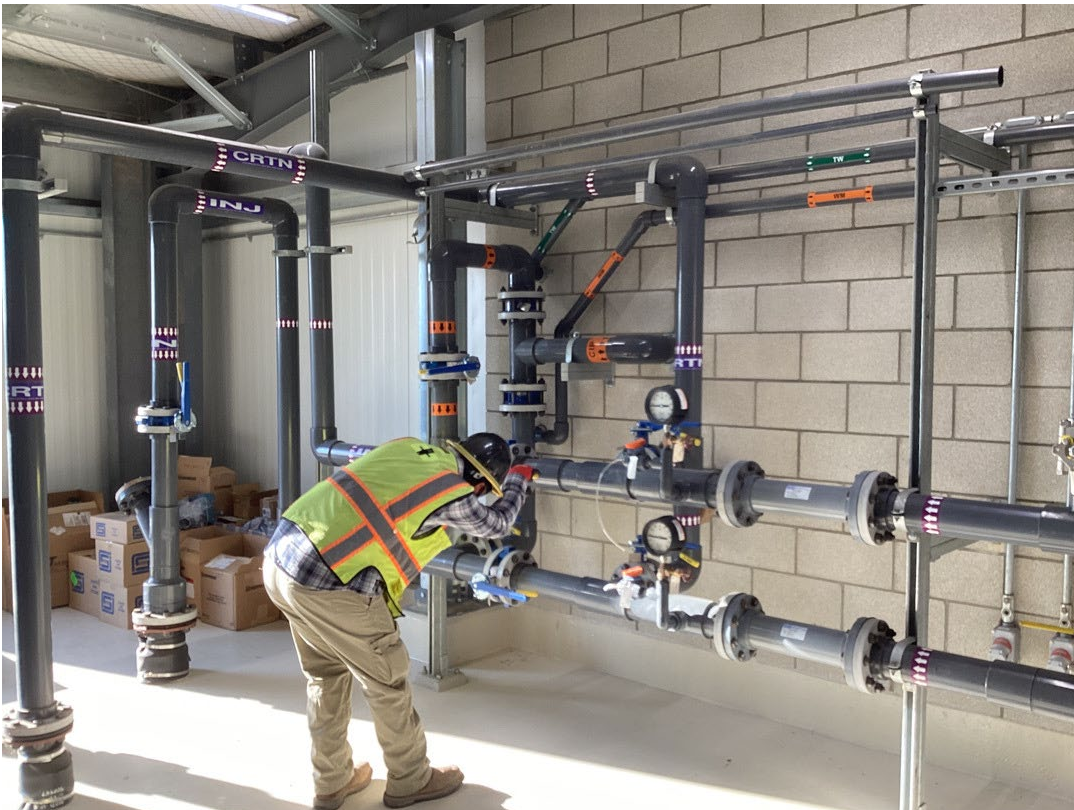
Photos showing mechanical work inside the Carbon Amendment Building.

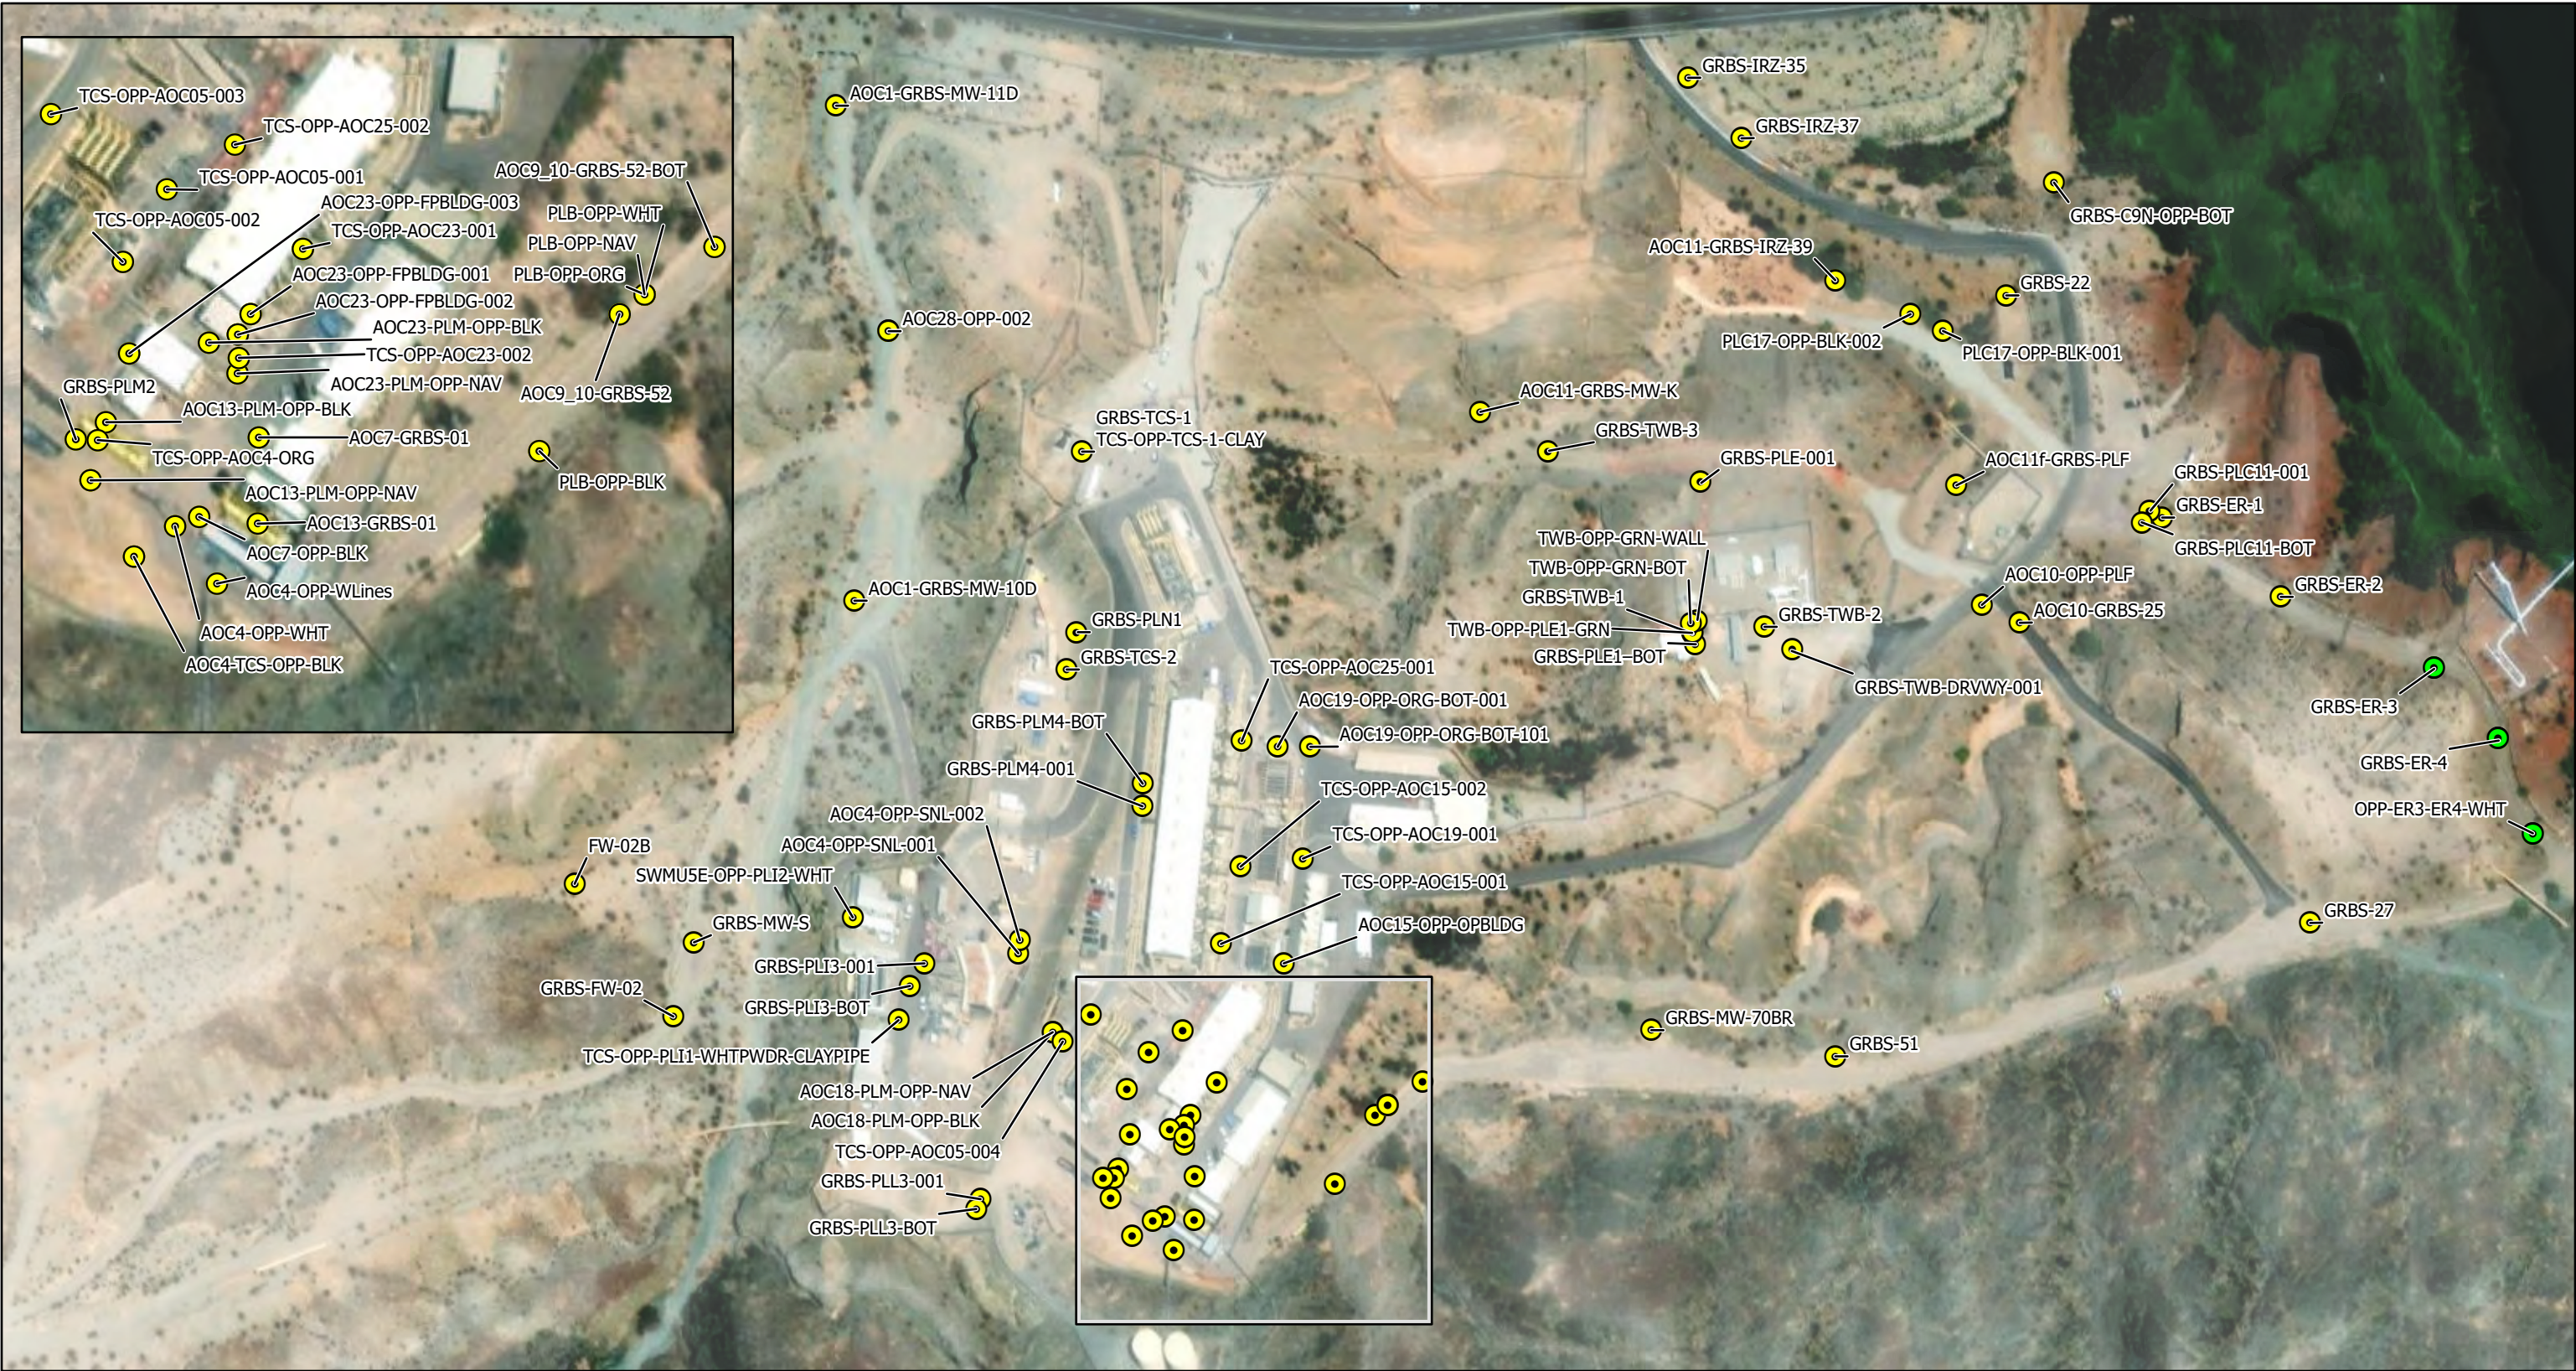
- Legend
- Soil Sample Collected March 2023
 - Soil Sample Location

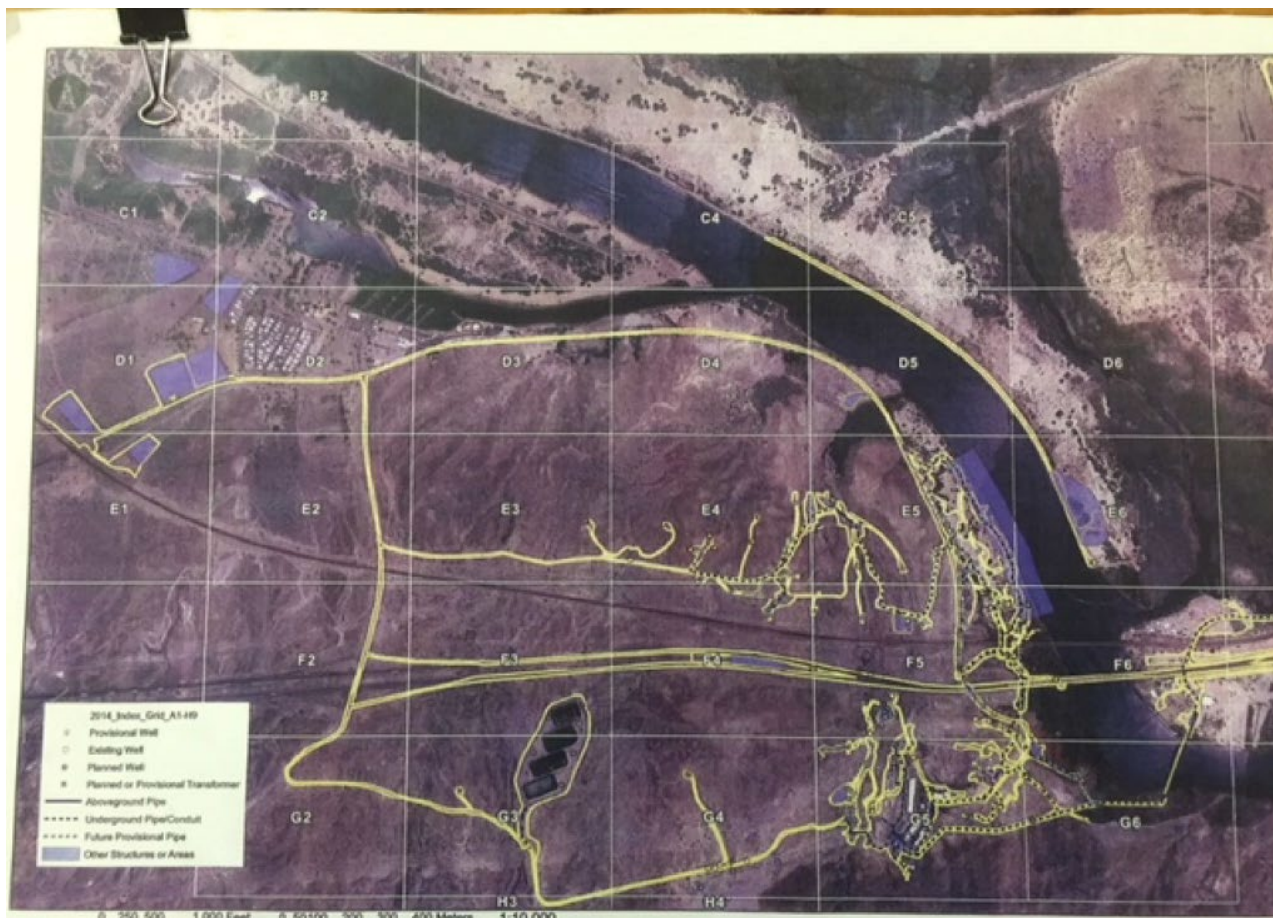
Figure showing a grid superimposed on the Topock site map. Each grid position is denoted by an letter followed by a number.
