Subject: March 2023 Monthly Progress Report for the Final Groundwater Remedy Construction and Startup, PG&E Topock Compressor Station, Needles, California
(Document ID: TPK_Monthly_Progress_Rpt_March_2023_20230410)

March 2023
Monthly Progress Report for the
Final Groundwater Remedy Construction and Startup

PG&E Topock Compressor Station
Needles, California

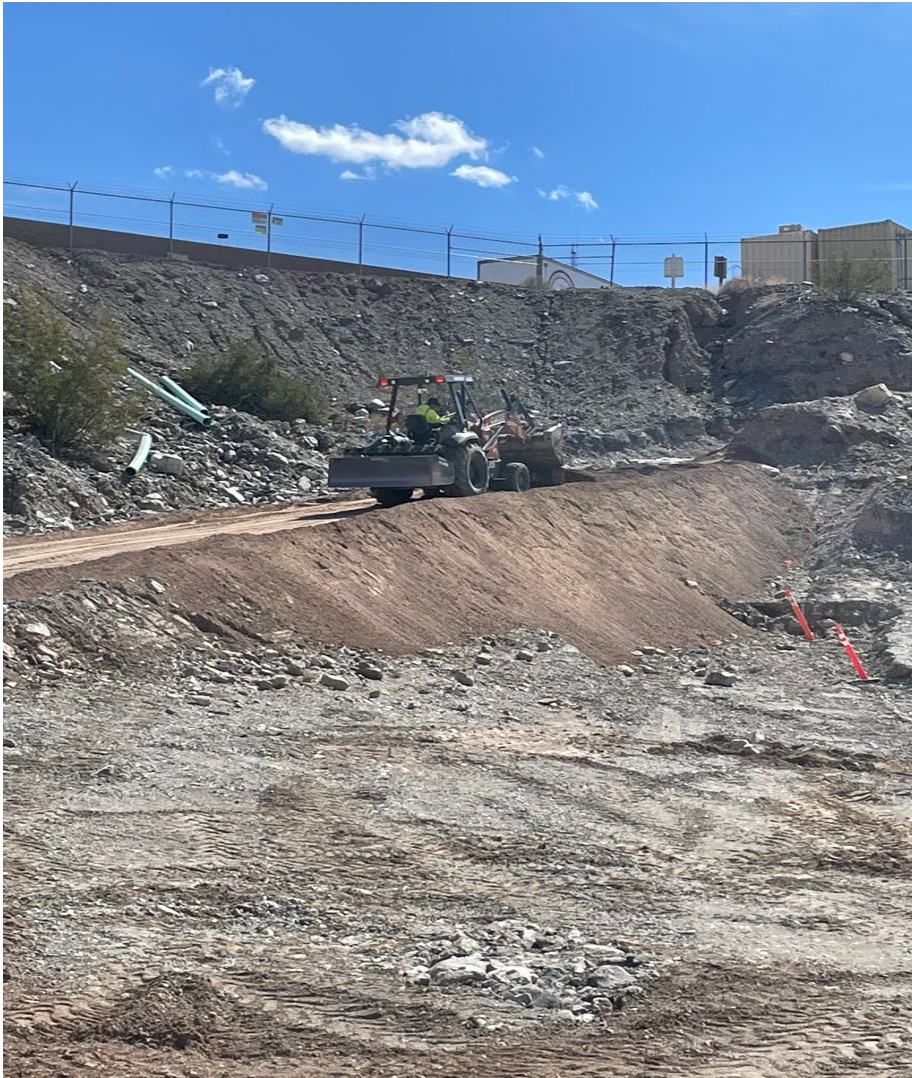
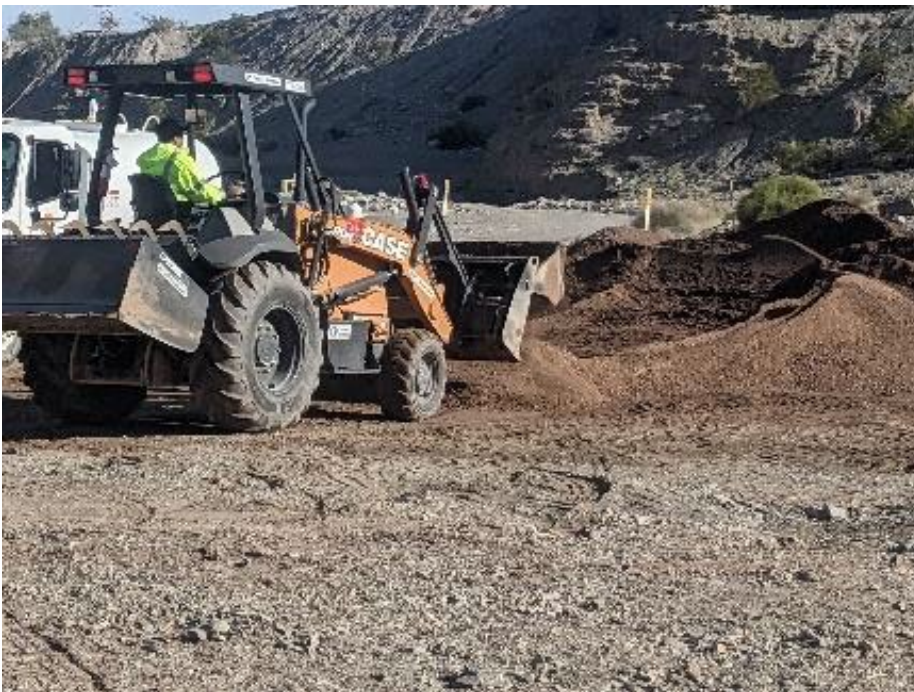
Photos showing
rebuild of the
Pipeline I2 access
road

- Completed storm erosion repairs on road to ER-4.
- Commenced storm erosion repairs on IM-3 road.
- Conducted rare plant survey.
- March 26 to April 1 activities:
 - Continued construction of pipelines outside the TCS at I2.
 - Continued IRZ O&M activities.
 - Completed well drilling with sonic rig at ER-4 to 167'. Commenced well installation.
 - Completed storm erosion repairs on ponds road.
 - Completed storm erosion repairs on IM-3 road.
 - Commenced storm erosion repairs at IRZ-39, Pipeline F and J roads.
 - Commenced storm erosion repairs on Pipeline B road.
- Remedy Baseline/Opportunistic Soil Sampling:

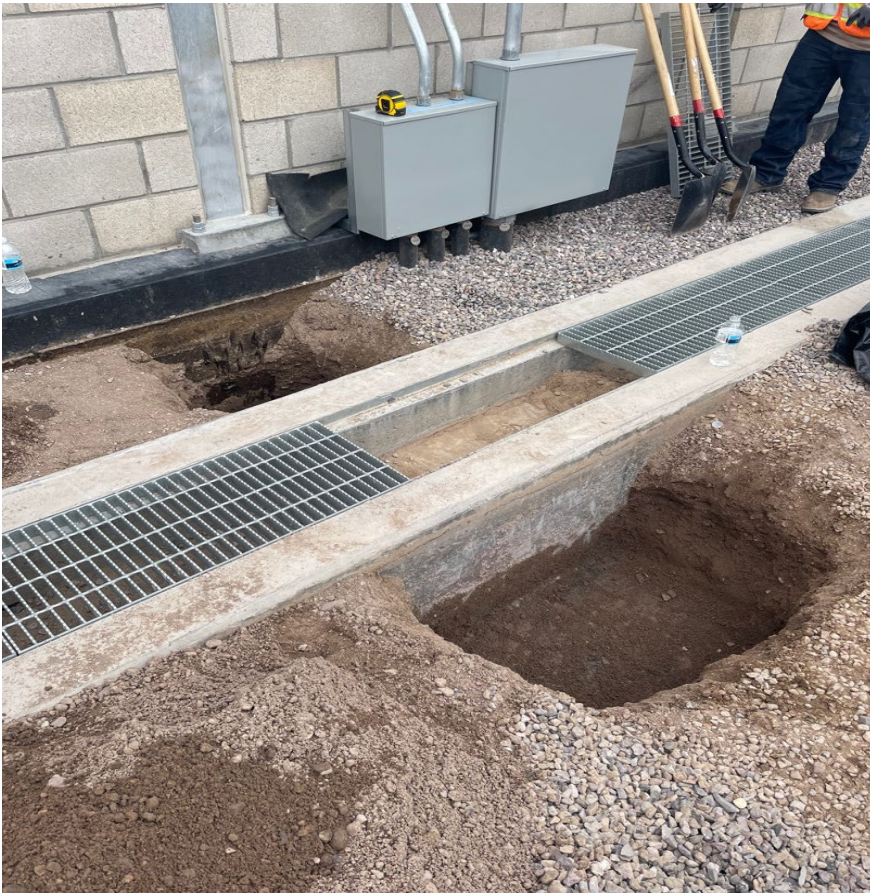
Photo showing
hand excavation at
remedy tank farm
at TCS to install
additional conduits

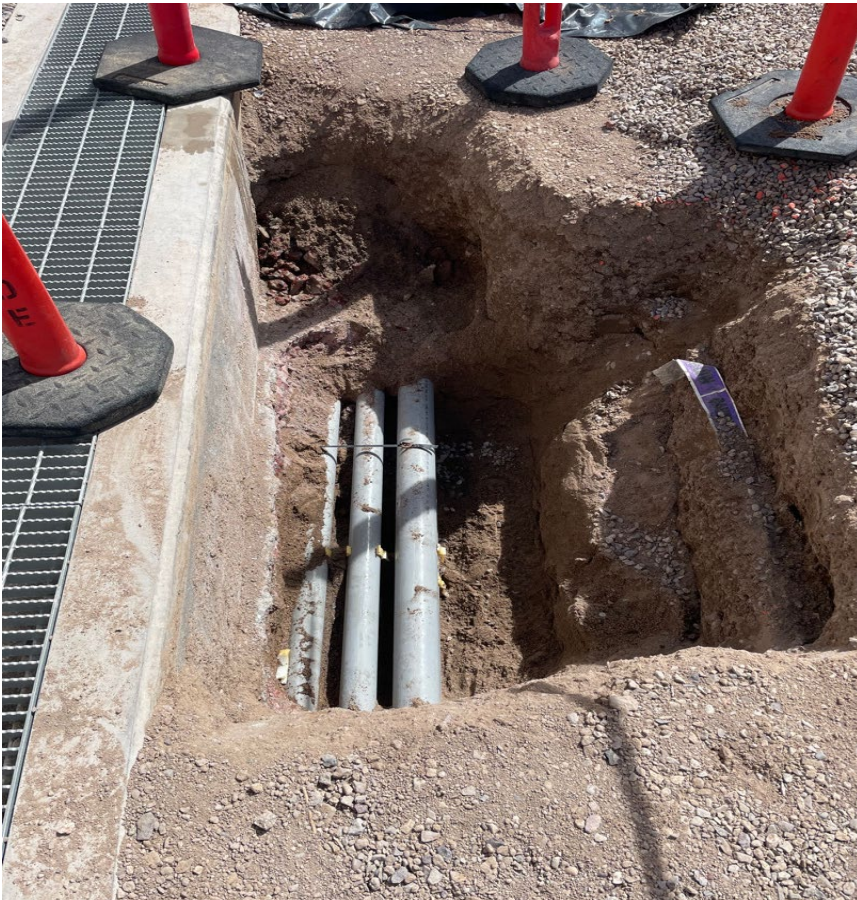
Photo showing
slurry cap and
bedding sand
removed to expose
spare conduit

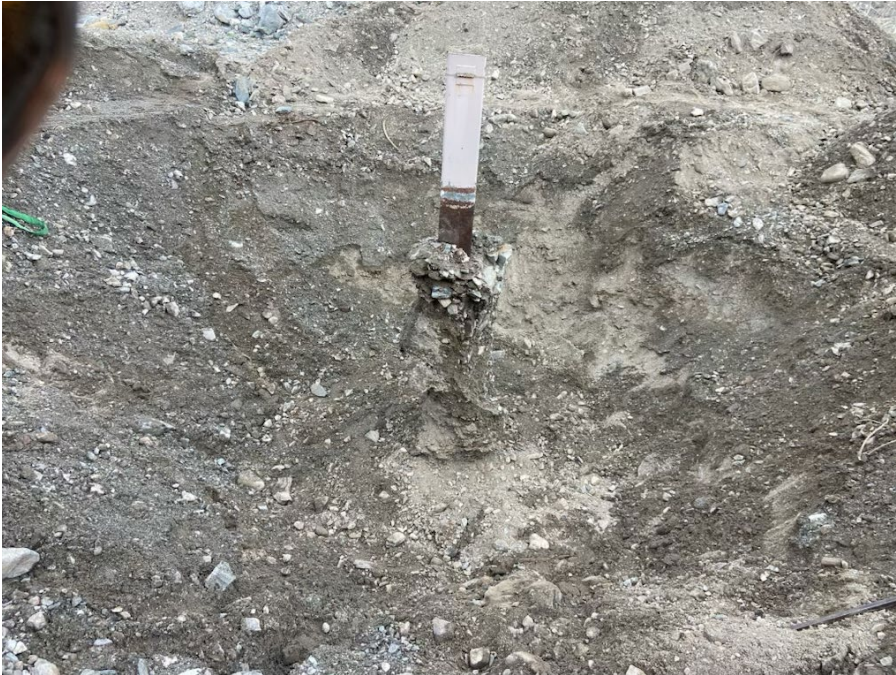
Photo showing
excavation and
condition of MW-11S

- Completed site preparation for well drilling activities at ER-3 and ER-4.
 - Commenced well pad repair at MW-11.
 - Conducted groundwater sampling at various locations.

- Commenced well drilling with sonic rig at ER-4.
 - Completed well pad repair at MW-11.
 - Commenced storm erosion repairs on ponds road and road to ER-4.

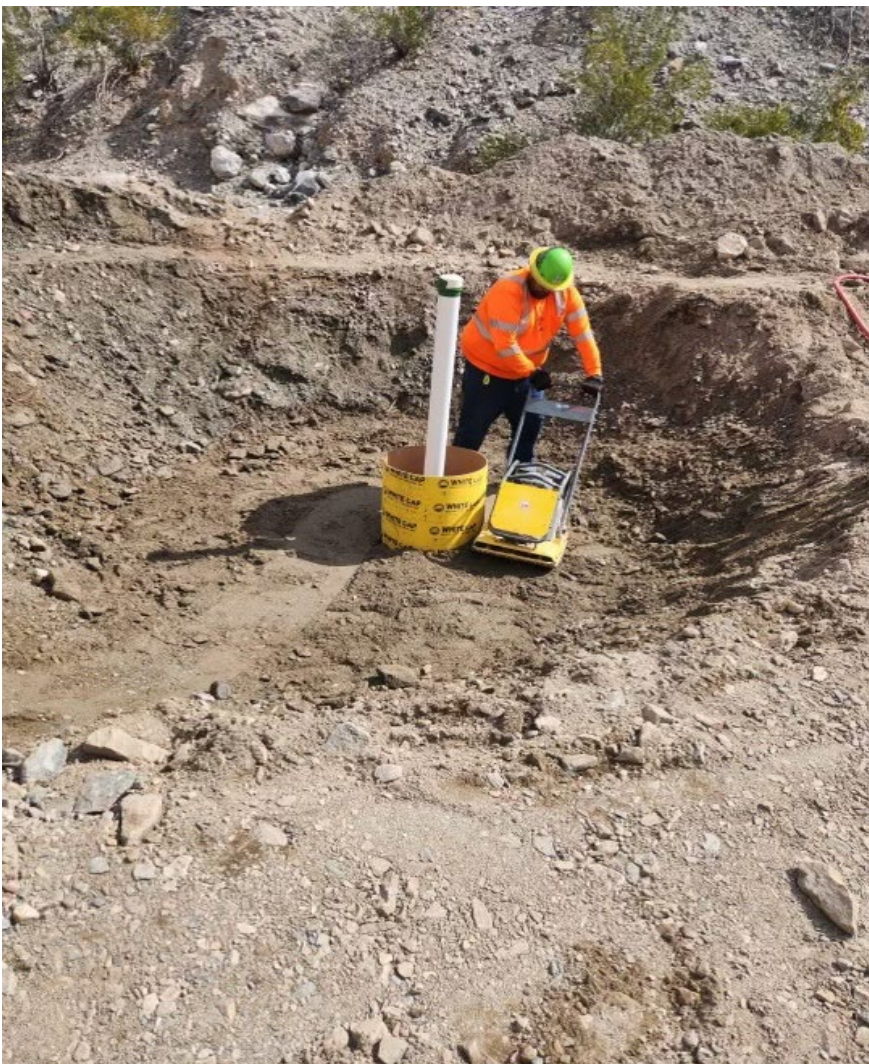
Photo showing backfill
excavation around
Sonotube (MW-11S)

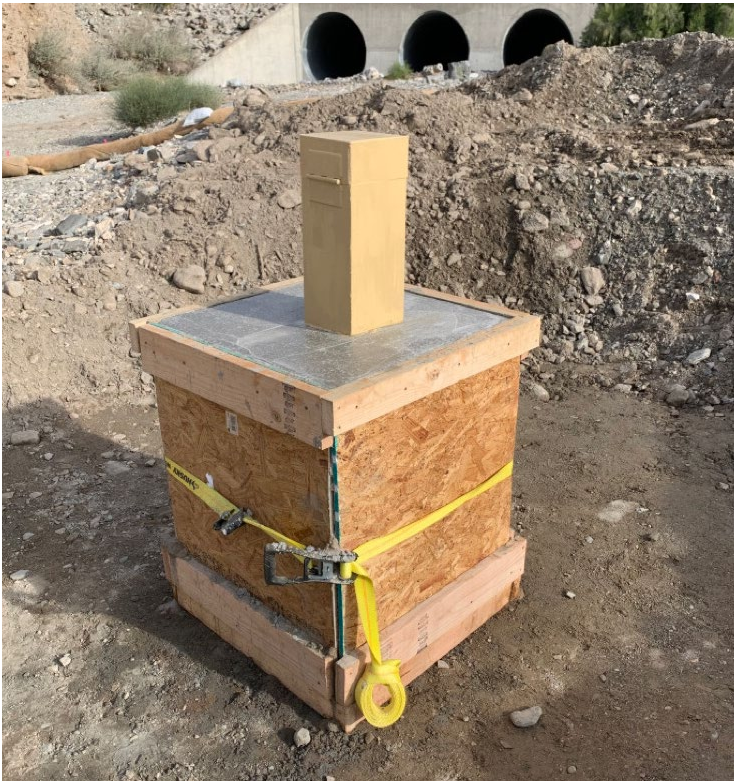
Photo showing the new stovepipe for MW-11S

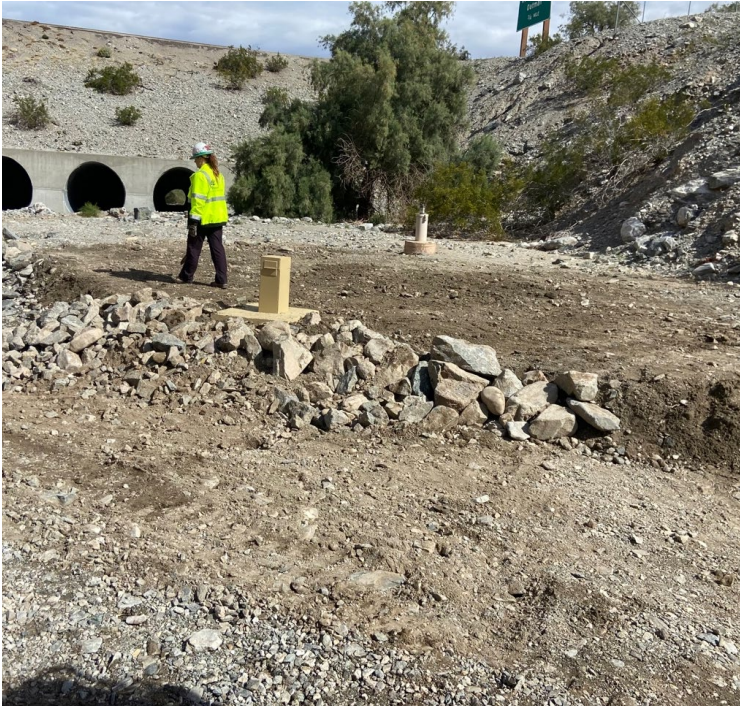
Photo showing MW-11S after well pad repair was complete

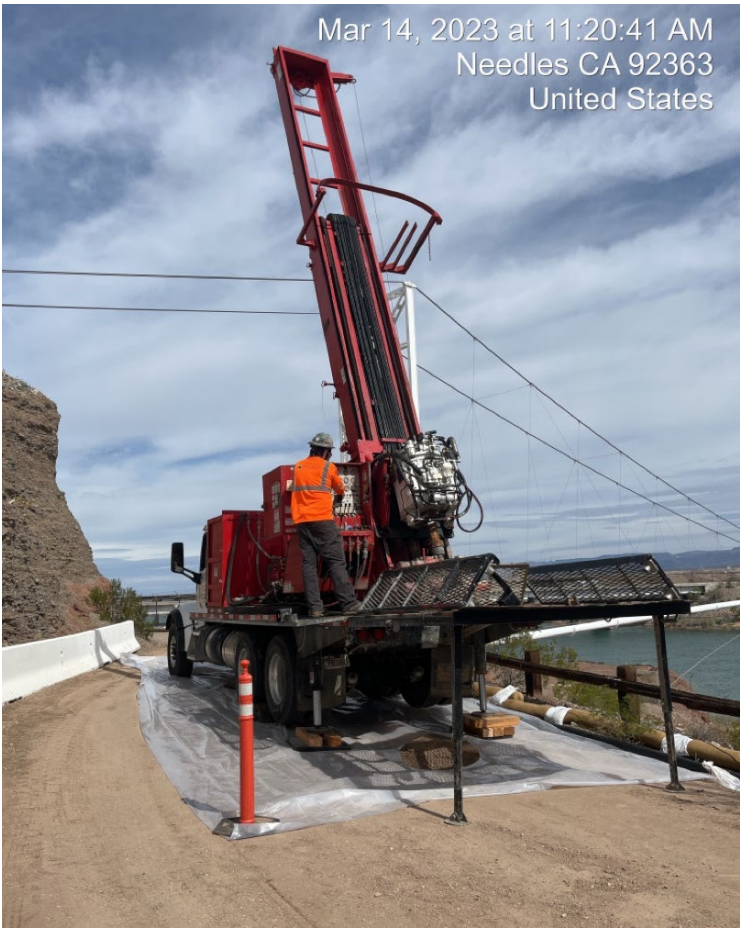
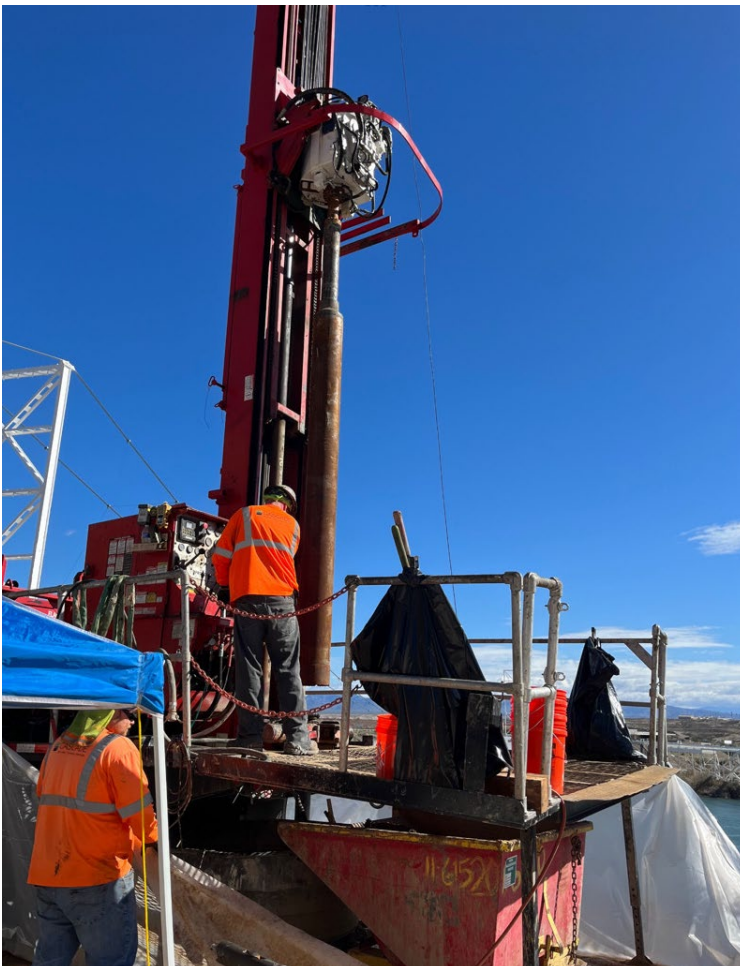
Photos showing drilling
at well ER-4

- Commenced well drilling with sonic rig at ER-4 to 67'.
 - Commenced and completed application of soil stabilizer at AOC-14.
 - Continued storm erosion repairs on ponds road.

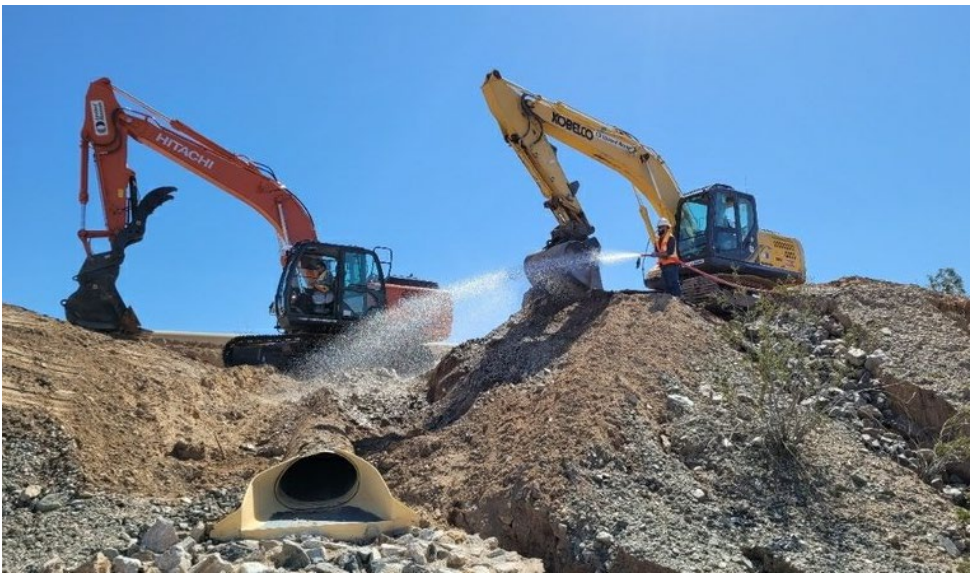
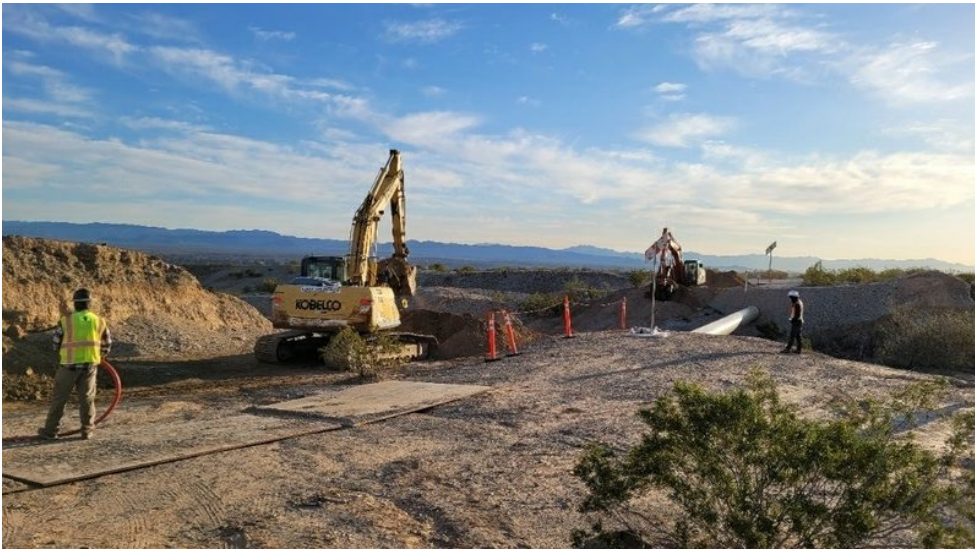
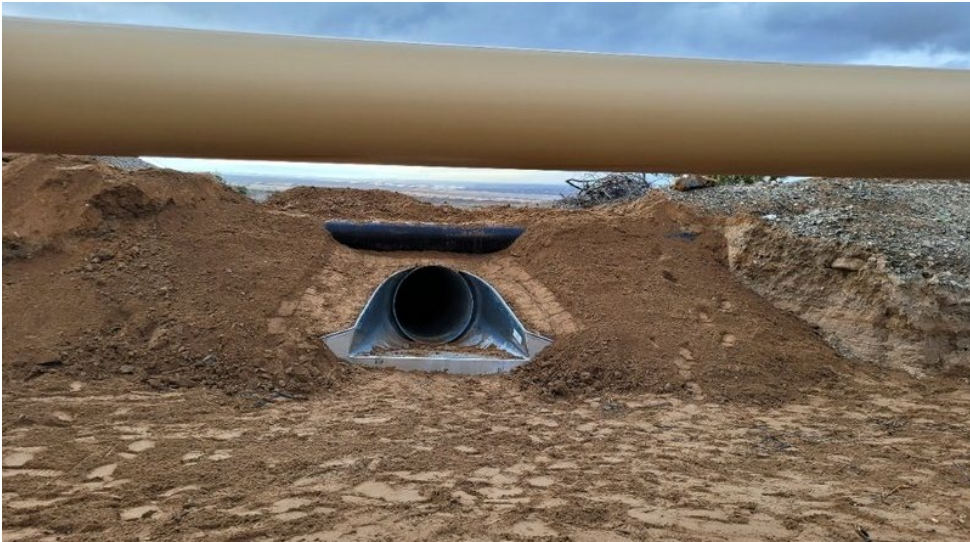
Photos showing
emergency repair of
culvert along Ponds
Road to Bat Cave Wash

- On March 17, 2023, PG&E conducted an emergency repair of a storm-damaged culvert along the access road to Bat Cave Wash. Road access was restored on March 22, 2023.
