**Subject: November 2022 Monthly Progress Report for the Final Groundwater Remedy Construction and Startup, PG&E Topock Compressor Station, Needles, California**  
(Document ID: TPK\_Monthly\_Progress\_Rpt\_November\_2022\_20221210)

# Topock Project Executive Abstract

*Prepared for*  
U.S. Department of the Interior and California Department of Toxic Substances Control

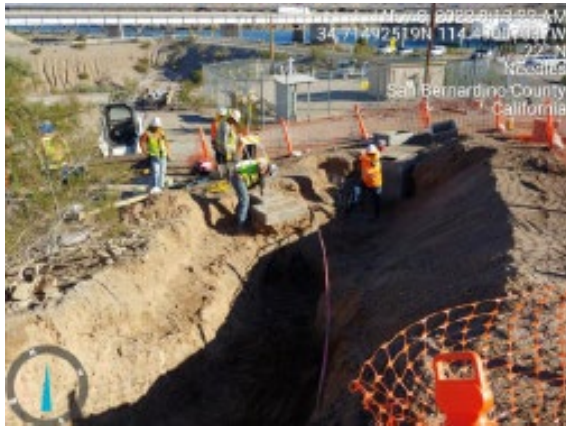
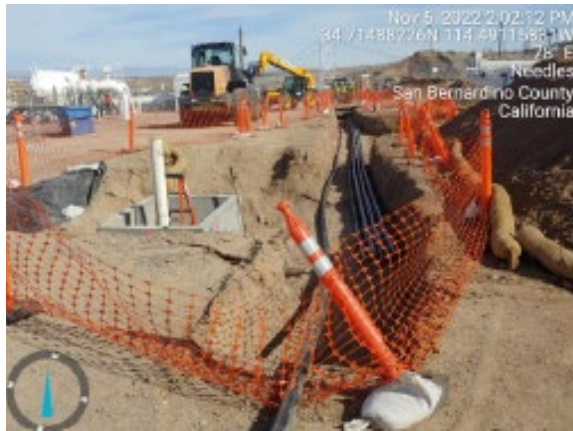
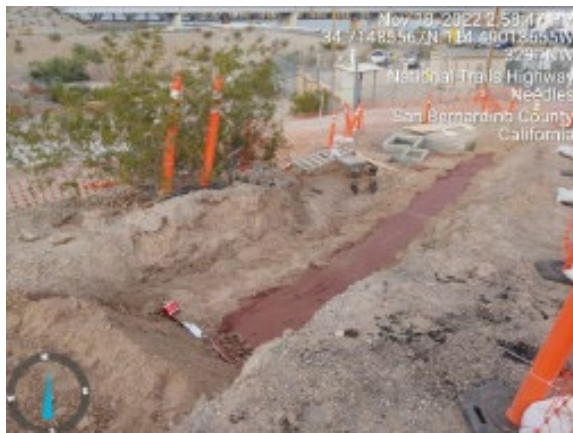
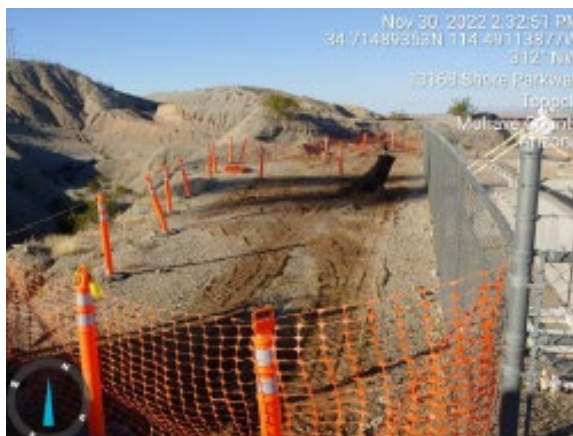
Photos showing Pipeline E  
 Installation on Transwestern  
 Bench

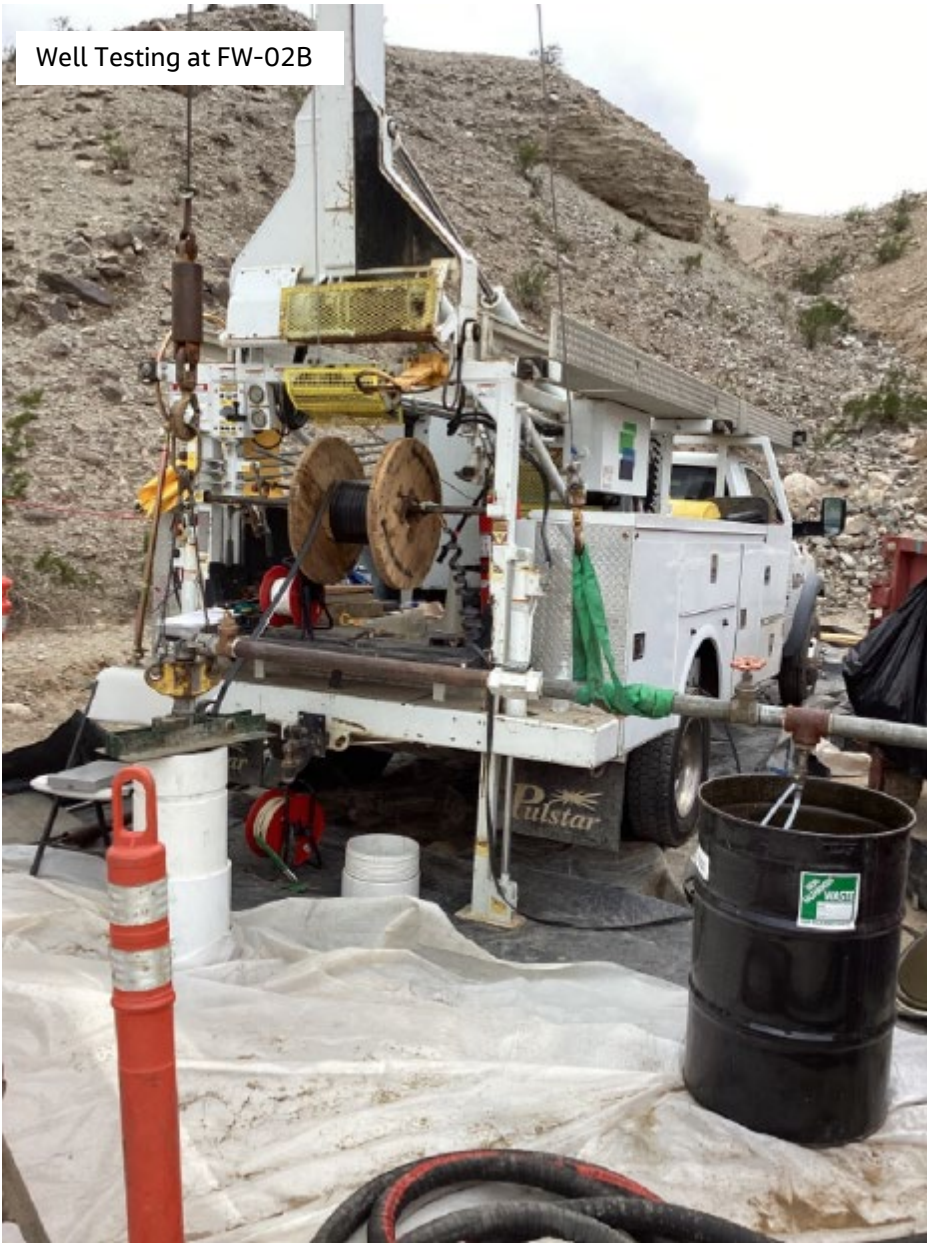
Well Testing at FW-02B

- Continued well development at FW-02B.
- Completed maintenance activities at revegetation area.
- Commenced and completed access repairs to MW-95.
- Conducted groundwater sampling at various locations.

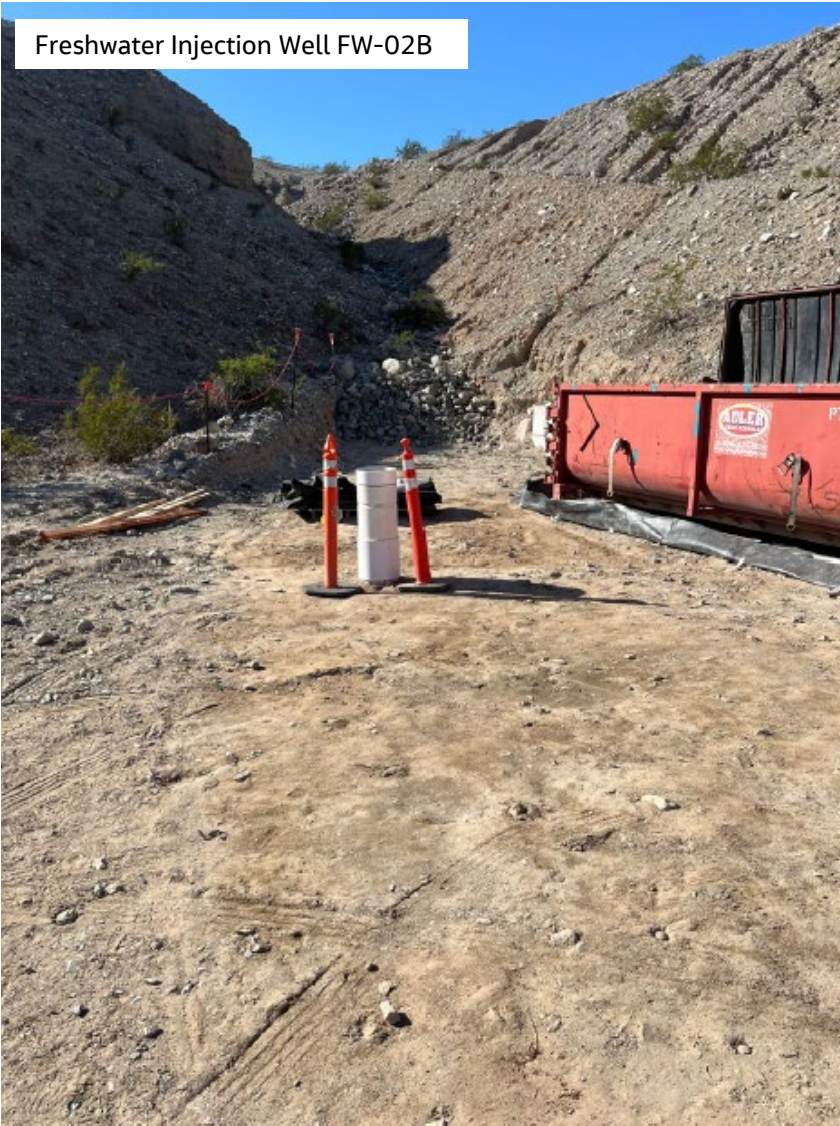
Freshwater Injection Well FW-02B

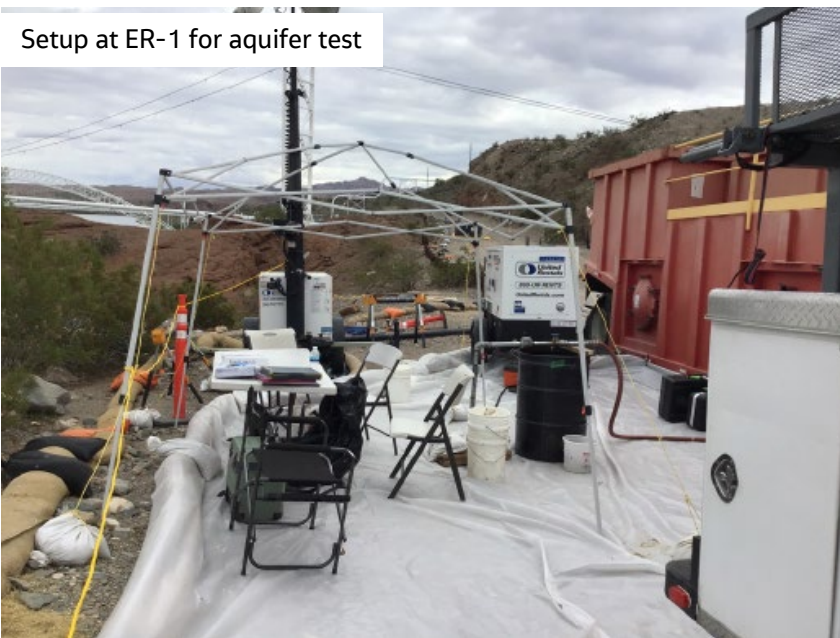
Setup at ER-1 for aquifer test

- On November 3 and 8, 2022, the illumination for night work at the ER-1 and ER-2 wells area during the aquifer test, was found to be non-compliant with the approved night work lighting plan (submitted by the contractor and approved by PG&E and Compliance) prior to the start of the aquifer test. The approved light plan requires, amongst others, portable lights to have shrouds to reduce light diffusion, be angled towards the ground, and be reduced in intensity to a level compatible with safe illumination requirements.

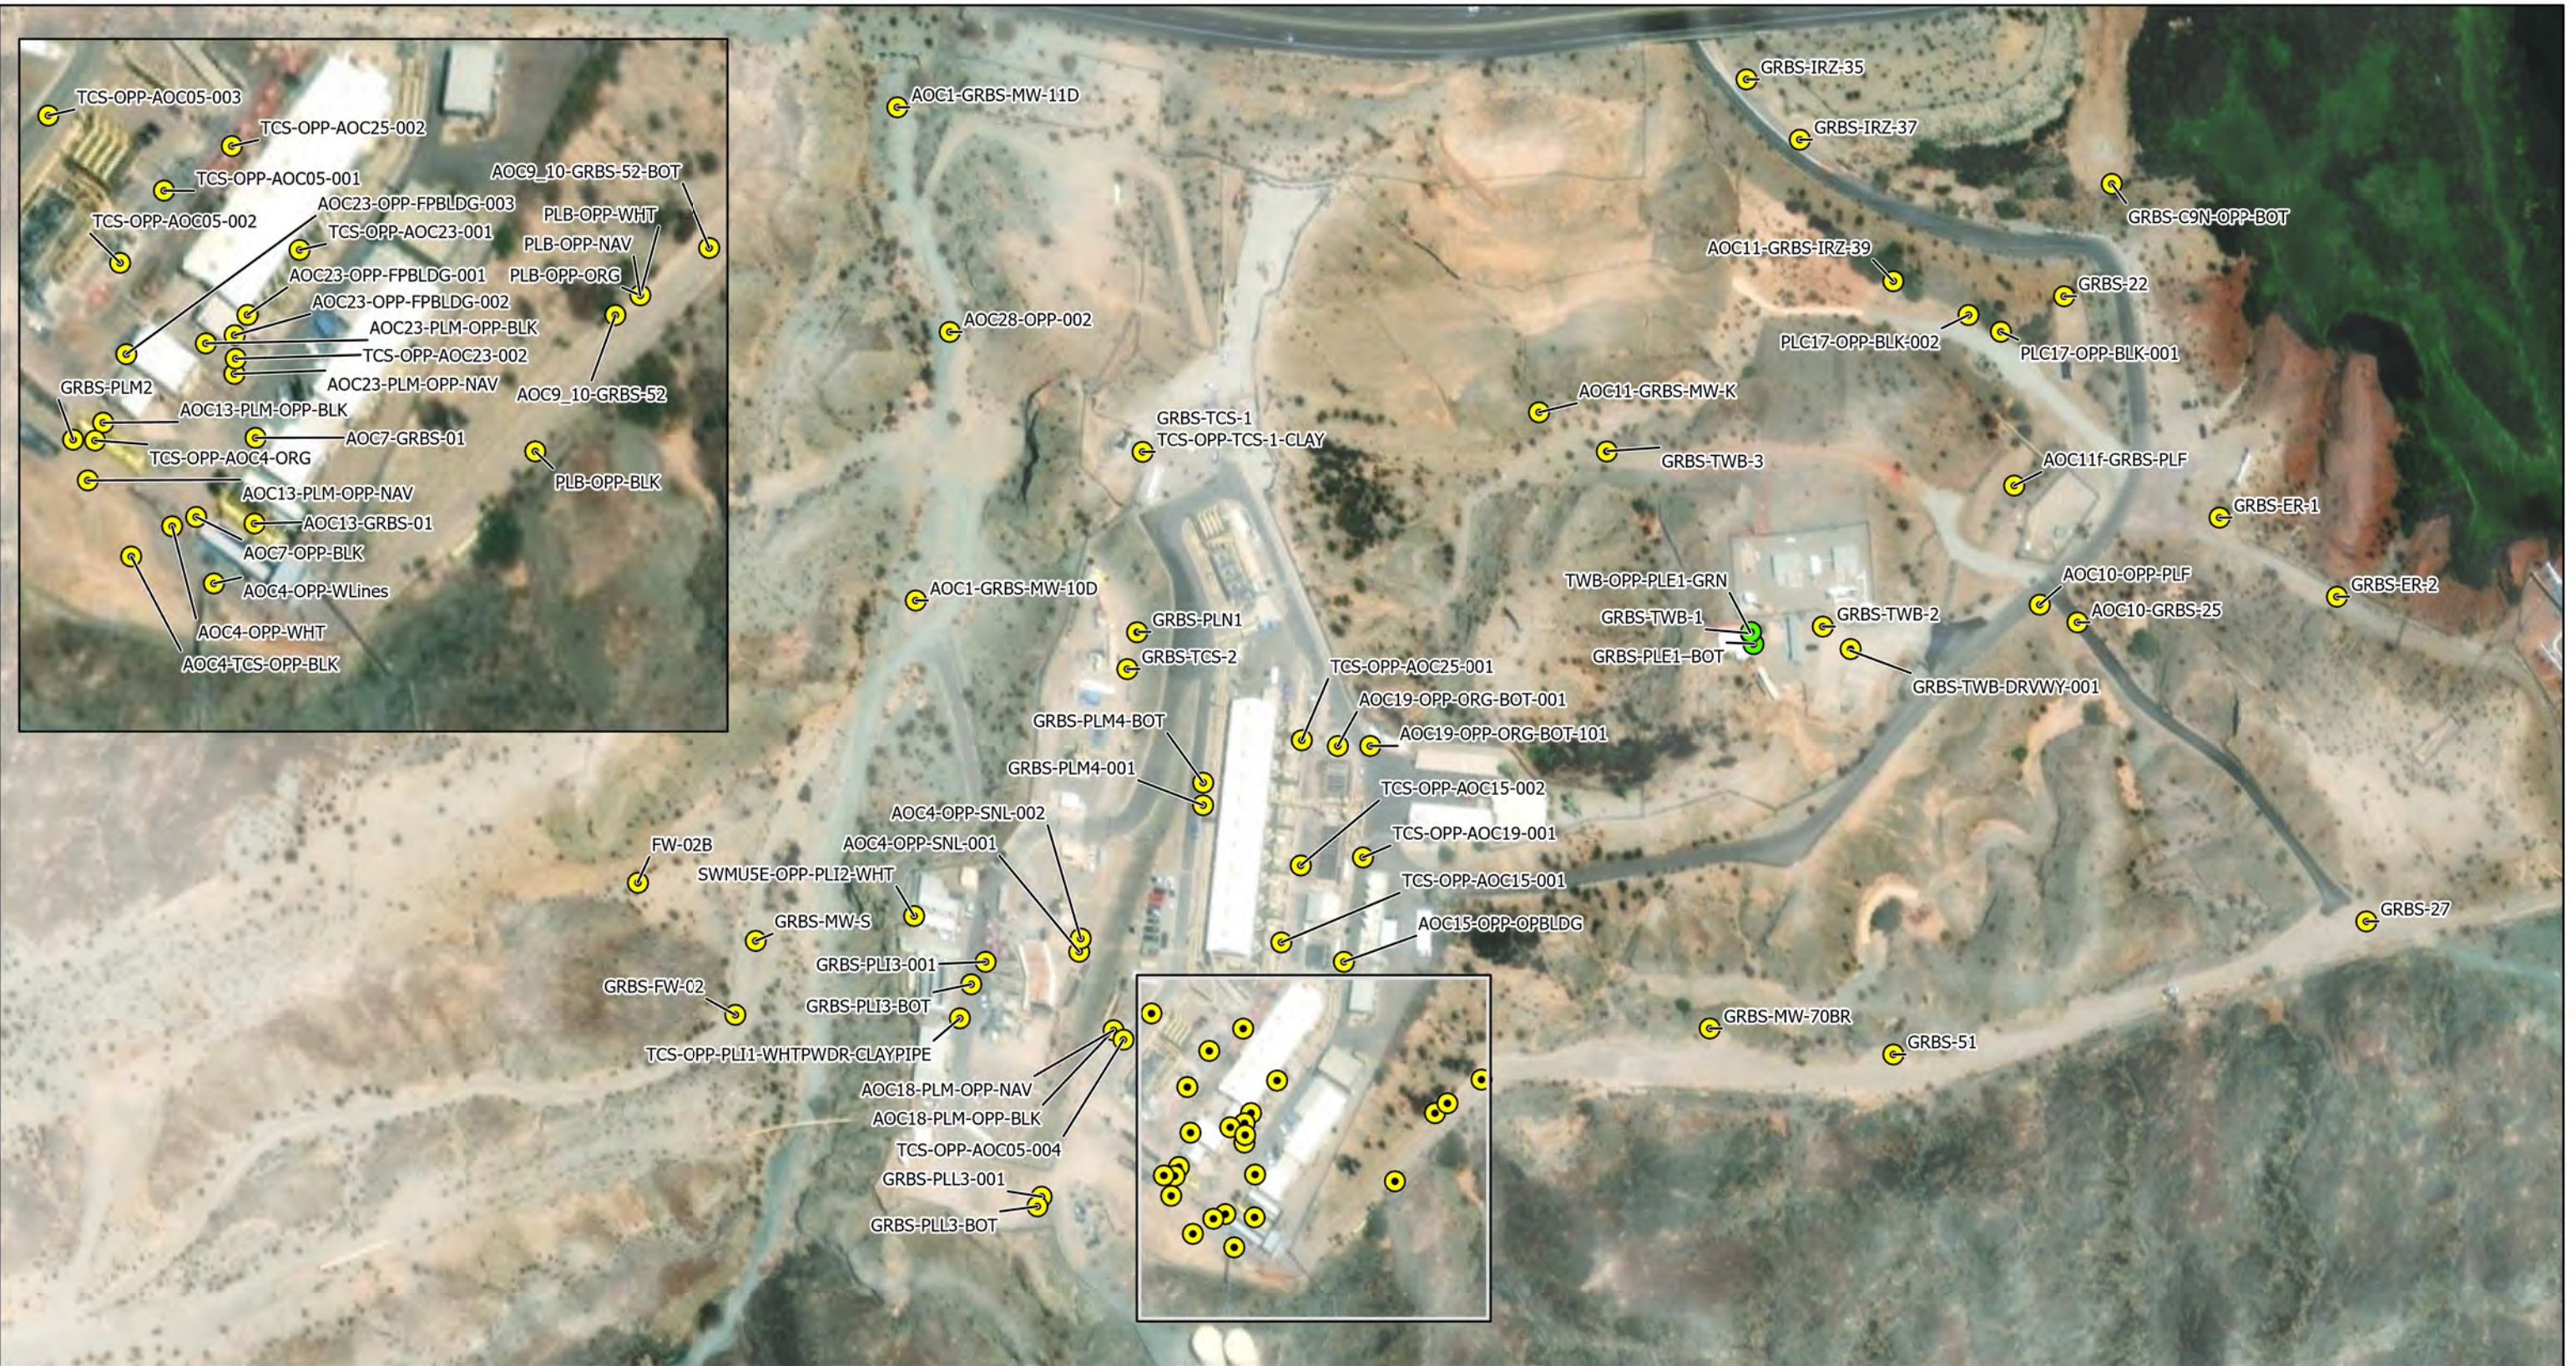
**Baseline Opportunistic Soil Sampling Locations**  
 Monthly Progress Report  
 Groundwater Remedy Construction  
 PG&E Topock Compressor Station,  
 Needles, California

- Legend**
- Soil Sample Location
  - Sample Collected in October 2022
