November 2023
Monthly Progress Report for the
Final Groundwater Remedy Construction and Startup

PG&E Topock Compressor Station
Needles, California

Document ID: TPK_Monthly_Progress_Rpt_November_20231210

December 2023

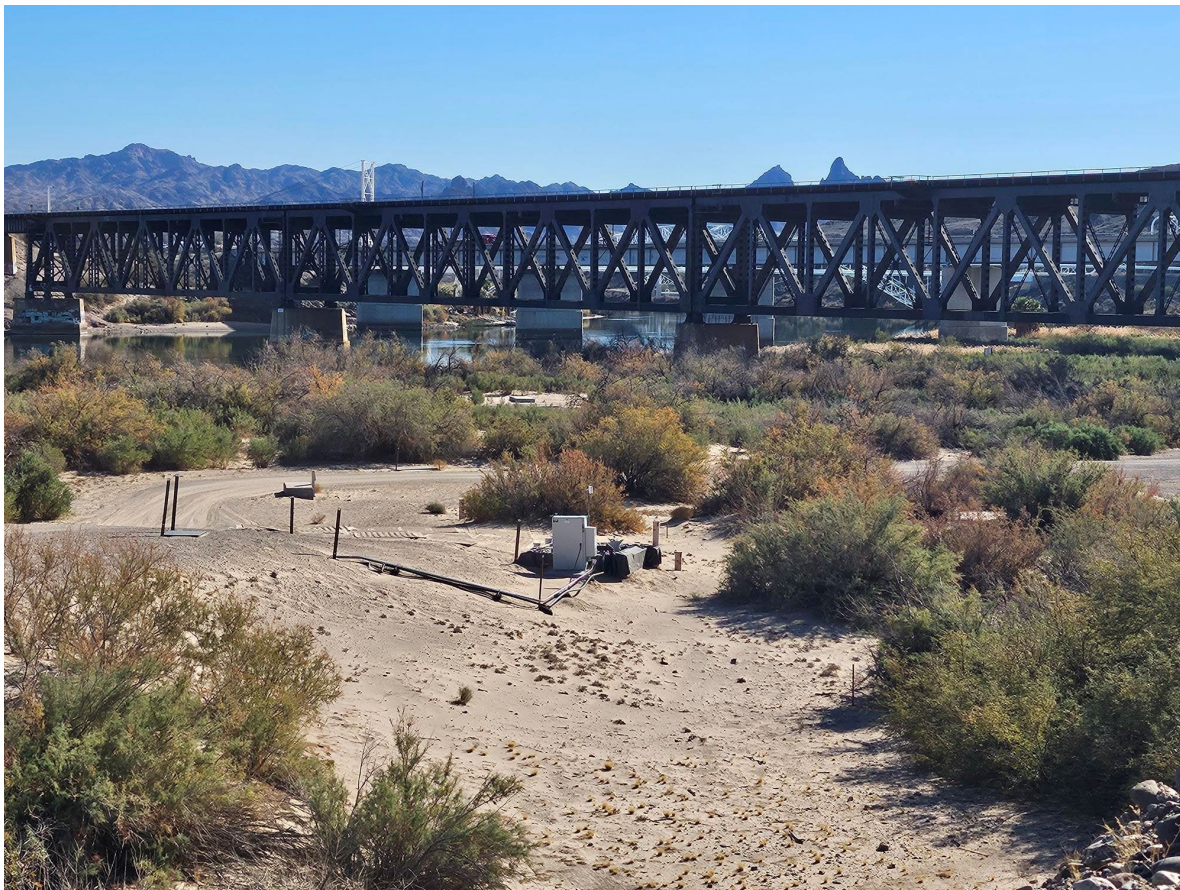
Photo showing aboveground PTI-1D extraction test infrastructure in the floodplain.

1. On September 25, 2023, DTSC stated in the conditional approval of the PTI-1D floodplain extraction test that the additional pipeline, electrical conduits and the trenching is considered an activity under the Future Activity Allowance. The following infrastructures are included in the FAA determination, based on information provided by PG&E:
 - A trench of approximate dimensions of 2 feet wide by 3 feet deep by 50 feet long will be installed between an existing well - PTI-1D and an existing electrical pull box HH3-14E.I. The estimated volume of soil to be displaced from trenching is approximately 11 cubic yards.
 - A new two-inch diameter High Density Polyethylene (HDPE) above ground and below ground conveyance piping will be installed to connect the existing well, PTI-1D, to an existing

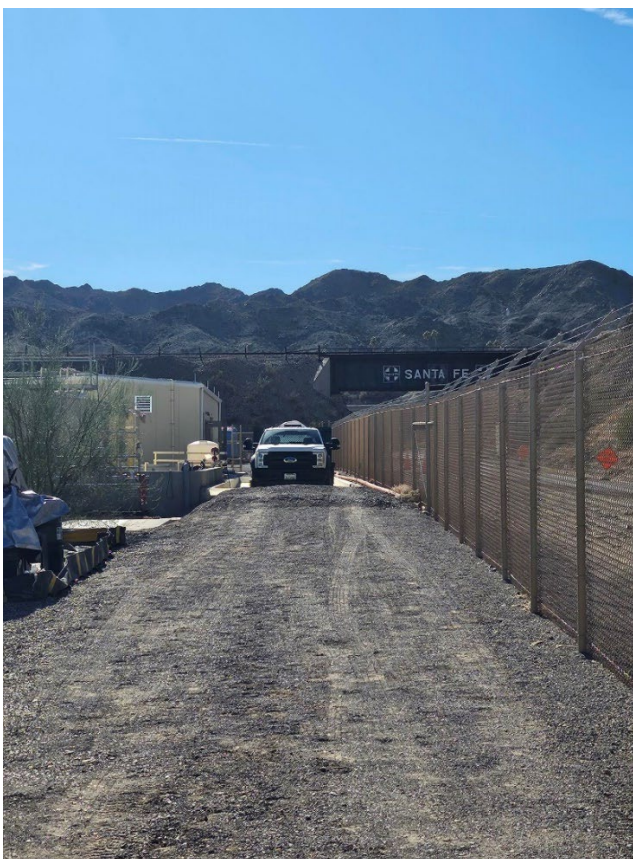
Photo showing the Carbon Amendment Building on the MW-20 Bench and the truck lane.
