**Subject: October 2023 Monthly Progress Report for the Final Groundwater Remedy Construction and Startup, PG&E Topock Compressor Station, Needles, California**  
(Document ID: TPK\_Monthly\_Progress\_Rpt\_November\_2023\_20231110)

**October 2023**  
**Monthly Progress Report for the**  
**Final Groundwater Remedy Construction and Startup**

**PG&E Topock Compressor Station**  
**Needles, California**

**Document ID: TPK\_Monthly\_Progress\_Rpt\_October\_20231110**

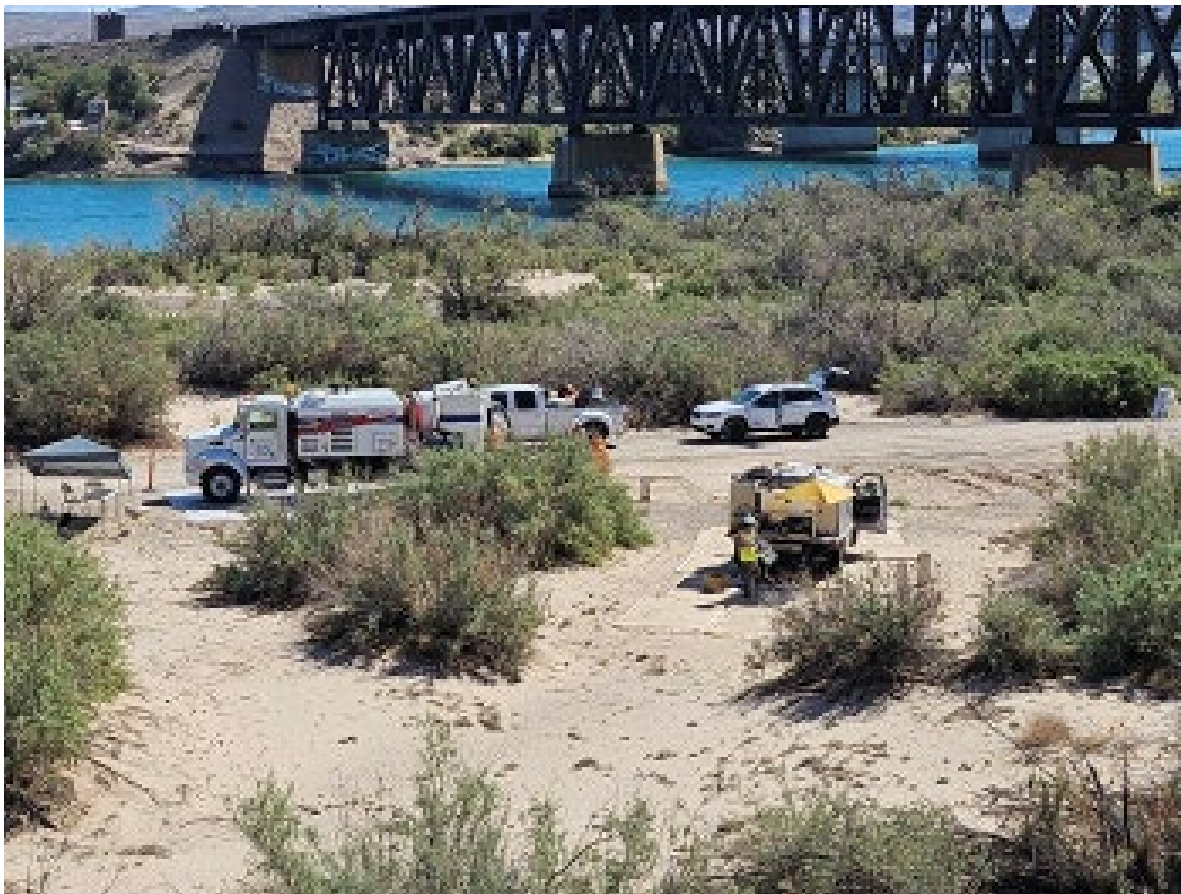
Photo showing site preparation for MW-30-30 replacement in the floodplain.

- Continued installation of infrastructure for PTI-1D floodplain extraction test.
    - Commenced and completed MW-30-30 well abandonment and replacement: over-drilling as planned; well replacement was installed at initial MW-30-30 borehole location.

Other Construction Activities	100%	<ul style="list-style-type: none"> <li>Well MW-30-30 was inoperable. Replacement was necessary. The old well was decommissioned in accordance with the approved WELL-SOP-01 (Standard Operating Procedure for Well and Borehole Permanent Decommissioning). The old well casing was removed, over-drilled to remove any well materials, and a new well was installed in the same borehole. In addition, the well pad and monument at nearby MW-30-050 was replaced.</li> <li>Construction of the infrastructure required for the PTI-1D floodplain extraction test has been completed.</li> </ul>

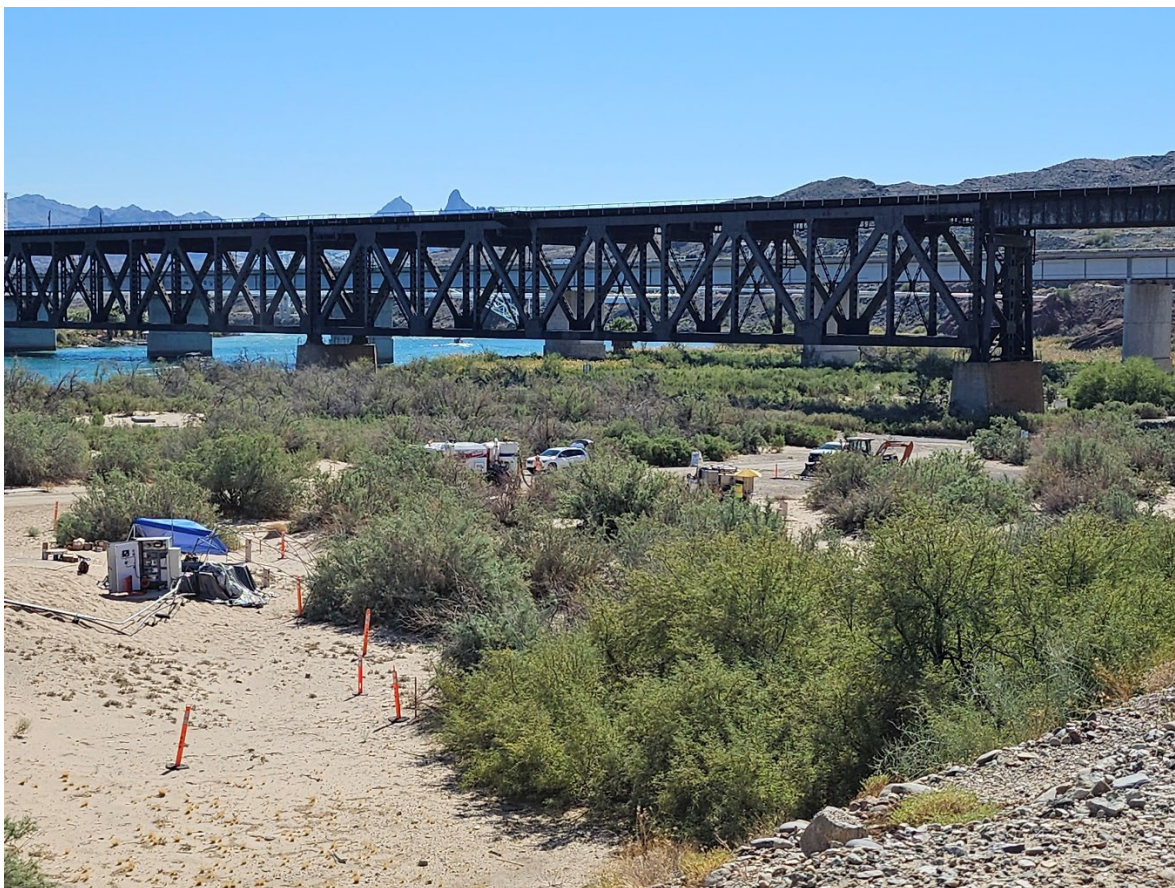
Photo showing the installation of infrastructure for the PTI-1D floodplain extraction test.

- A trench of approximate dimension of 2 feet wide by 3 to 4 feet deep by 470 feet long will be installed from well TWB-3 to well TWB-1. The actual dimension of the trench may vary depending on field conditions.

- Within the trench, there will be two High-Density Polyethylene (HDPE) pipes (2 or 3 inches in diameter by 470 feet long) and three conduits (2 inches in diameter by 470 feet long). Where the trench crosses over PG&E gas pipeline, one pipe sleeve (approximately 4 inches in diameter by 20 feet long, actual dimension may vary depending on field conditions) will be used to contain the HDPE pipes. Therefore, the total pipe length is 2 by 470 and 1 by 20, equaling 960 feet; and total conduit length is 3 by 470, equaling 1,410 feet.

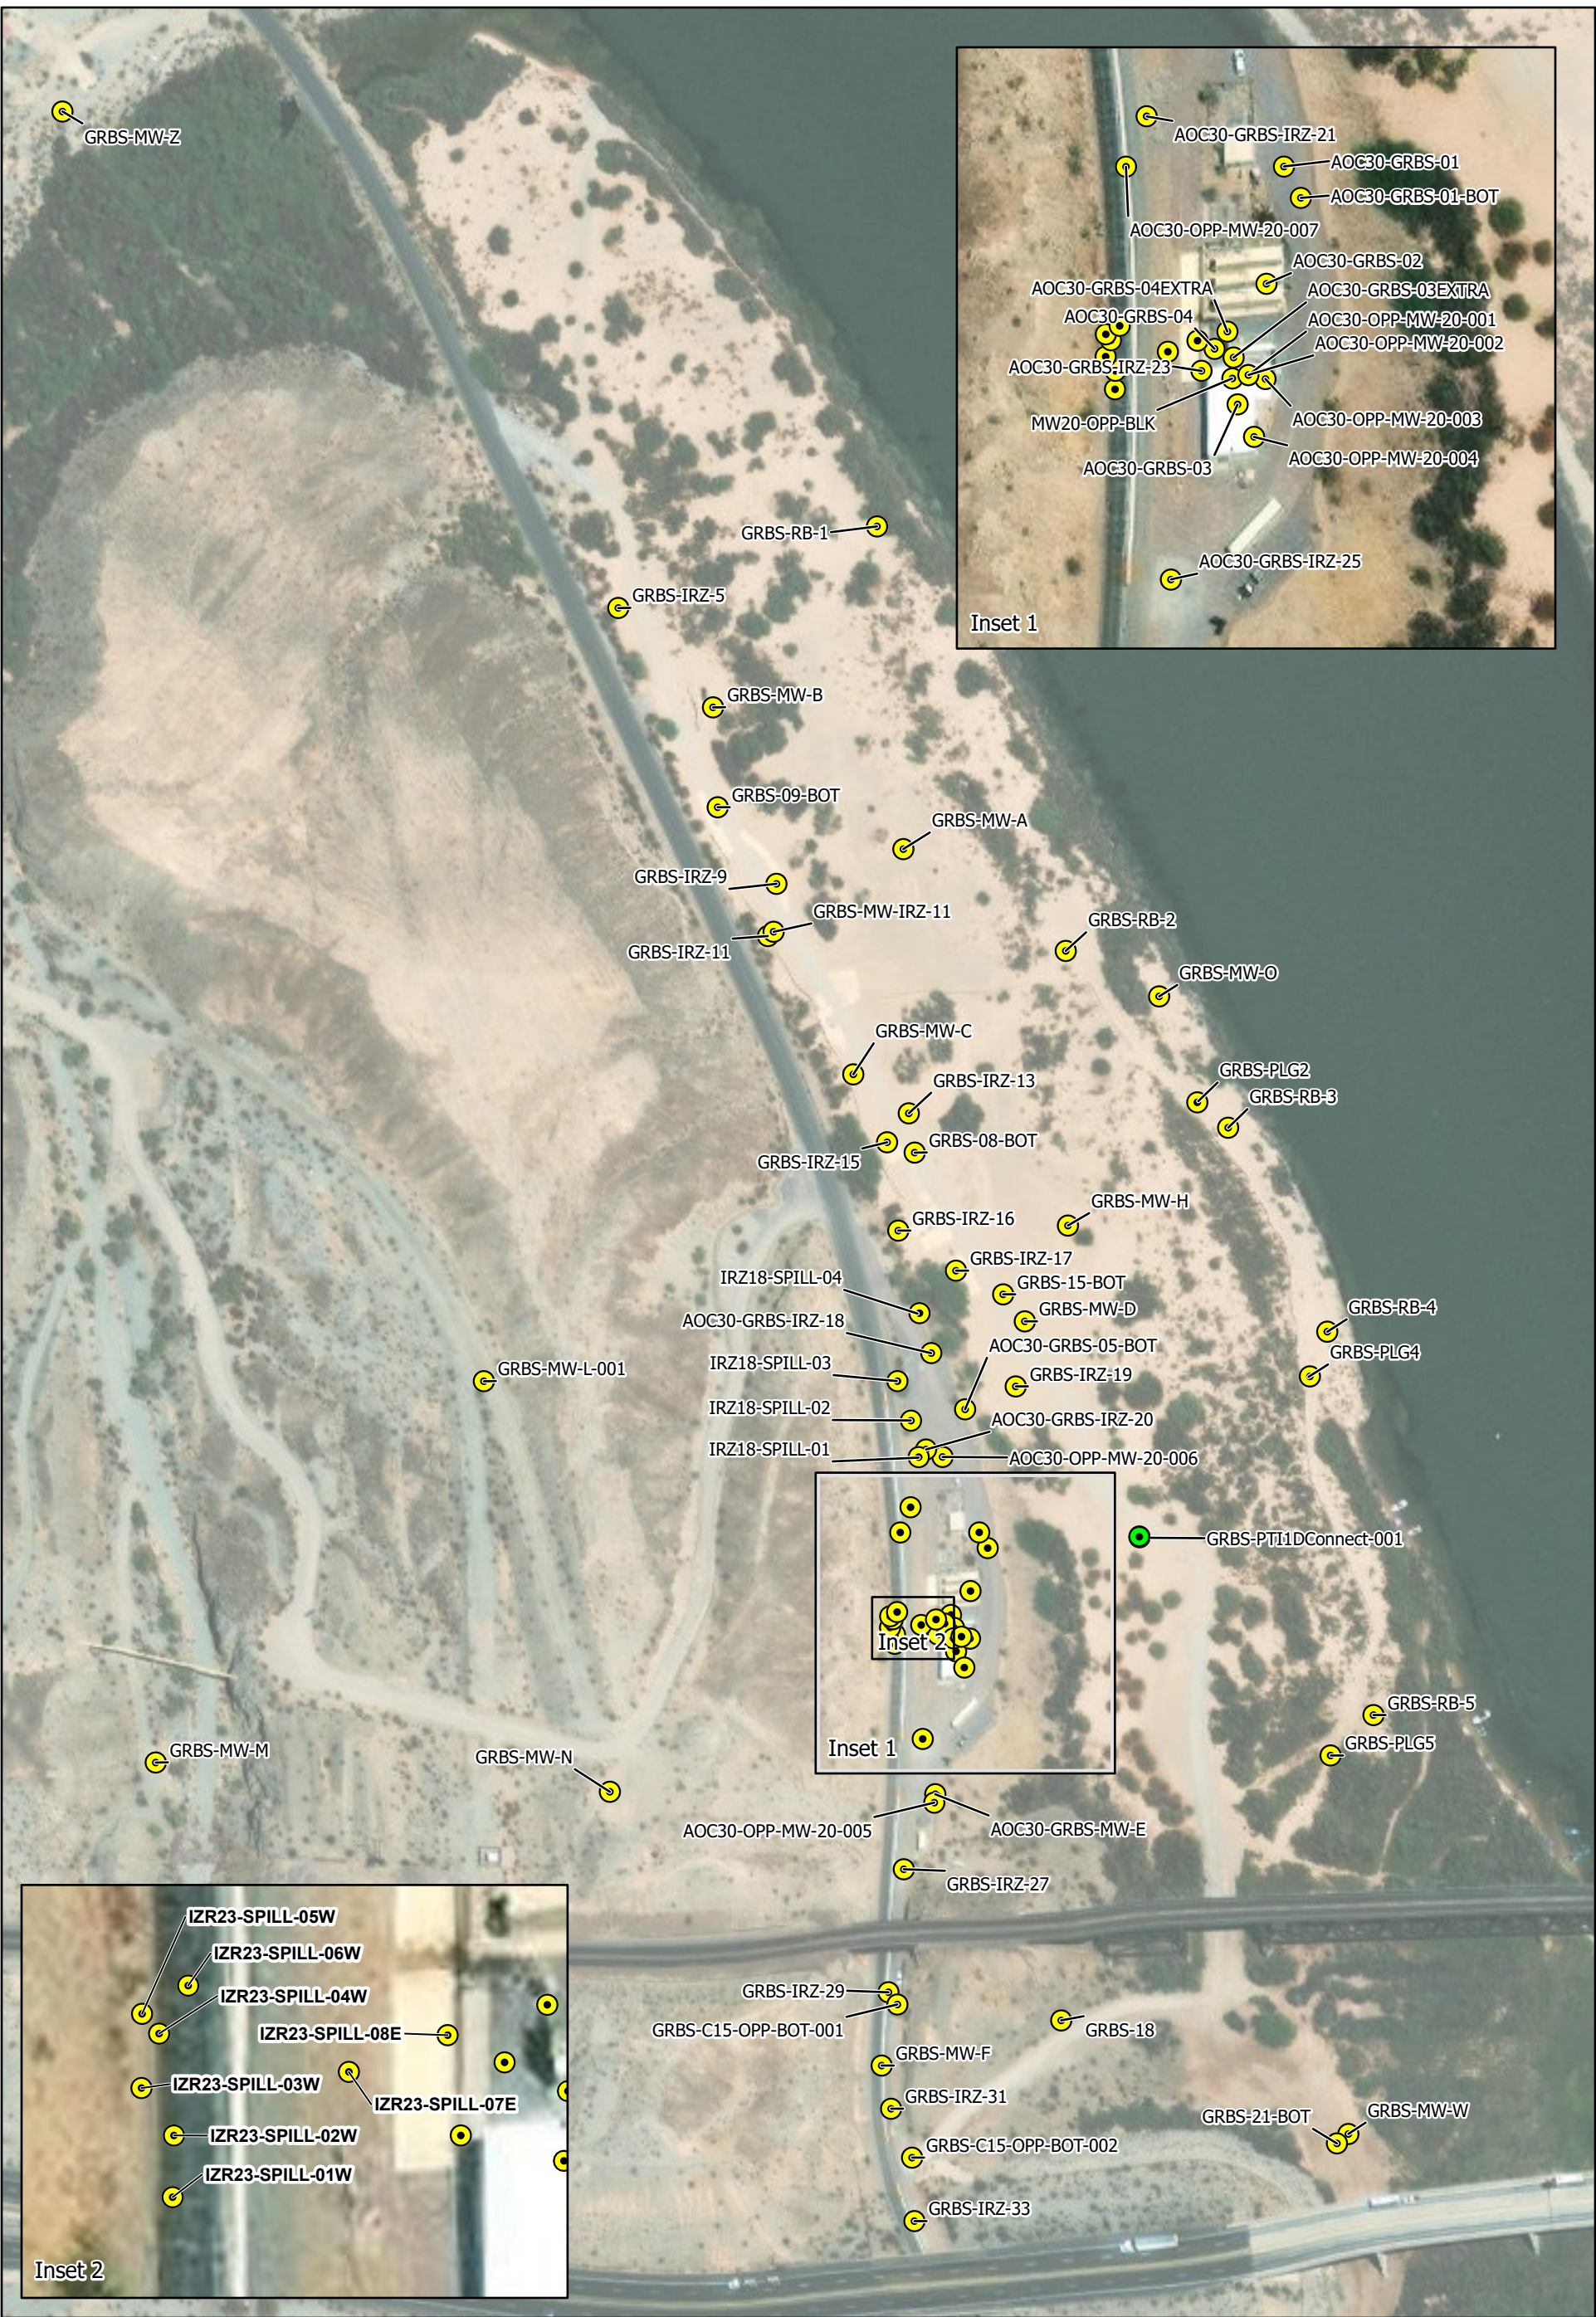
- Soil samples collected October 2023
- Soil Sample Location

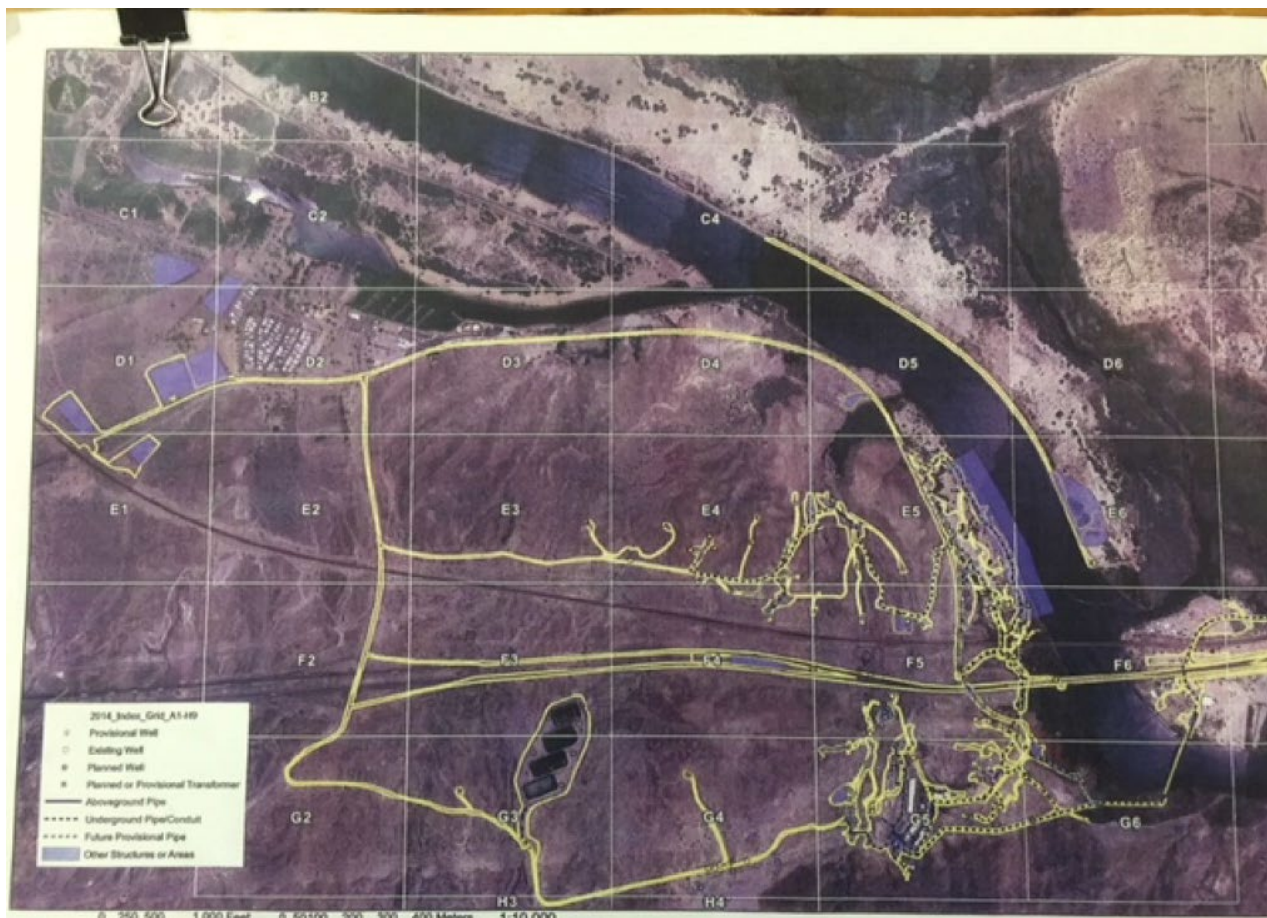
Figure showing a grid superimposed on the Topock site map. Each grid position is denoted by an letter followed by a number.
