Subject: September 2023 Monthly Progress Report for the Final Groundwater Remedy Construction and Startup, PG&E Topock Compressor Station, Needles, California
(Document ID: TPK_Monthly_Progress_Rpt_September_2023_20231010)

September 2023
Monthly Progress Report for the
Final Groundwater Remedy Construction and Startup

PG&E Topock Compressor Station
Needles, California

Document ID: TPK_Monthly_Progress_Rpt_September_20231010

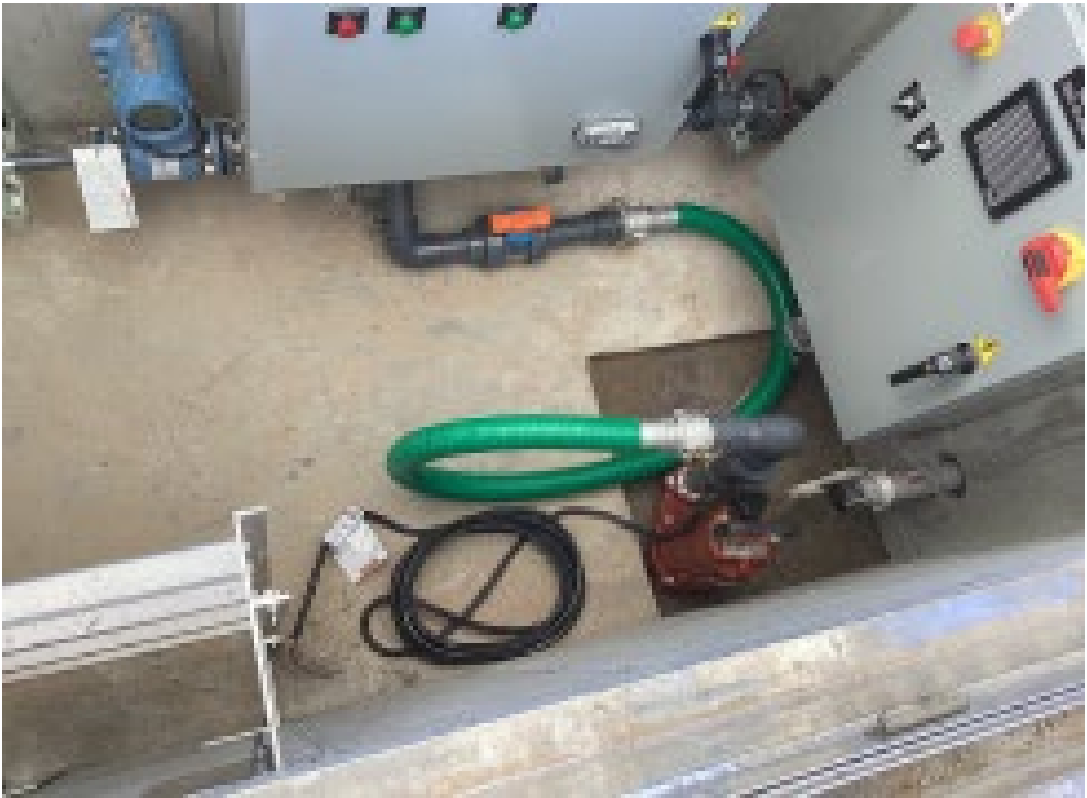
Photo showing sump pump installation in vault RB-5.

- Completed IRZ-23 extraction well modifications: replaced pump with a higher capacity pump.
 - Commenced sump pump installation in Phase 2a vaults.
 - Completed assembly of a temporary office trailer at the Transwestern Bench.

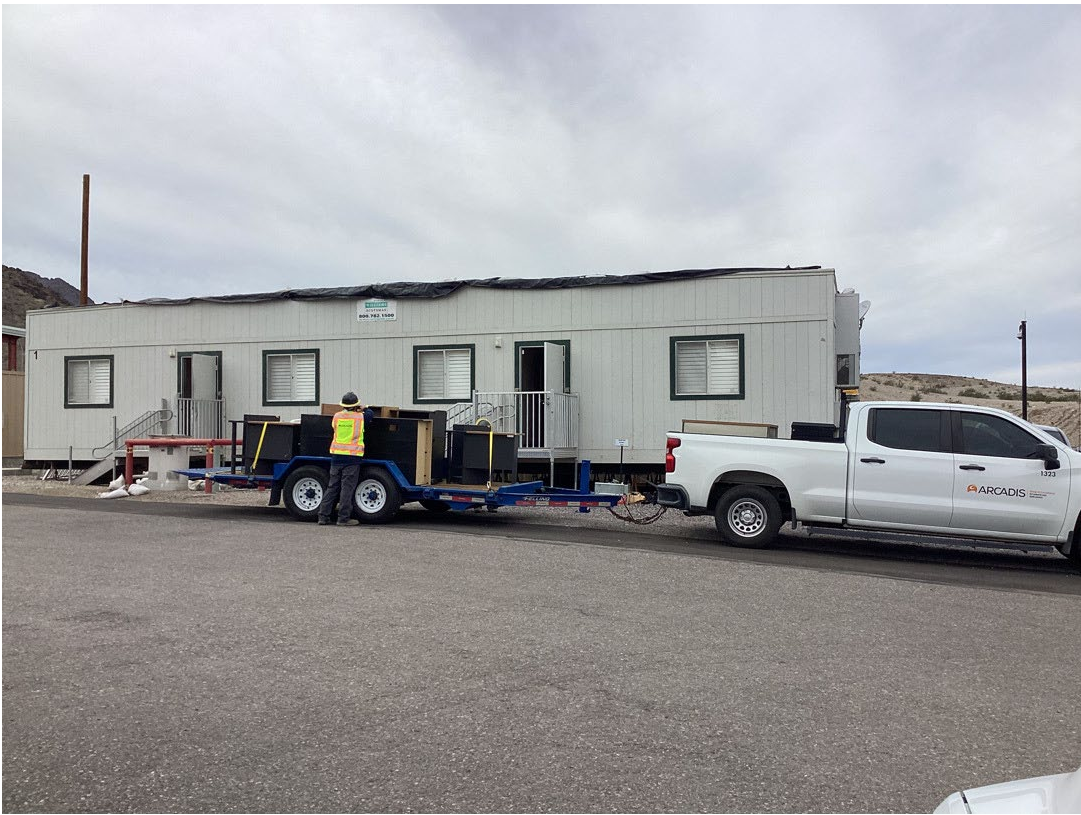
Photo showing loaded trailer ready to transport to Transwestern Bench.
