**Subject: September 2026 Monthly Progress Report for the Final Groundwater Remedy Construction and Startup, PG&E Topock Compressor Station, Needles, California**  
(Document ID: TPK\_Monthly\_Progress\_Rpt\_September\_2026\_20260910)

**September 2026**  
**Monthly Progress Report for the**  
**Final Groundwater Remedy Construction and Startup**

**PG&E Topock Compressor Station**  
**Needles, California**

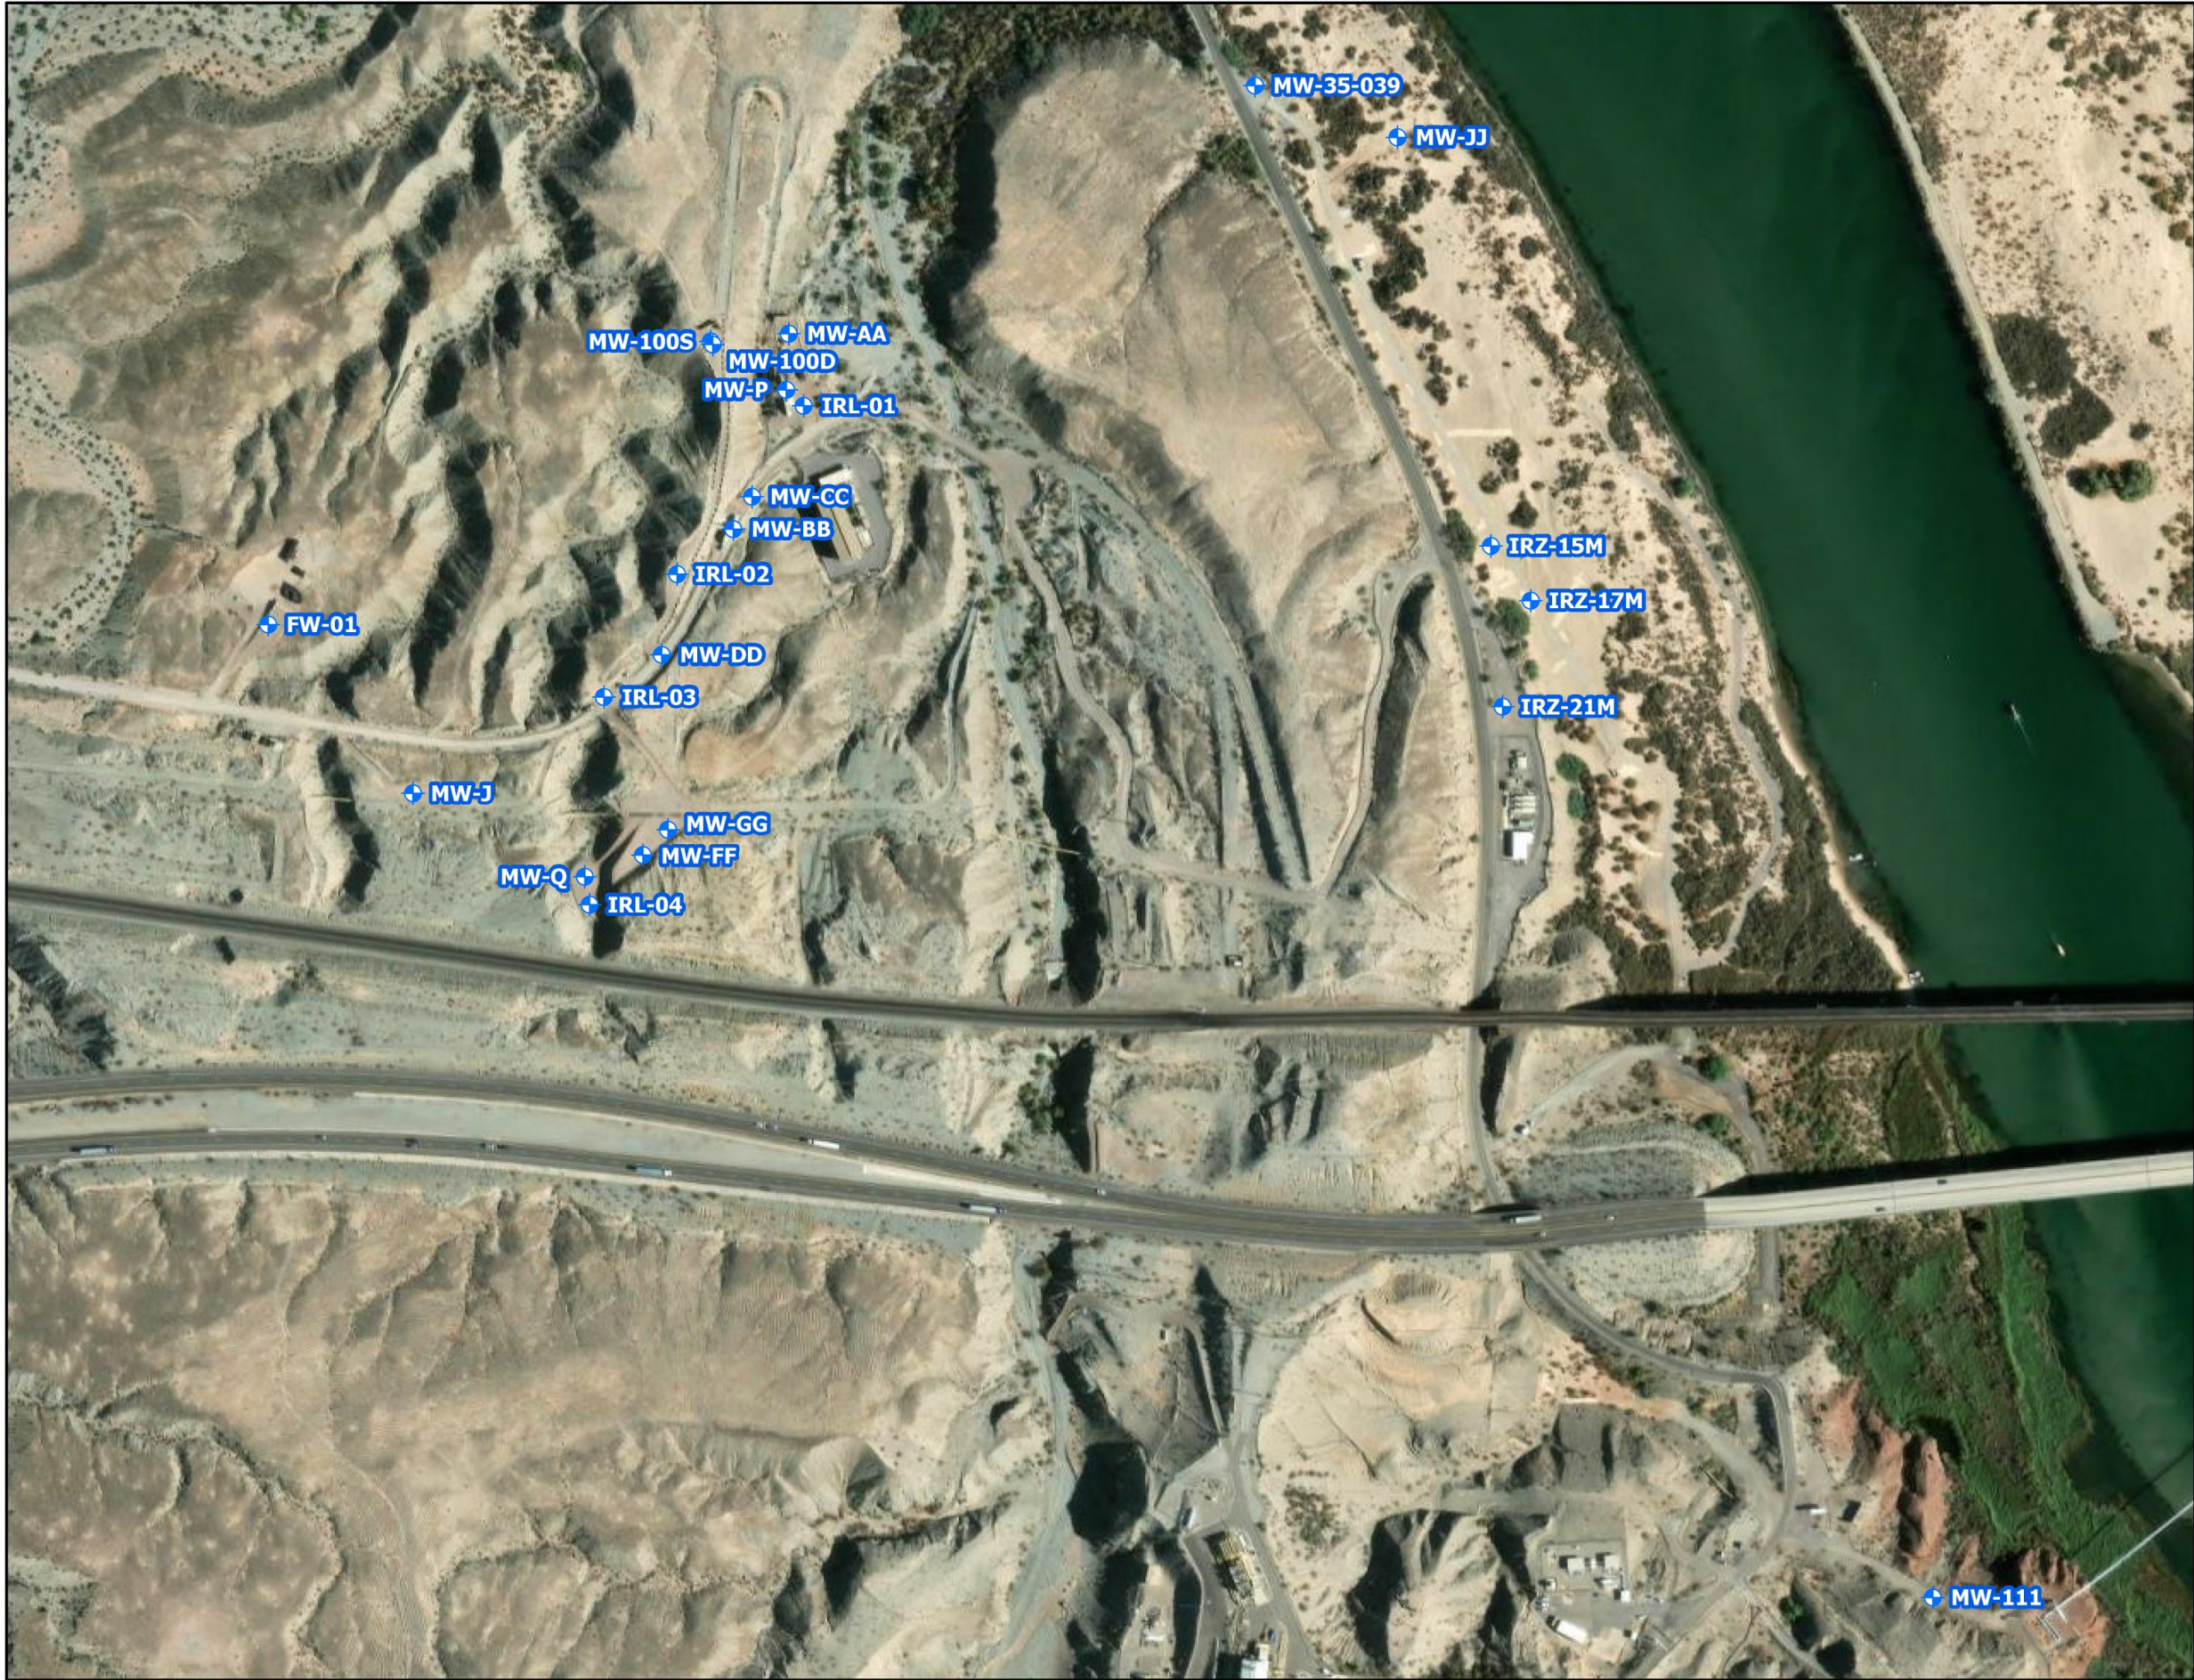
**Figure 2-2**  
**Phase 2b Well Locations**  
 PG&E Topock Compressor Station,  
 Needles, California

⛶ Phase 2b Well

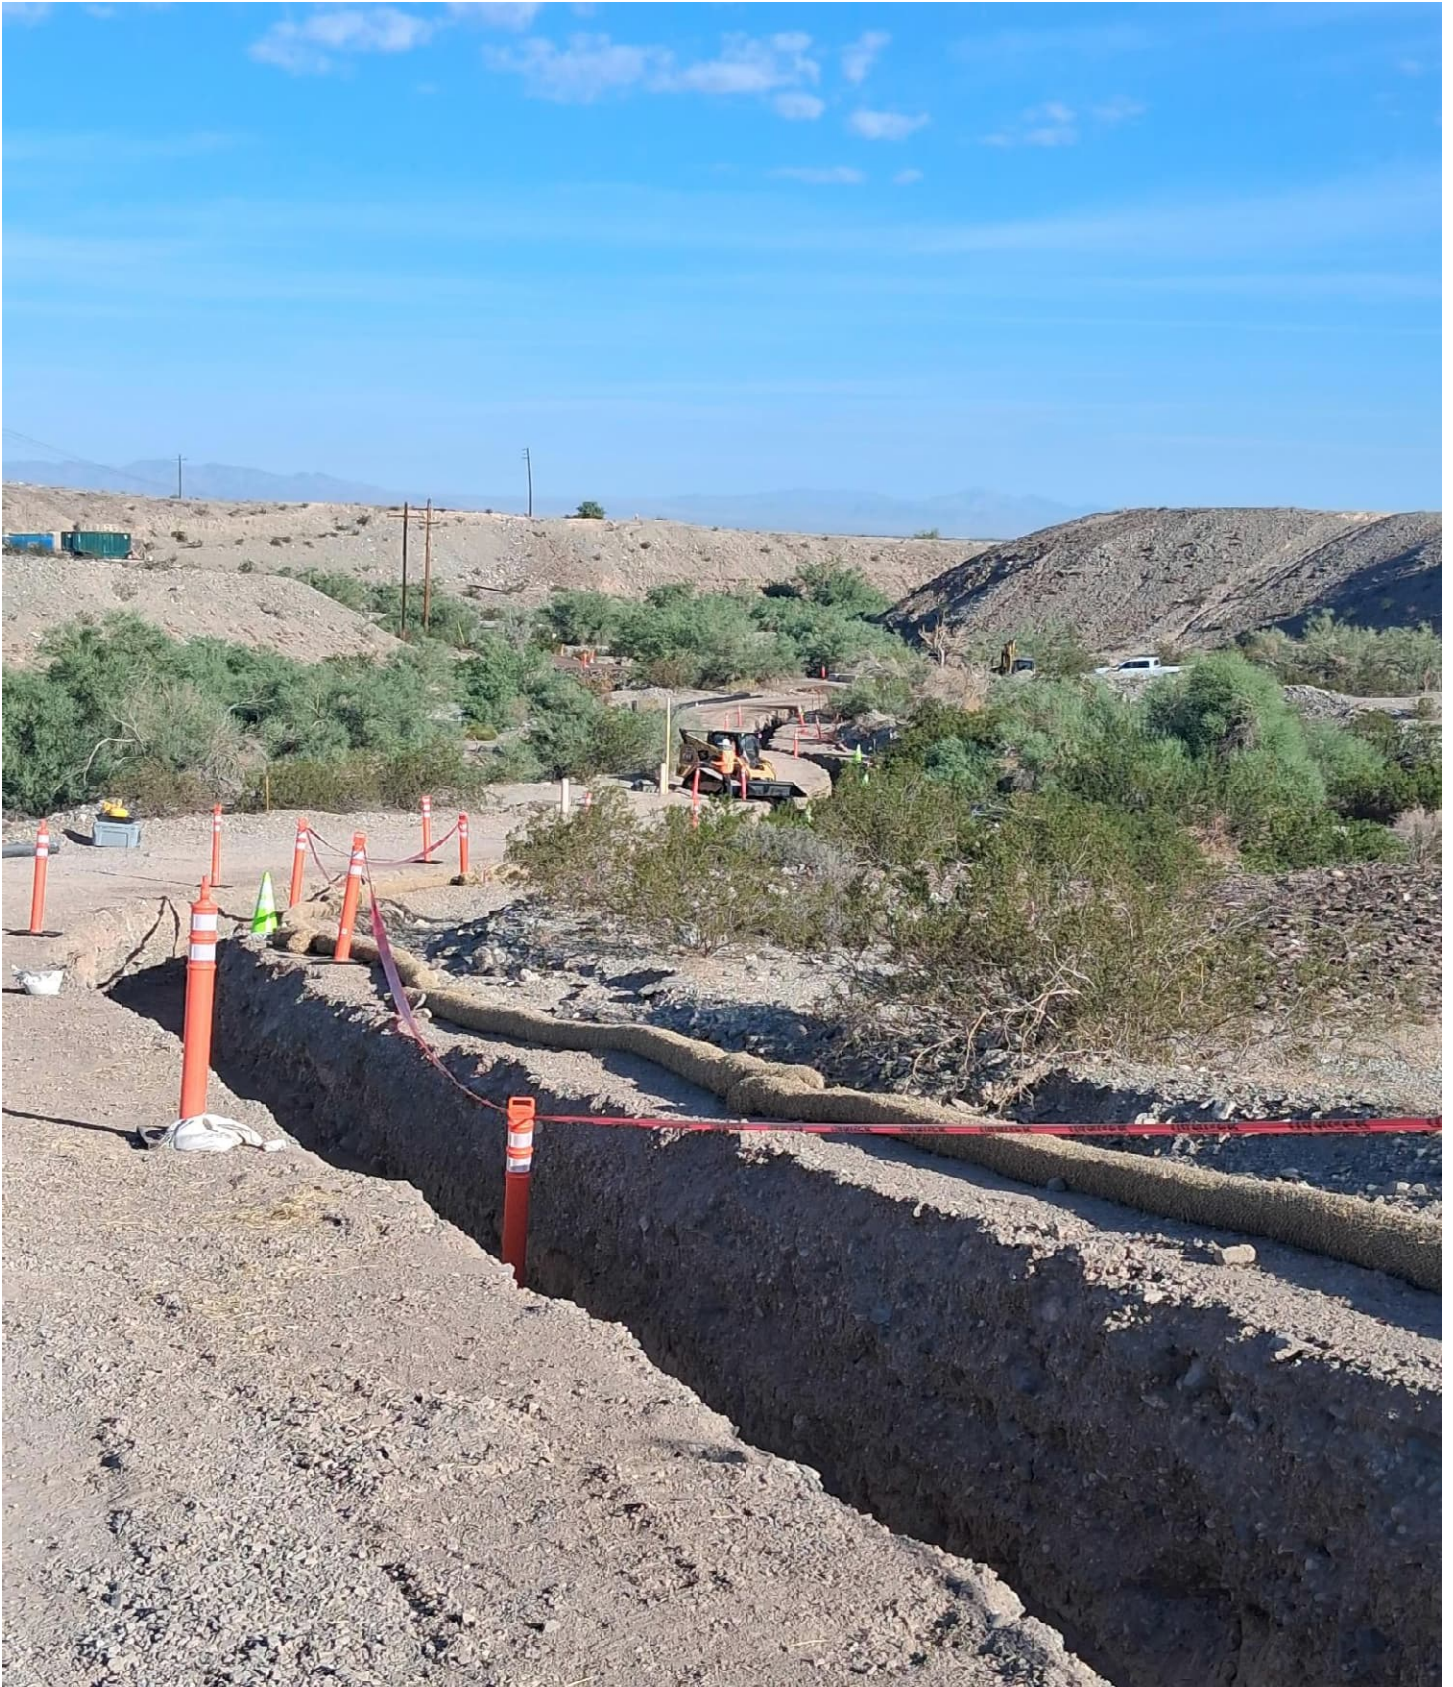
Photo showing in-progress Pipeline A, looking towards IM3 and Bat Cave Wash. Photo taken on 09/26/26.

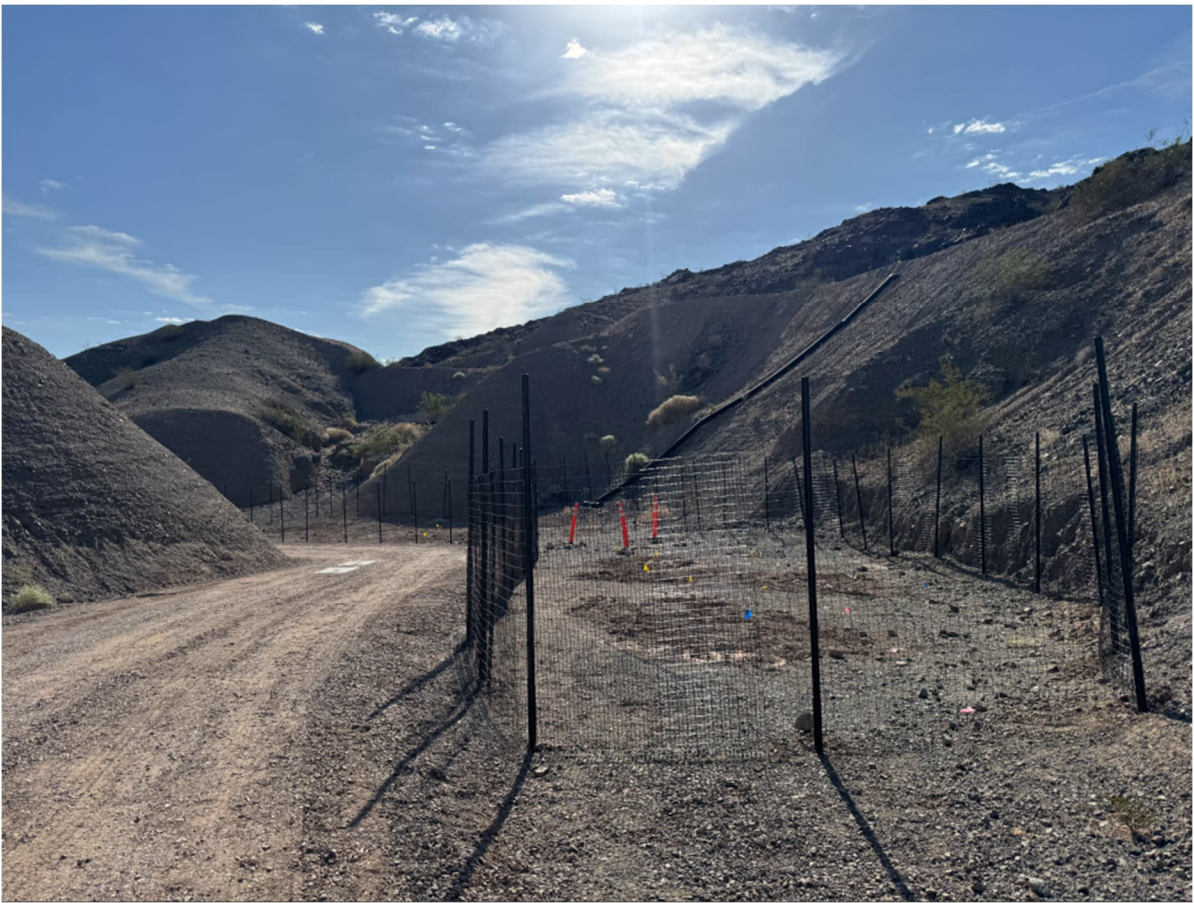
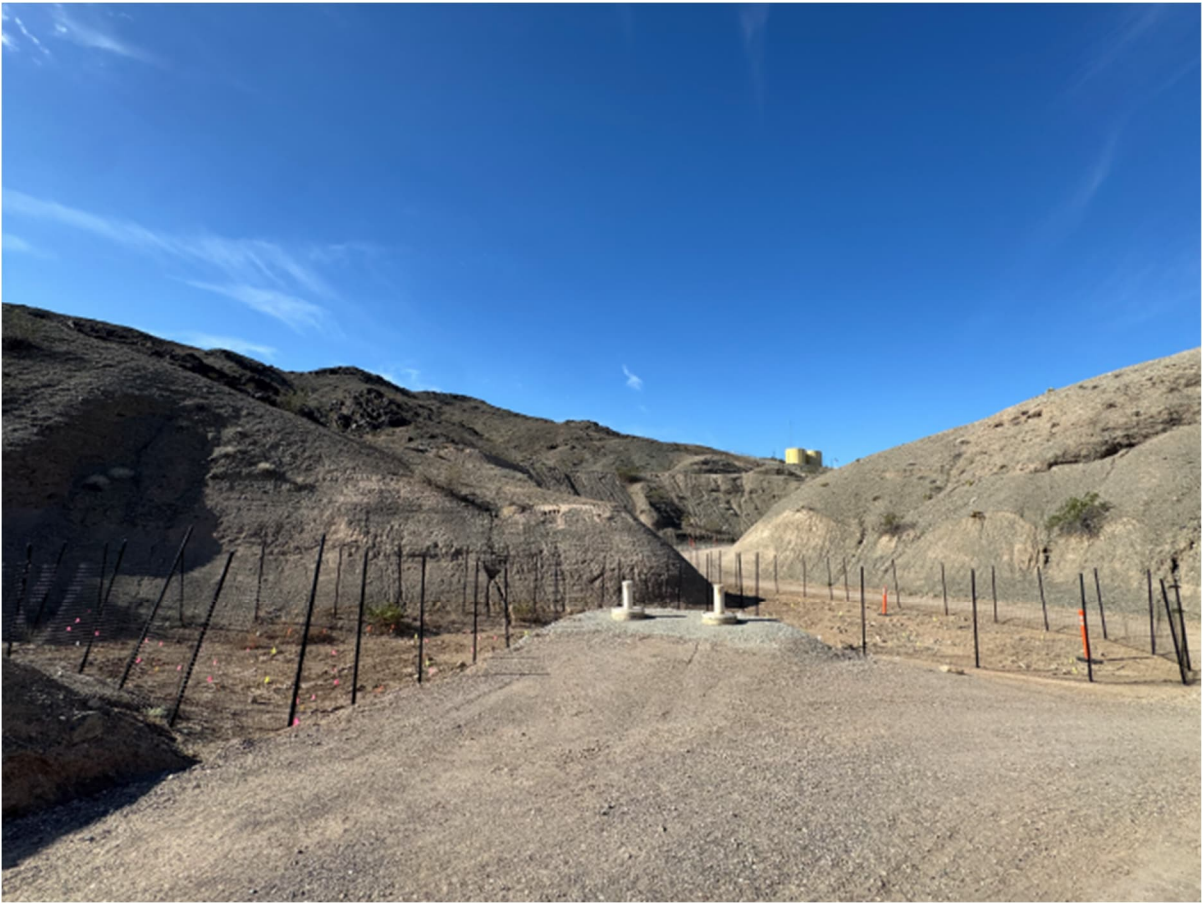
Photos showing in-progress Soil NTCRA mitigation planting areas in East Ravine. Photos taken on 09/26/26.

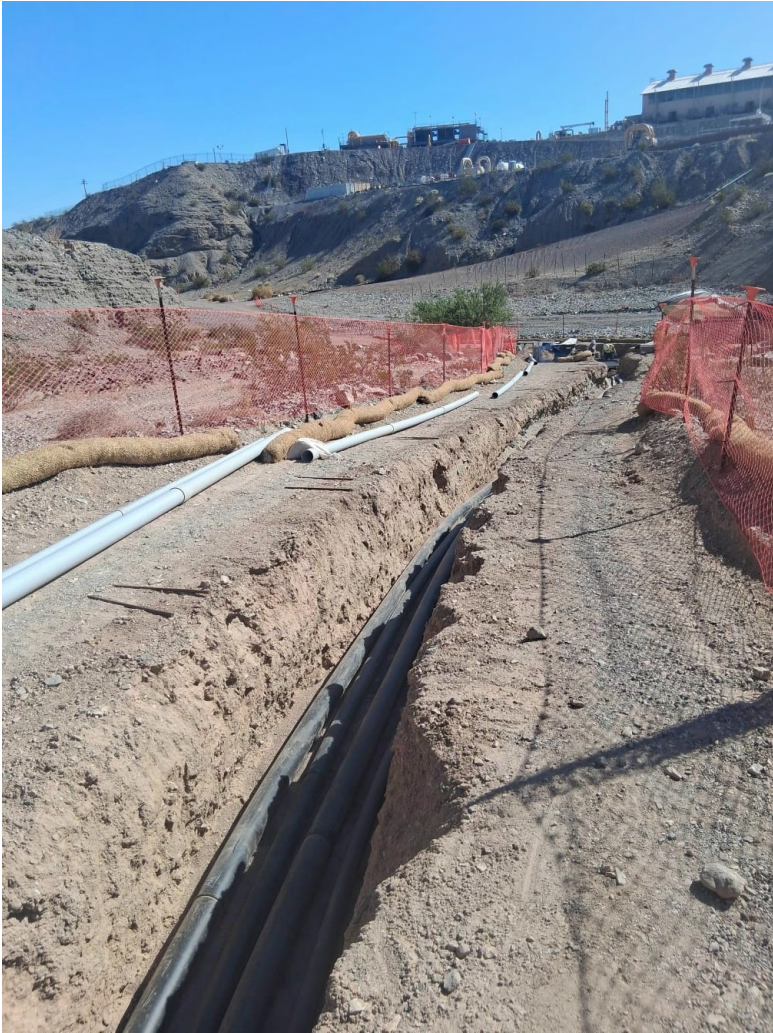
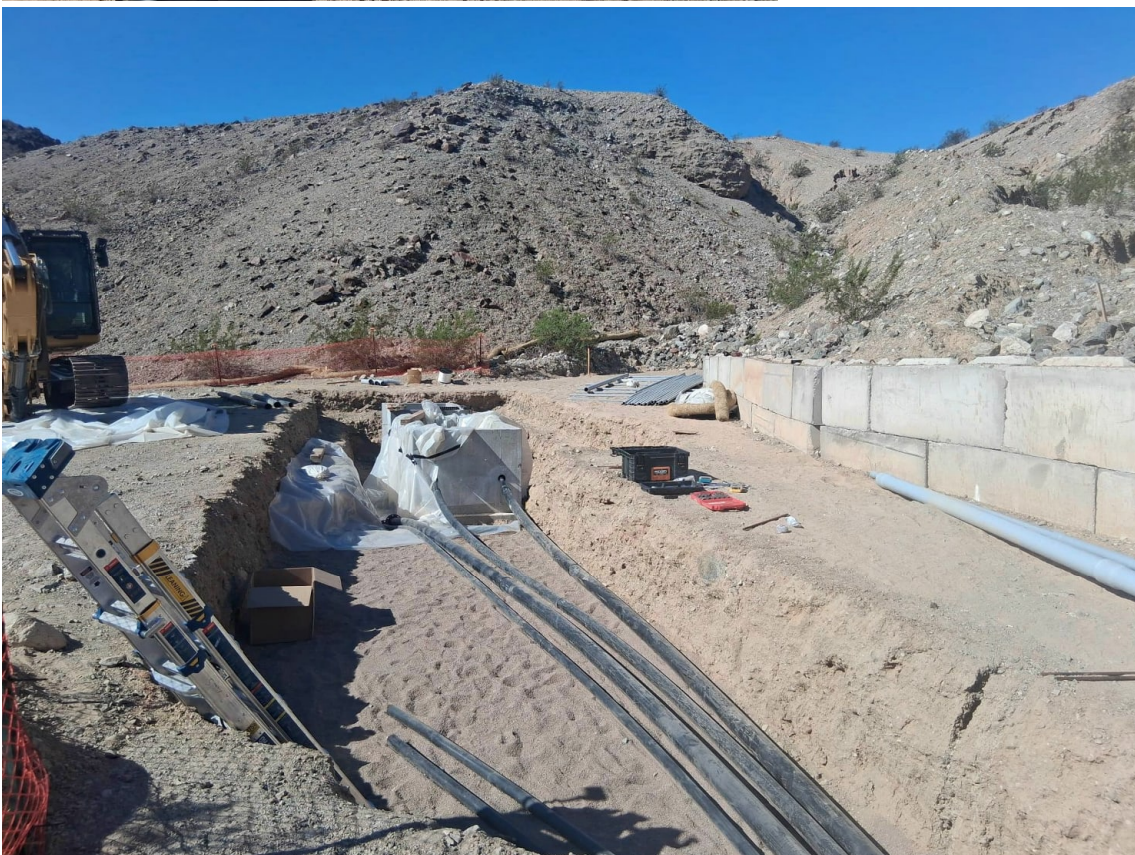
Photos showing in-progress Pipeline I2 and well vault at FW-02B looking towards Bat Cave Wash. Photos taken on 09/26/26.

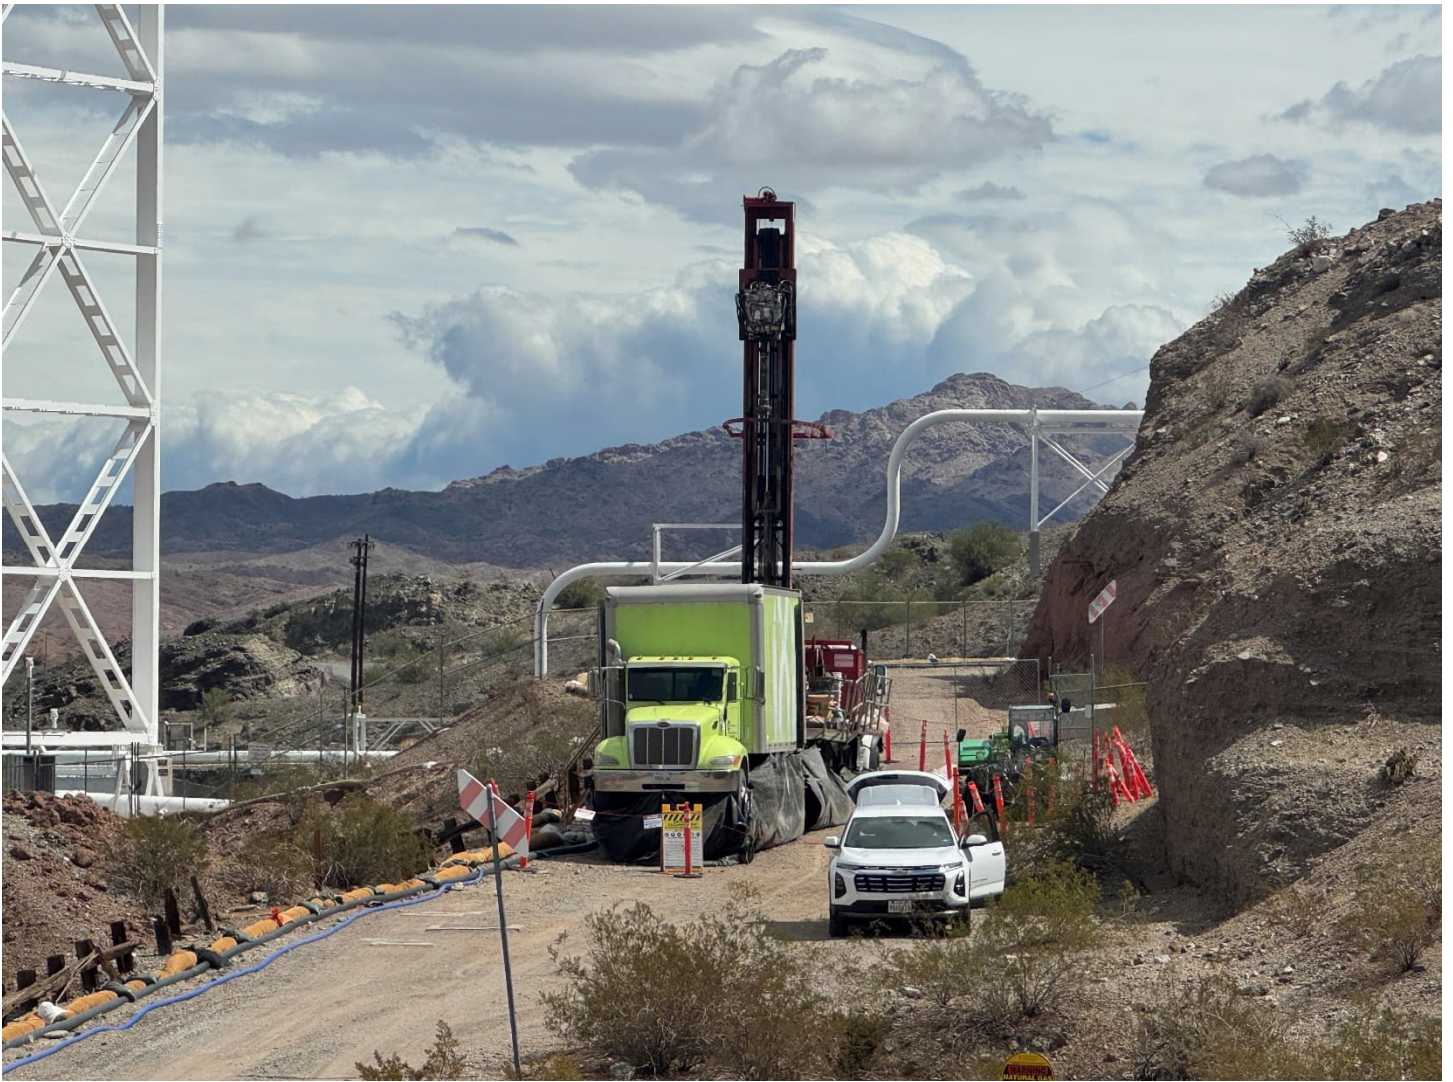
Photos showing the drill rig at MW-111 (former MW-T). Photo taken on 09/30/26.

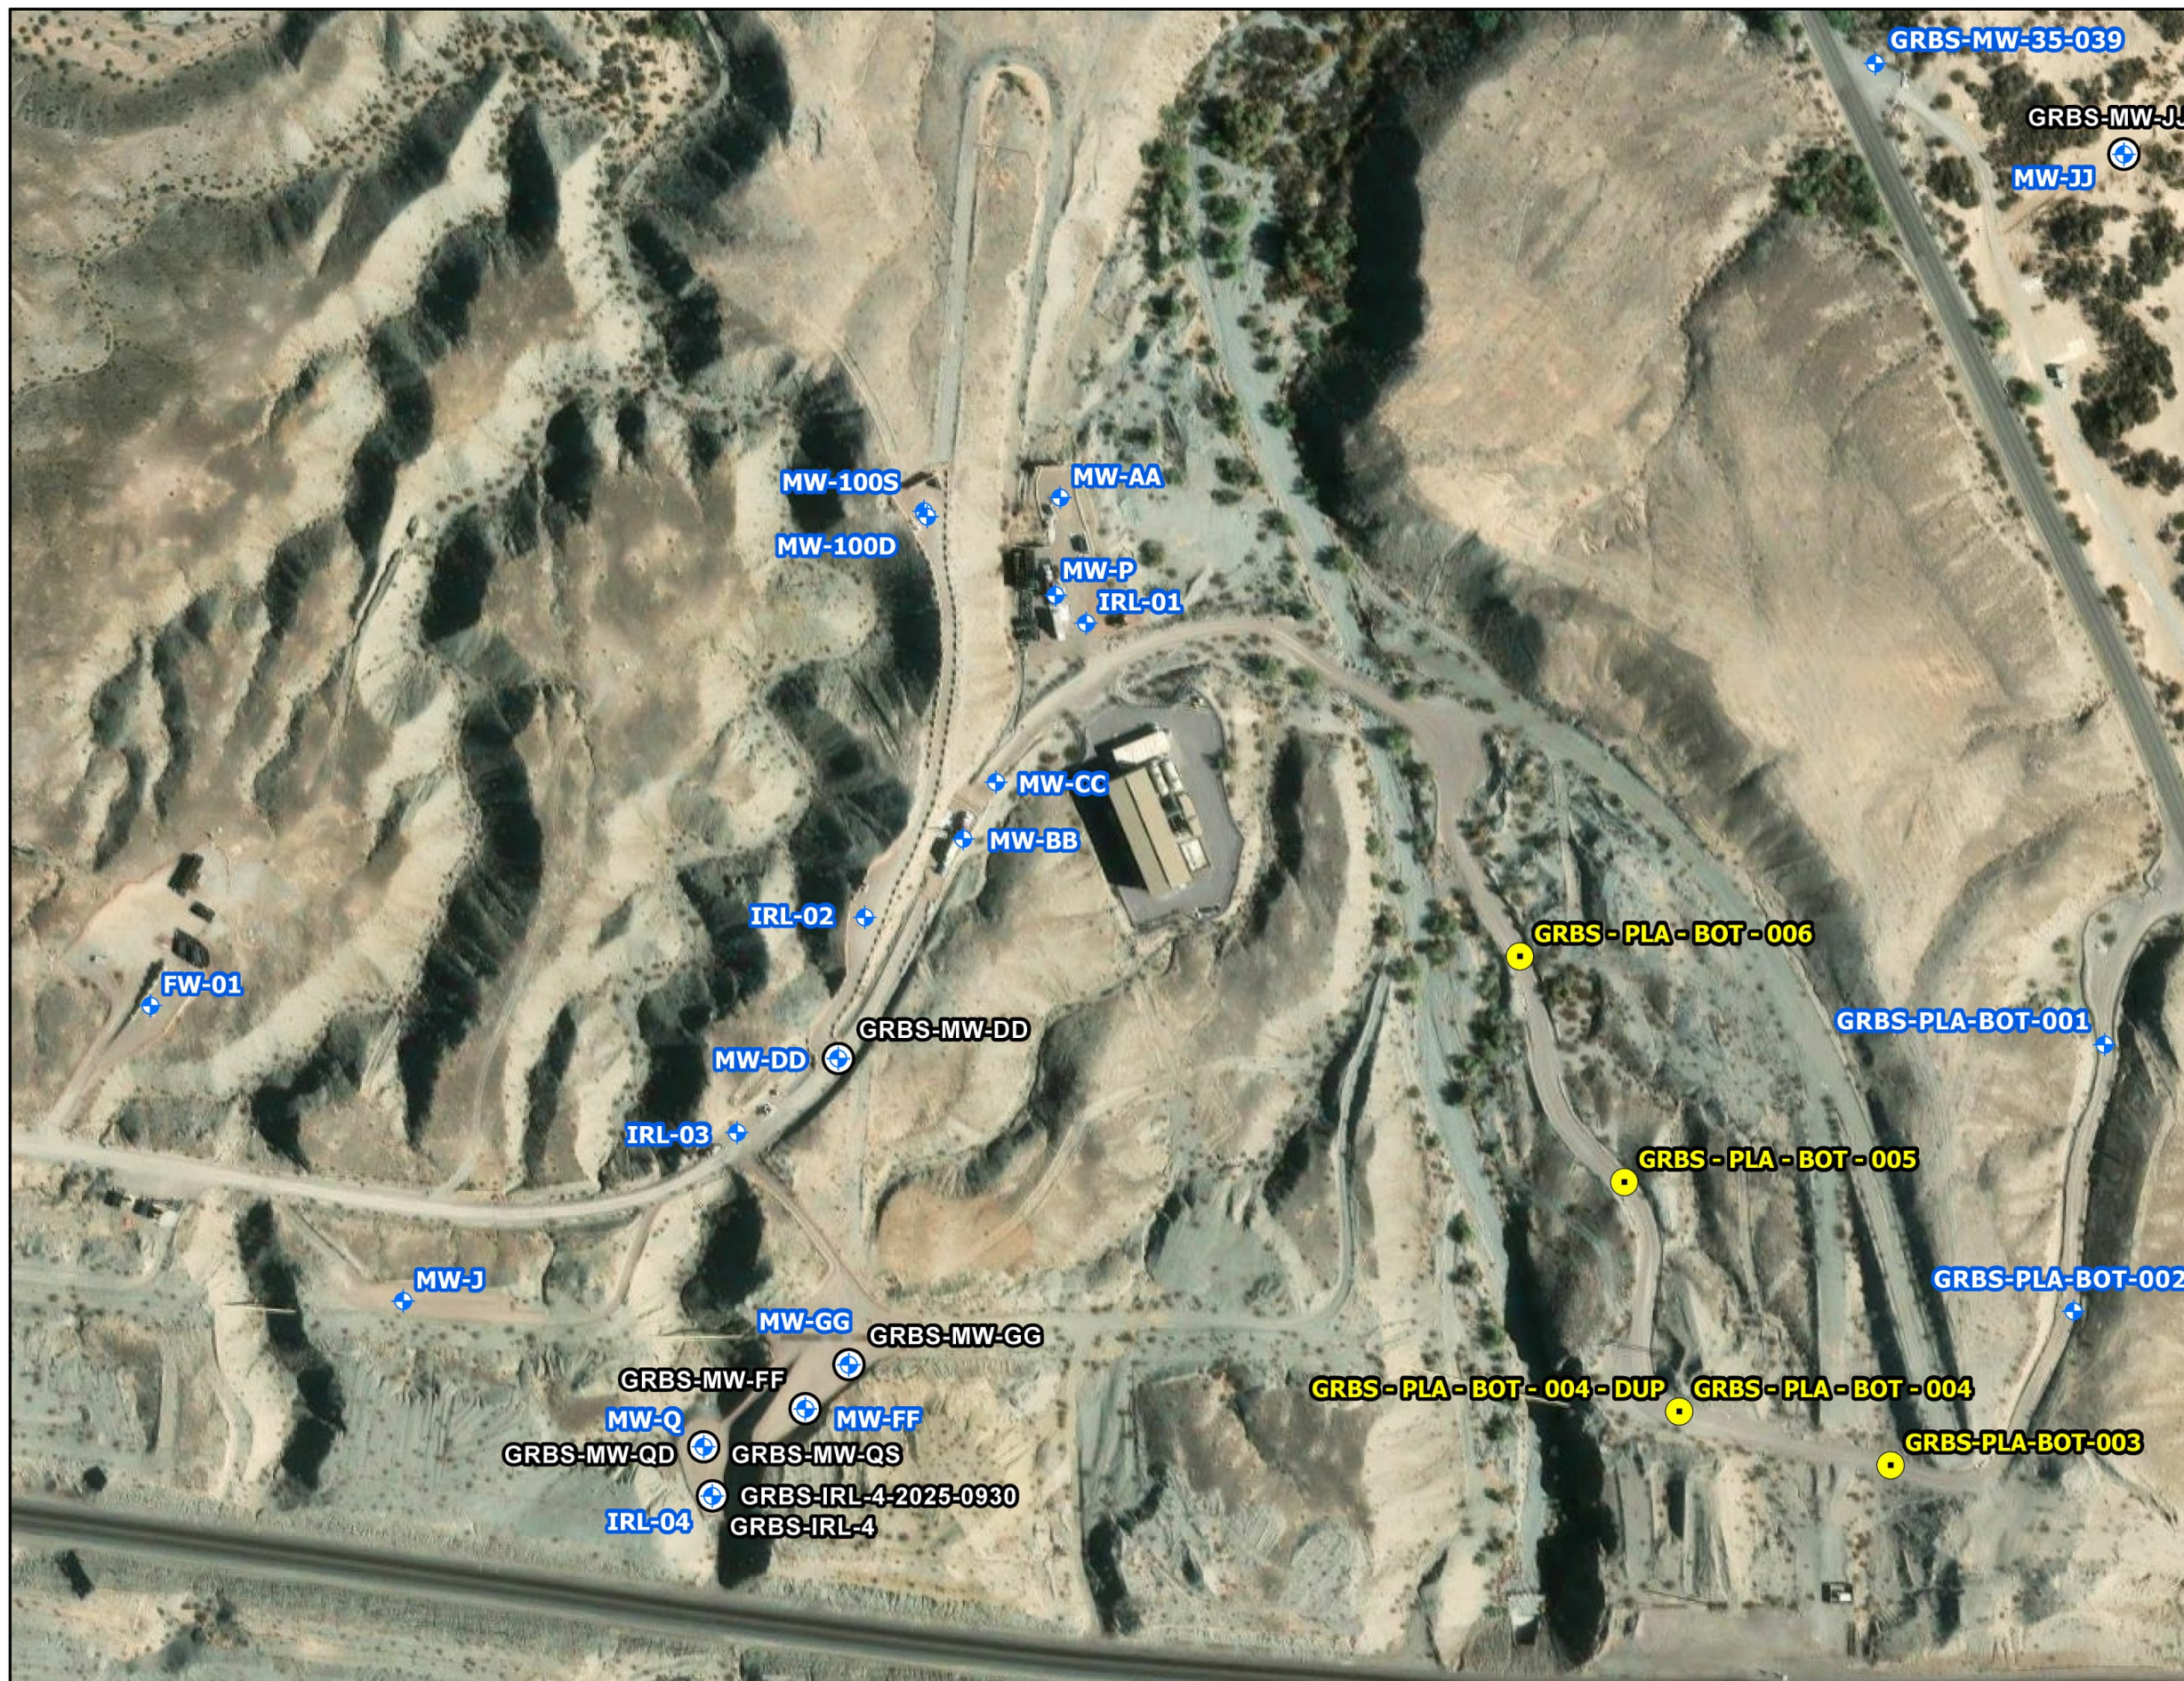
**Baseline Soil Sampling September 2026**  
 PG&E Topock Compressor Station,  
 Needles, California

- Legend**
- + Phase 2b Well
  - ⊙ Previous Soil Sample Location
  - Soil Sample Collected in September 2026
