**Subject: May 2023 Monthly Progress Report for the Final Groundwater Remedy Construction and Startup, PG&E Topock Compressor Station, Needles, California**  
(Document ID: TPK\_Monthly\_Progress\_Rpt\_May\_2023\_20230610)

**May 2023**  
**Monthly Progress Report for the**  
**Final Groundwater Remedy Construction and Startup**

**PG&E Topock Compressor Station**  
**Needles, California**

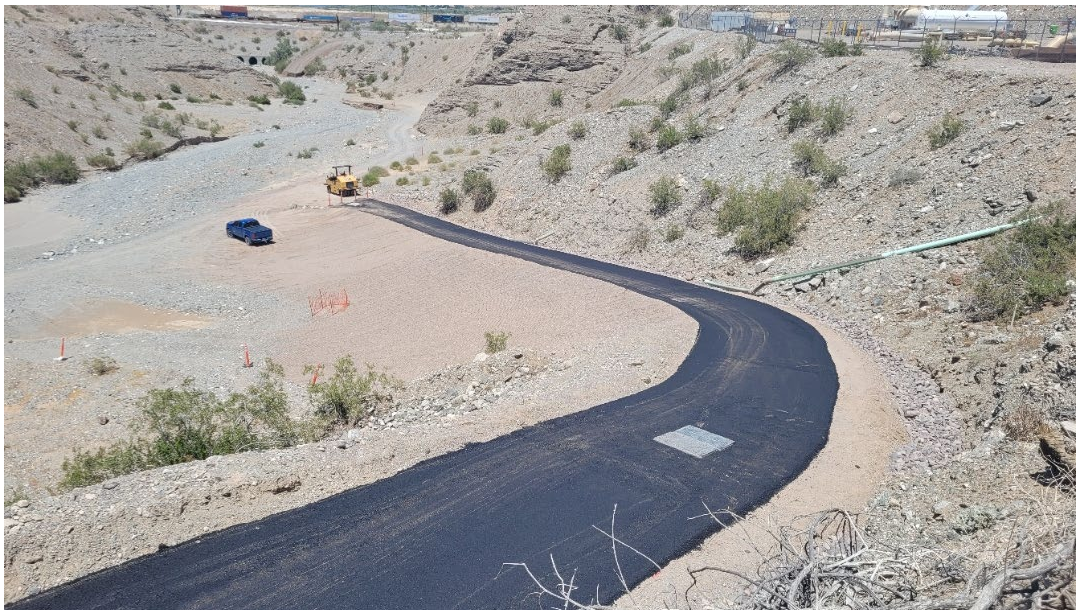
Photo showing asphalt placement on Pipeline I2 access road from TCS to Bat Cave Wash.

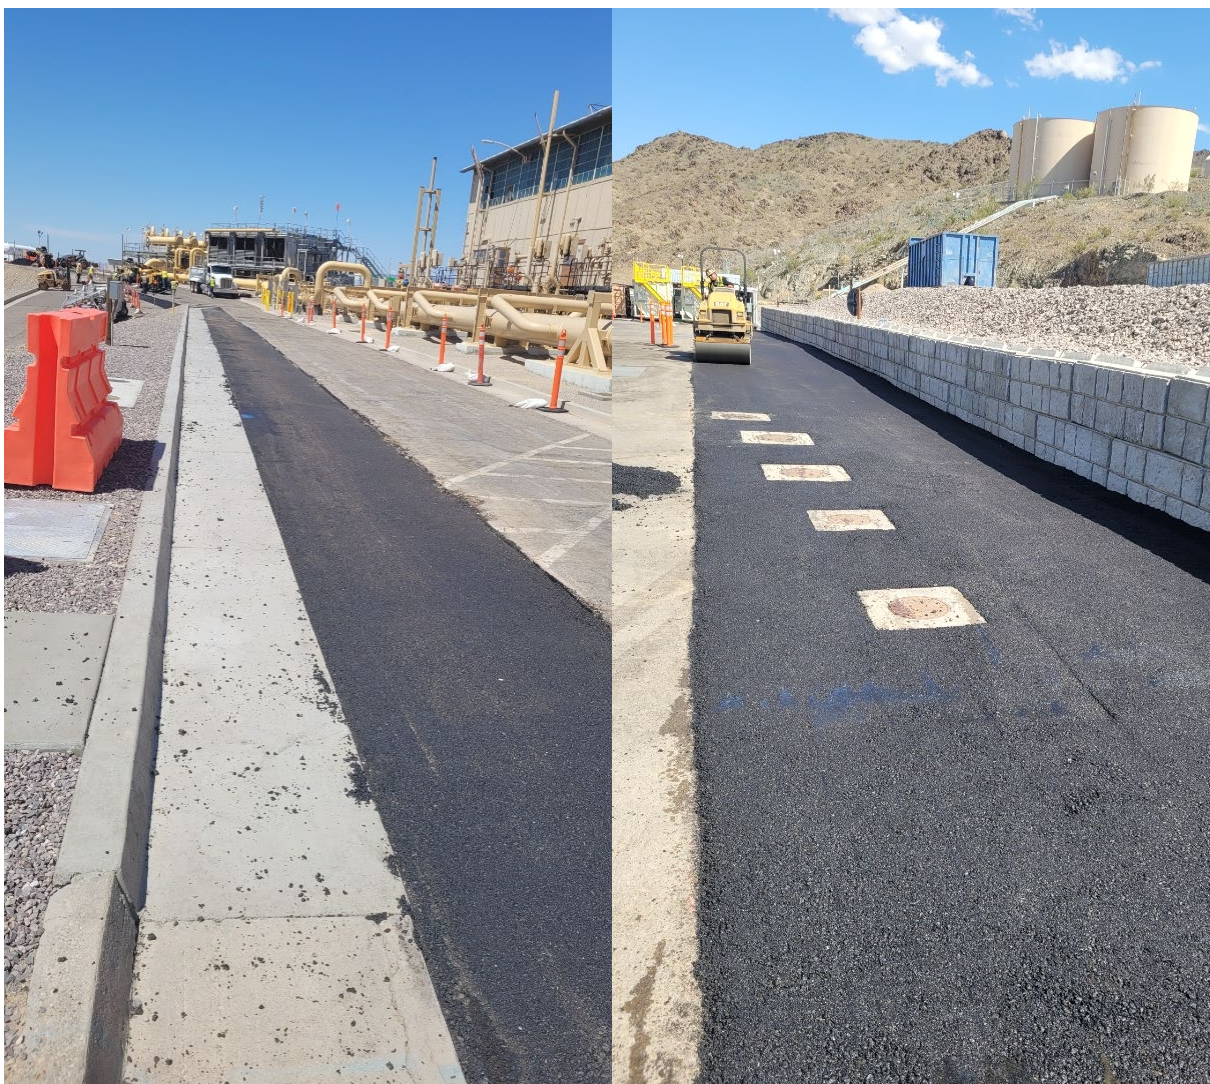
Photos showing asphalt placement atop remedy pipelines inside TCS.

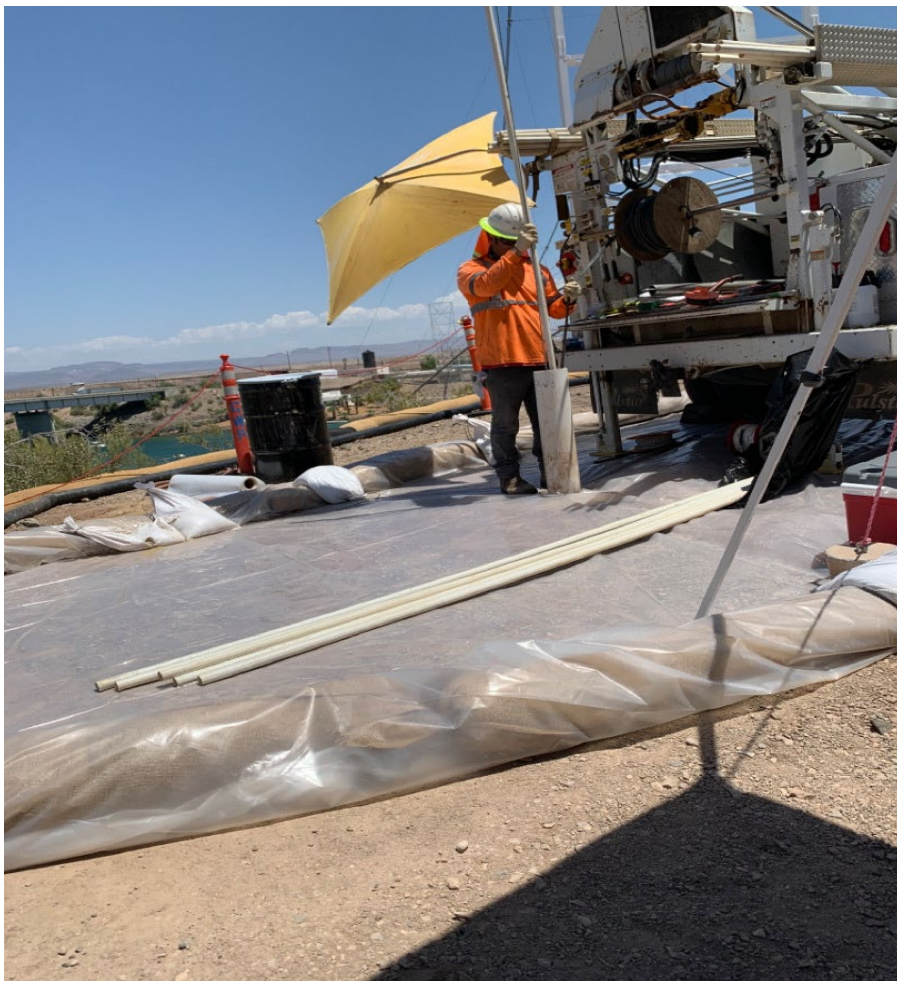
Photo showing installation of downhole equipment at well ER-3.

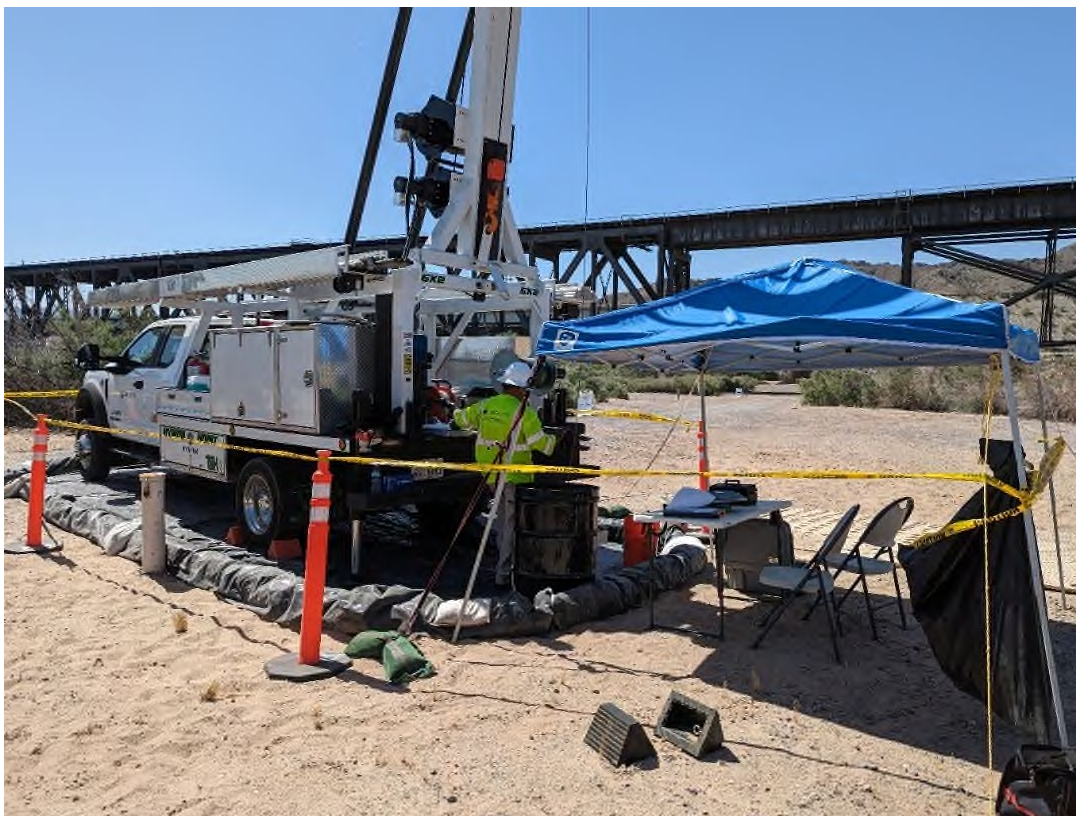
Photo showing well redevelopment at MW-30-30.

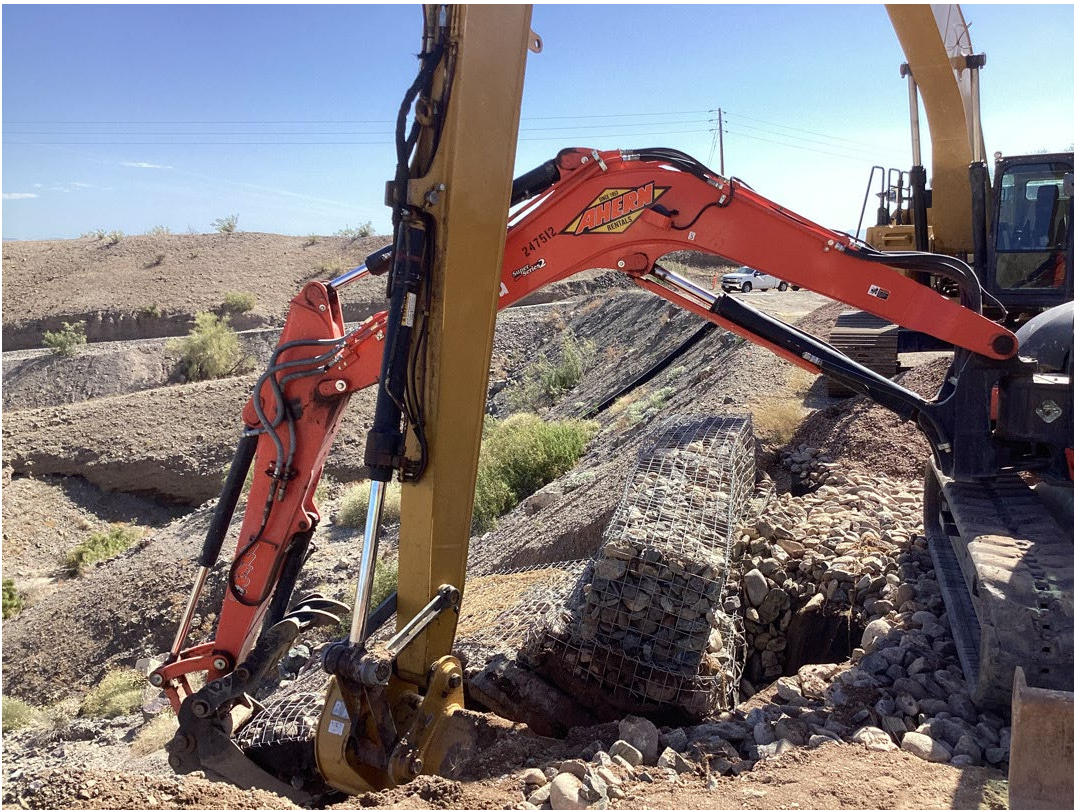
Photo showing the use of excavators to lift and adjust the damaged gabions along Pipeline B access road.

- Repair of stormwater erosion control measures along Pipeline B access road resumed in March 2023. March repair activities occurred within the designated work area (aka, maximum construction footprint). To complete the scope of repair, on May 8, 2023, PG&E requested approvals from BLM, CDFW, and USFWS for work outside of the designated work area. Approvals were received from BLM on May 8, CDFW on May 15, and USFWS on May 17, 2023. Repair work is underway.
- During redevelopment (5/13-5/14), the surge block that was used to disturb settled sediments at the bottom of MW-30-030 became sand locked during the process. Several attempts to dislodge the tool, including adding water and pushing down on the block, were unsuccessful. PG&E presented the issue encountered to DTSC and DOI on 5/23/23 and proposed to abandon and replace this well.

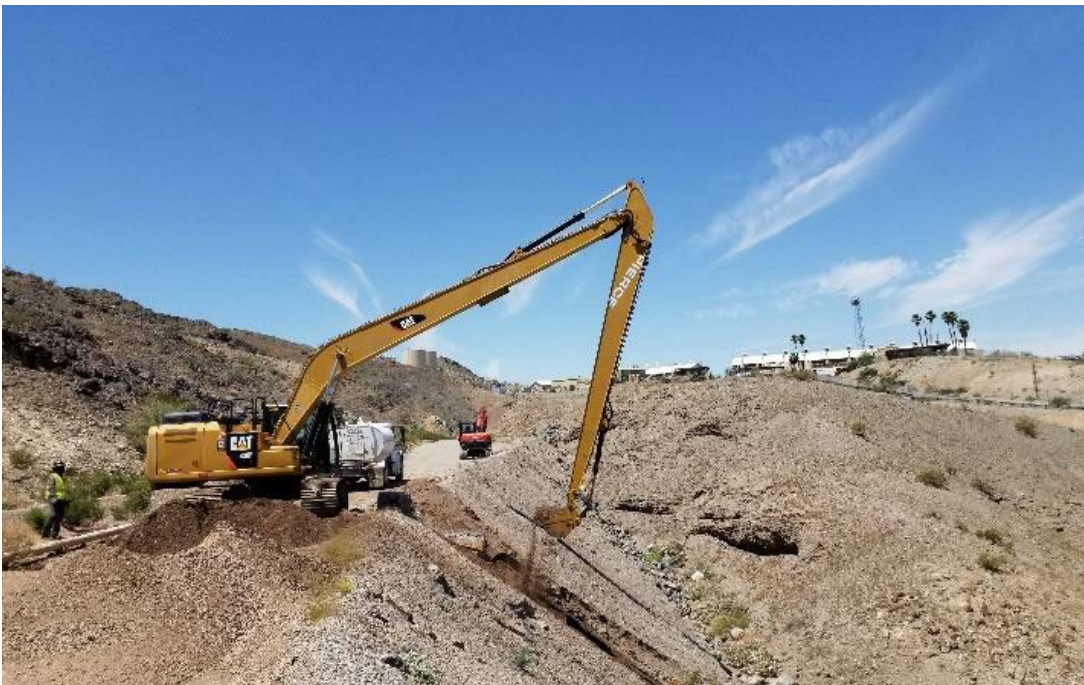
Photo showing repair of stormwater erosion control measures along Pipeline B access road.

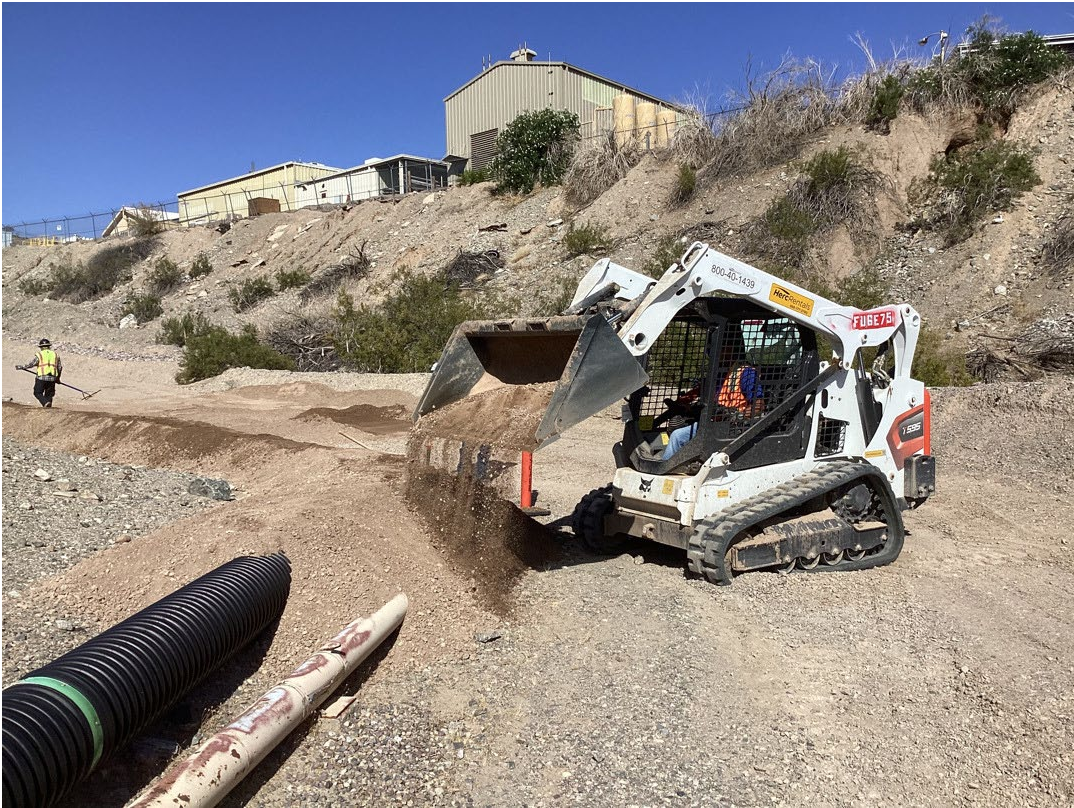
Photo showing shading over a stormwater drain pipe along Pipeline B access road.
