Pacific Gas and Electric Company

Topock Revegetation Year 1 Mitigation Monitoring Report

December 2023

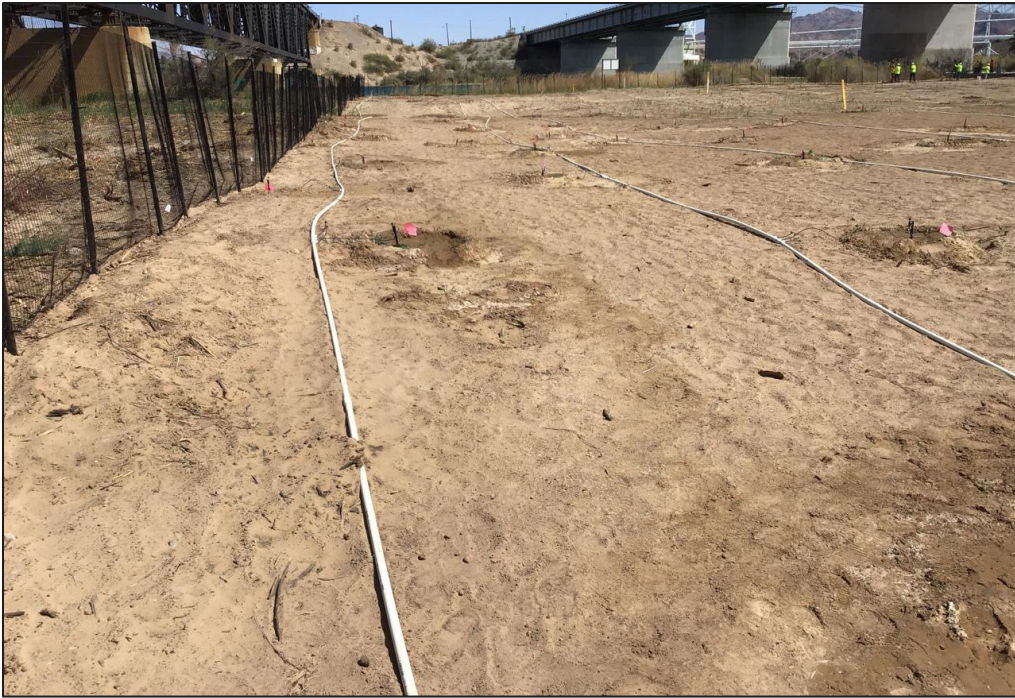
Photostation-001

Located on the northwest corner of Area 1 below and south of railroad bridge

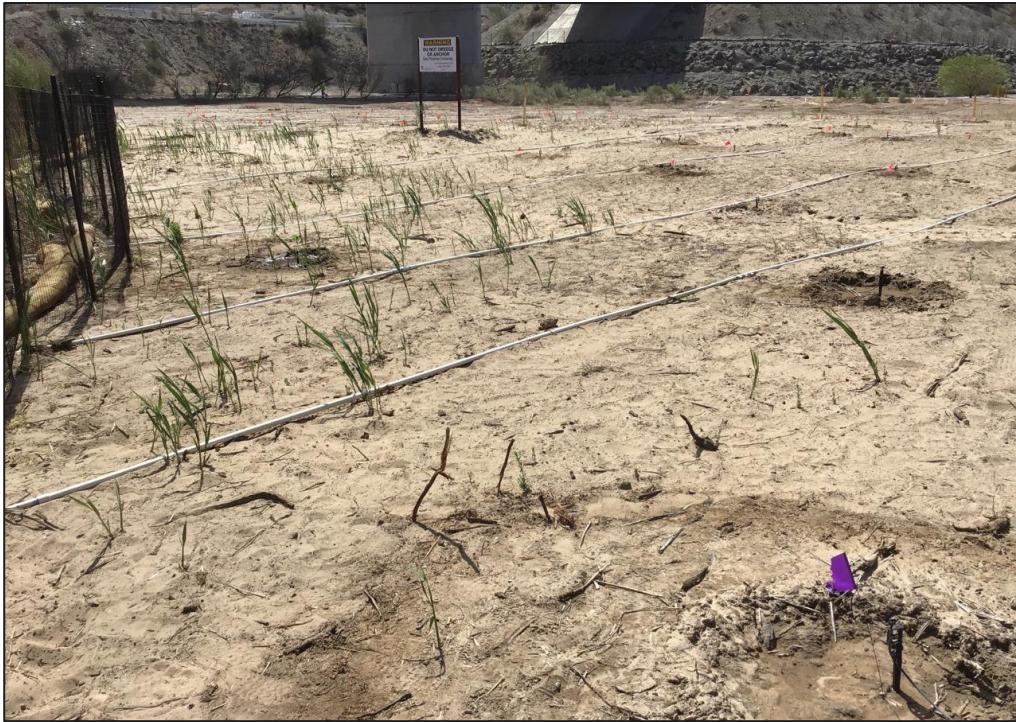
Photostation-002

Located on the northeast corner of Area 1 just west of the Colorado River

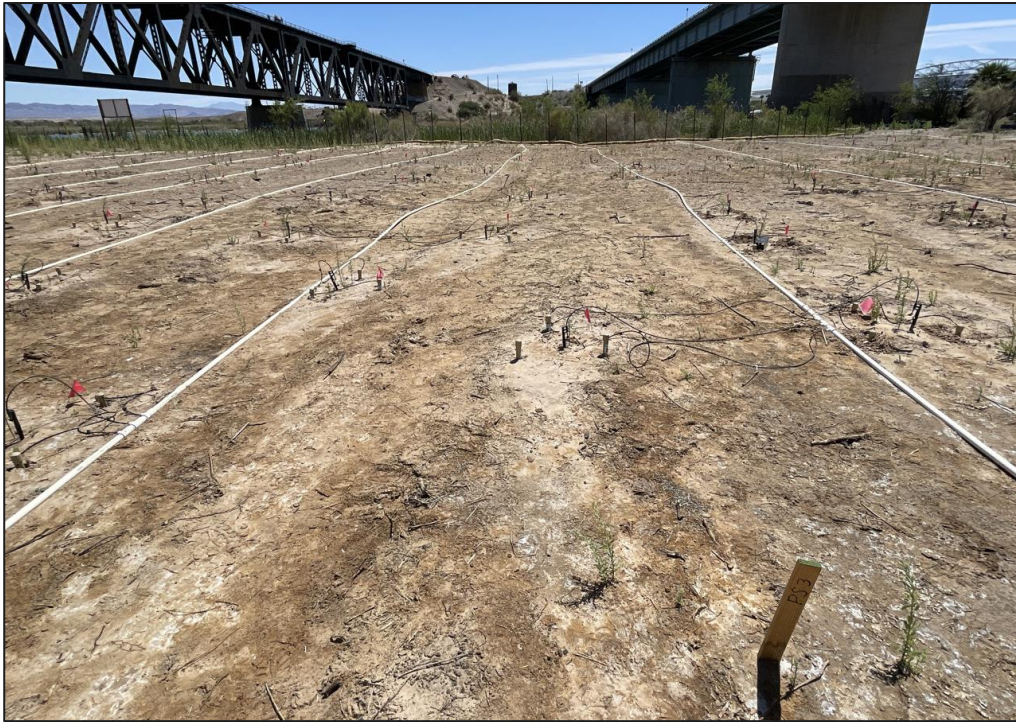
Photostation-003

Located in the center of Area 1 between the I-40 bridge and the railroad bridge

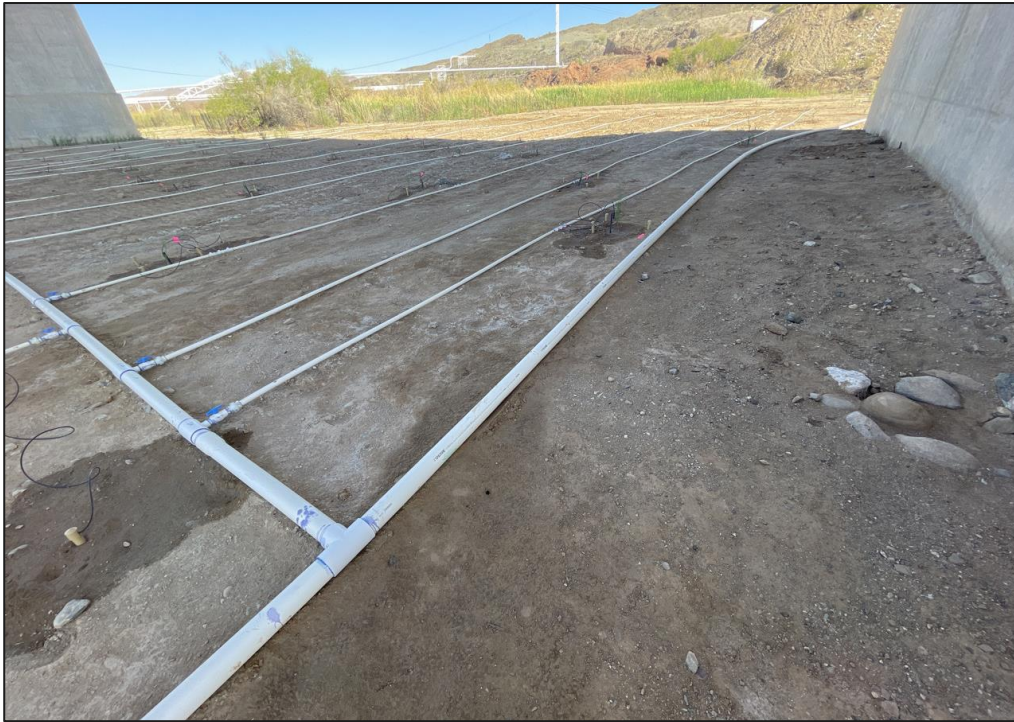
Photostation-004

Located in Area 2 in the northwest corner under the I-40 bridge

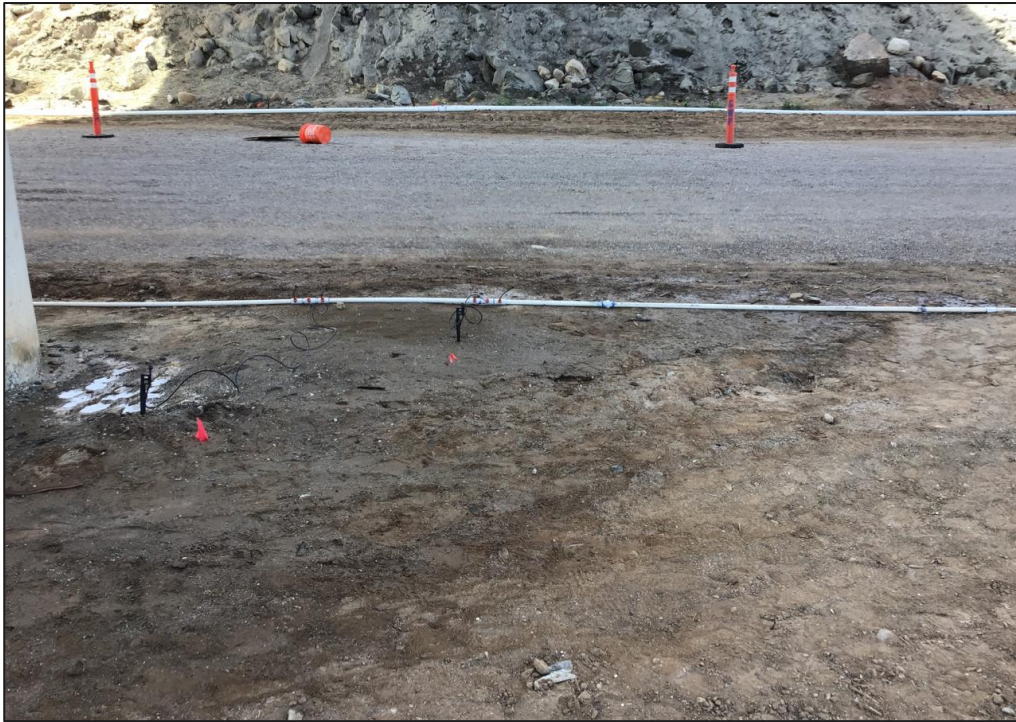
Photostation-004b

Located between Area 2
and Area 4

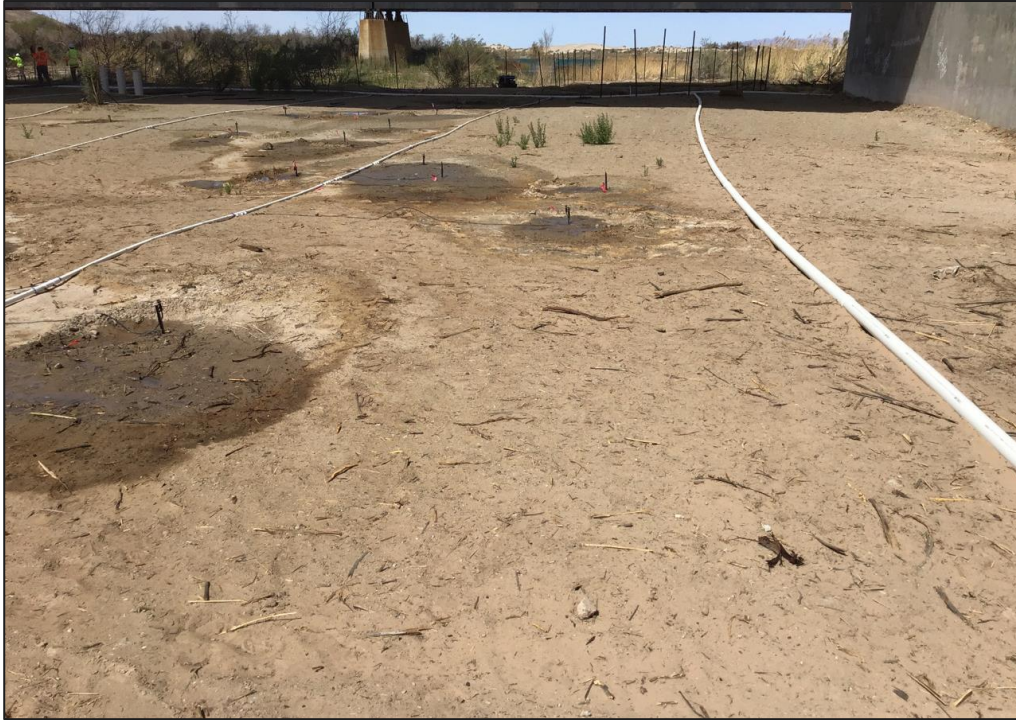
Photostation-005

Located in Area 2 near the eastern boundary south of the I-40 bridge.

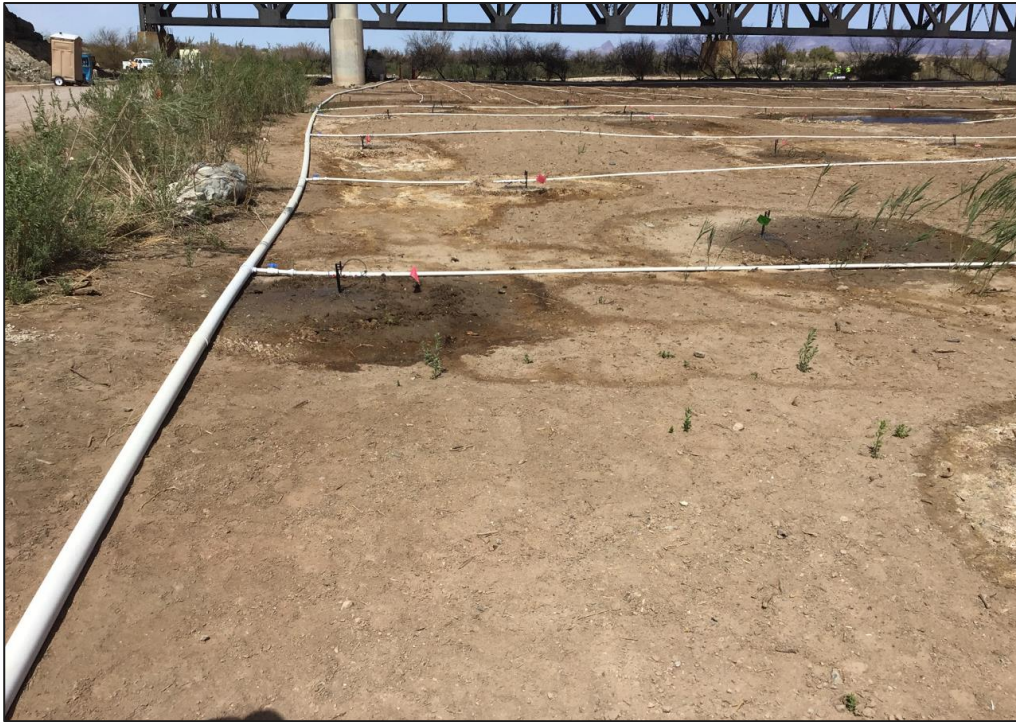
Photostation-006

Located in Area 2 near its western boundary in the southwest corner.

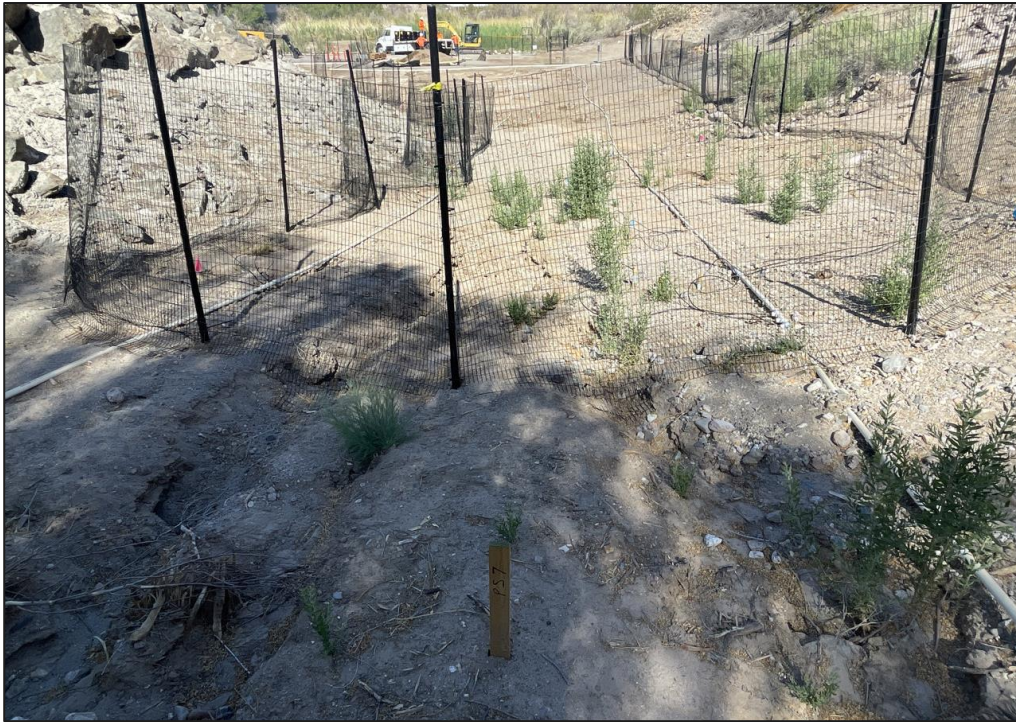
Photostation-007

Located in Area 3 at the western end

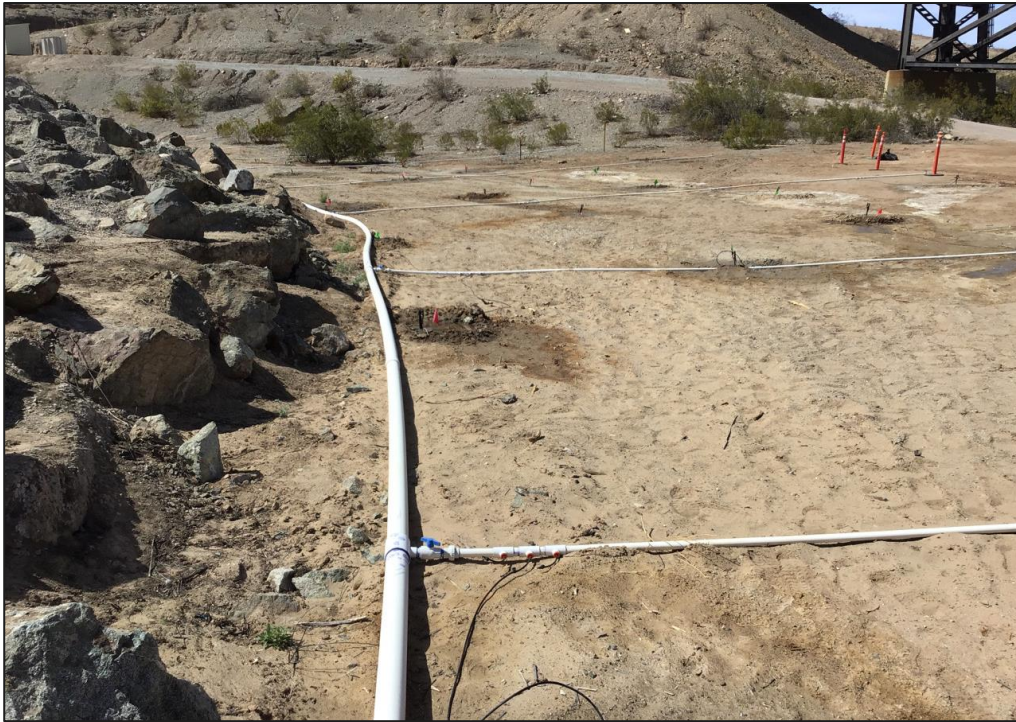
Photostation-008

Located in Area 5 along the southern perimeter

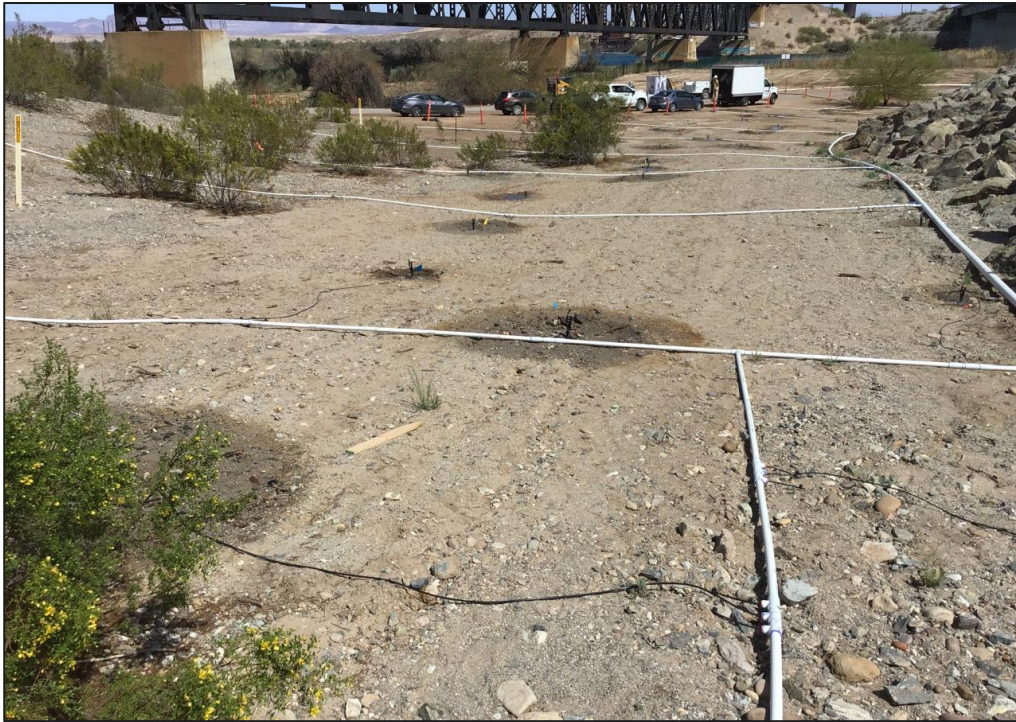
Photostation-009

Located in Area 5 near the furthest west corner

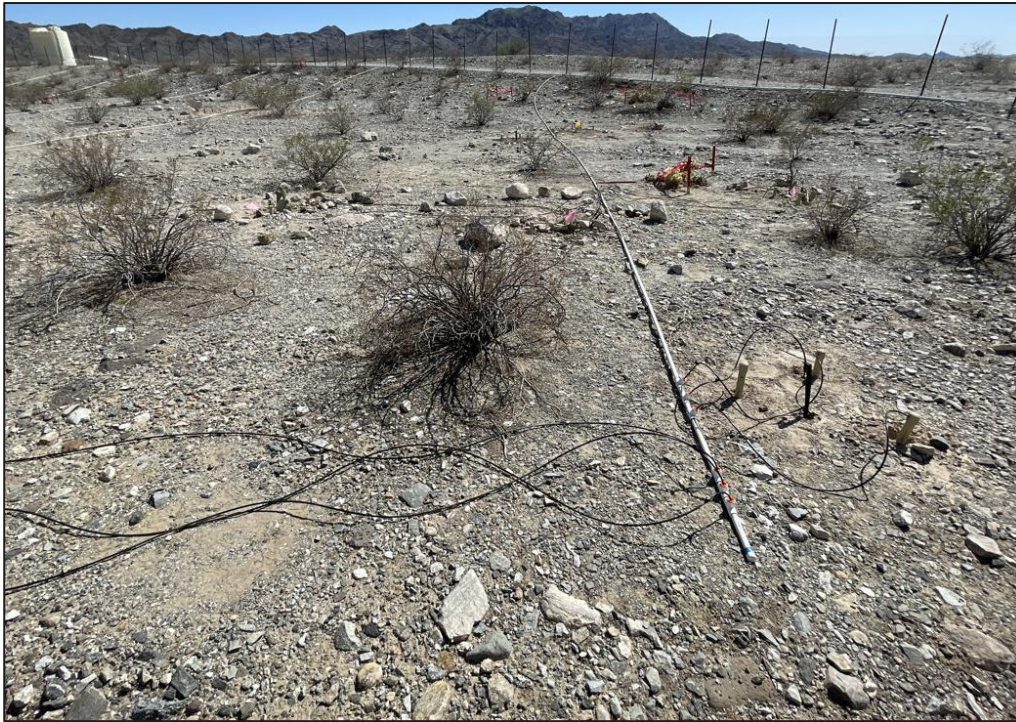
Photostation-012

Located in UHR-1 in the northernmost corner

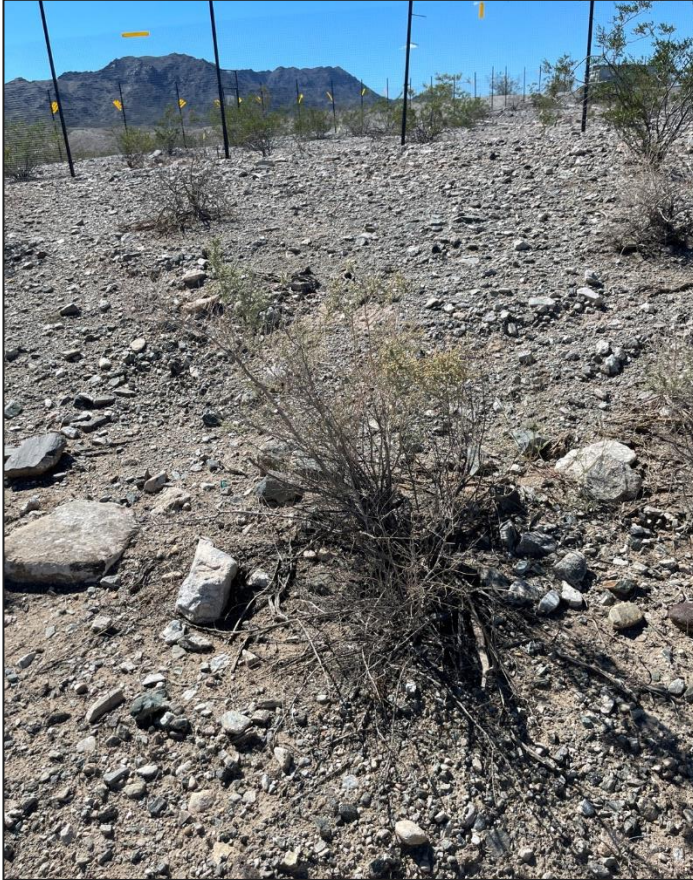
PS020 – RF-6 (October 7, 2022). Reference site located adjacent to UHR-1, a rocky slope that supports mitigation plant species, including cattle spinach, beavertail cactus, and buckhorn cholla. Native cover = 10%. View looking south.

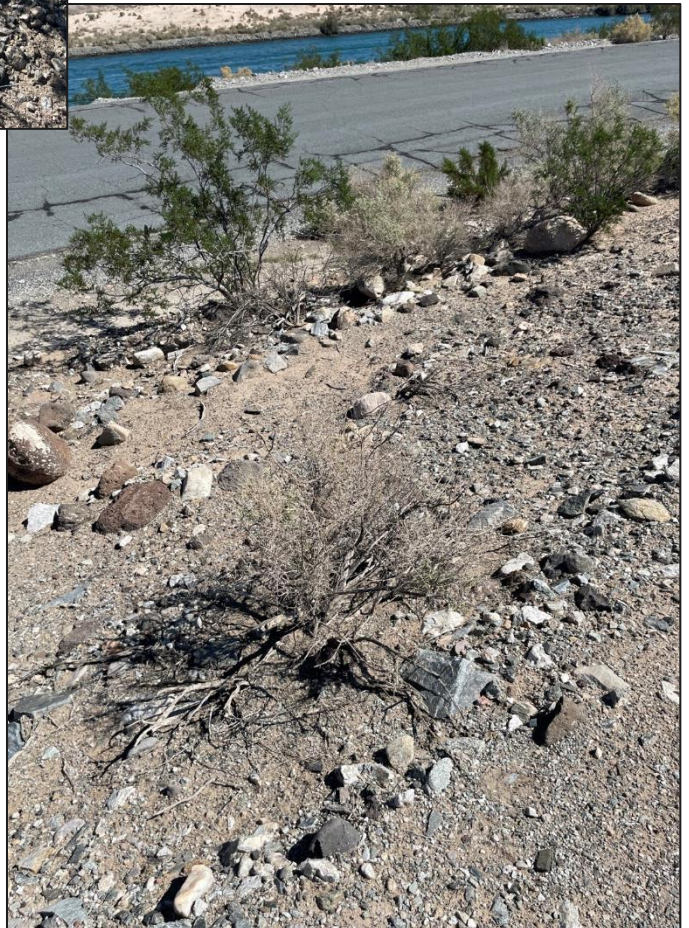
PS021 – RF-6 (October 7, 2022). Rocky slope just outside of UHR-1 supports mature individuals of mitigation plant species, including mature individuals of cattle spinach and beavertail cactus within a creosote bush-dominated community. Native cover = 10%. View looking east.
